Model : Finisher-D1**Ref. No.** : FF-T01-W-000087-01**Date** : October 8, 1999© Canon (UK) Limited

Location FEEDER ASSEMBLY**Subject** PERMANENT COUNTERMEASURE FOR POOR ALIGNMENT DURING SORTING WITH FINISHER D1**Reason** As a permanent countermeasure for poor alignment during sorting with Finisher D1, the shape of the stop arm has been modified.**Details** : <Symptom>
During staple sorting, the ejected paper is not properly aligned.

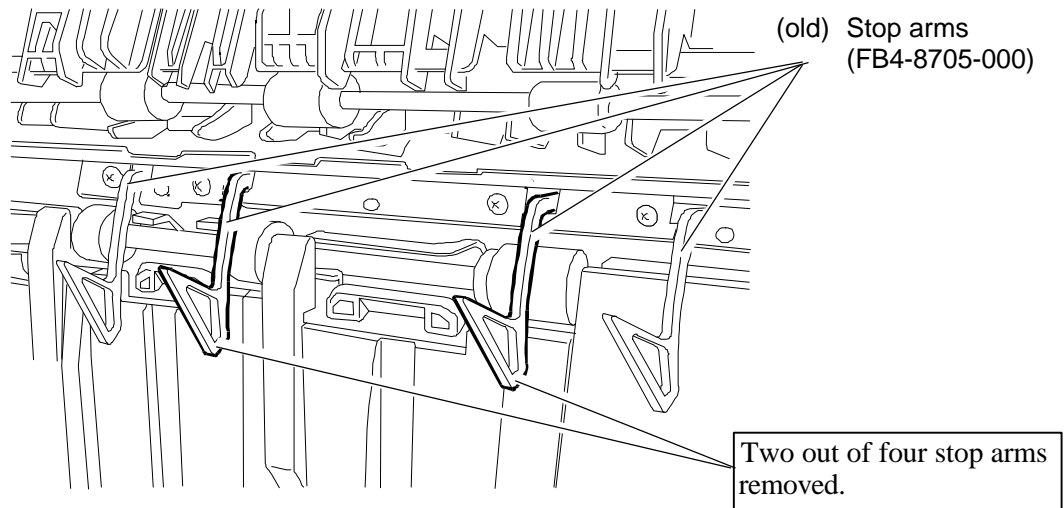
<Temporary countermeasure>

Due to the weight of the stop arm in the sort guide, a lower curl tends to develop when the paper is being ejected. In that case, if the paper being used has absorbed moisture, the curl will be all the more pronounced, leading to alignment failure during staple sorting.

As a temporary countermeasure, two out of the four stop arms were removed (see Service Information FF-T01-W-000055-01), and the modification of the shape of the stop arm is being implemented as a permanent countermeasure.
