Model : Saddle Finisher-D2

Ref. No. : FF-T01-W-000090-01

Subject : REDUCTION OF SOUND WHEN SIDE REGISTRATION OF PUNCH UNIT IS IN OPERATION

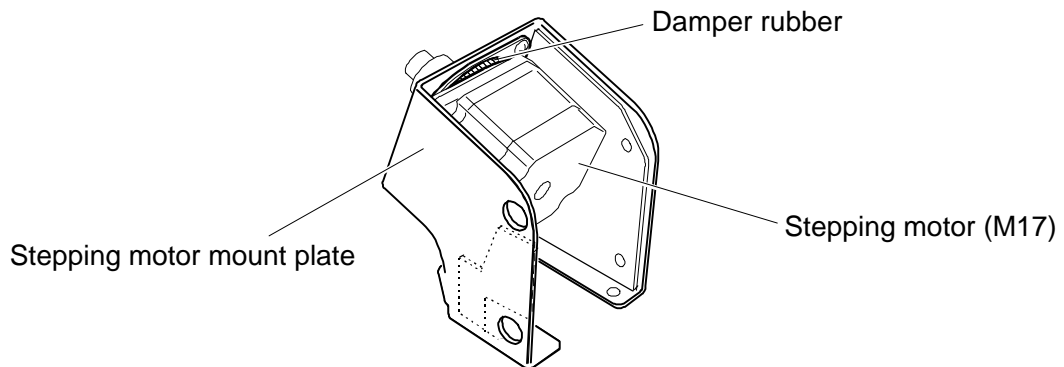
Fig. 1

The stepping motor (M17) is the source of vibrations, which cause the noise.

1. Vibrational noise from the stepping motor alone.
2. Vibrational noise from the stepping motor's gears and rack.
3. Slight noise from the punch slide unit.

1. As procedures to handle causes 1 and 2, the versions of the master ROM and slave CPU will be upgraded along with a change to the stepping motor unit.
 - 1-1. The stepping motor unit will be changed as follows. This change will serve to keep stepping motor (M17) vibration in check.
 - The hardness of the stepping motor's (M17) damper rubber will be lowered, resulting in absorption of vibrations (Fig 1).
 - A vibration-absorbing paint will be added to the stepping motor's (M17) mount plate (Fig 1).

- Servicing** : If the above symptoms occur, put the following 3 procedures into effect.
1. Replace the stepping motor unit with a new one.
 2. Replace the punch slide unit punch left cover with a new one.
 3. Simultaneously upgrade the master ROM (IC105) and the slave CPU (IC121) from Ver. 3 to at least Ver. 4.

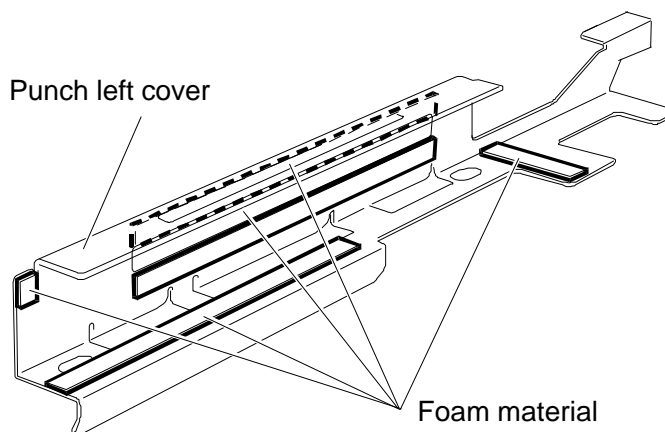
Fig. 2

2. As the procedure to handle cause 3, foam material will be added to 5 locations on the punch slide unit punch left cover (Fig 2). This change will reduce the slight noise in the punch slide unit.
