Model: Finisher-E1

Ref. No. : FF-T01-W-000137-02

Date : July 12, 2001

Subject: To prevent 0081 jam due to the stack delivery belt overrunning

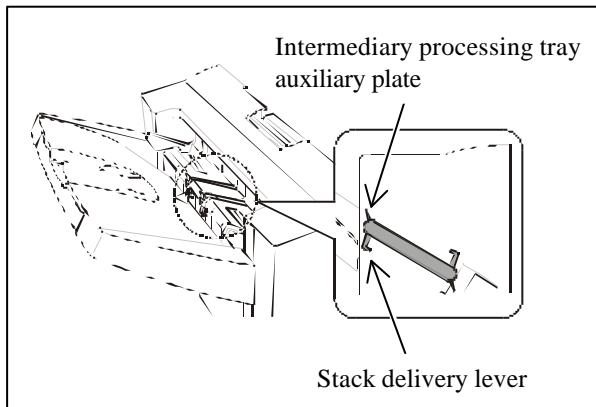
Correct stop position of stack delivery belt

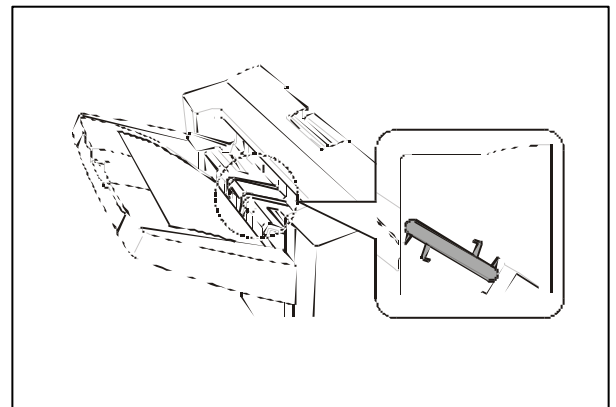
In some cases, the partially floating stack delivery belt may loose. As a result, the stack delivery lever of the stack delivery belt goes beyond the home position sensor (S8).

At 0081jam occurrence

Temporary: Until a permanent measure is implemented, mount a new part, the leaf spring, on the stack delivery pulley shaft.

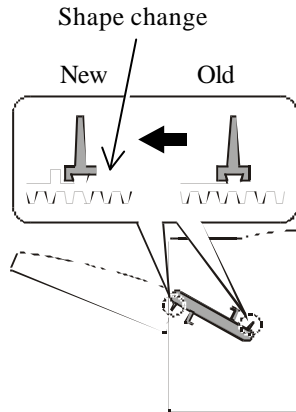
How to judge the belt:
 As for the countermeasure stack delivery belt,
 the shape of the root of the intermediary
 processing tray auxiliary plate is changed.

Permanent: The shape of the stack delivery belt is changed in an attempt to prevent the belt from floating. Along with it, a type of the tension tight screw for the stack delivery belt is changed from a binding screw to a binding screw with a washer.

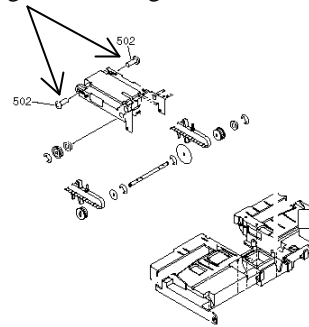
Tension tight screws
 for the stack delivery belt (2 pcs.):
 They were changed from the binding screw
 to the binding screw with a flat washer

Changed to binding screws with flat washer
