REVISION TO
30L-1 SERVICE BULLETIN NO. 1

SERVICE BULLETIN NO. 1

EQUIPMENT TYPE: 30L-1 R-F LINEAR AMPLIFIER

SUBJECT: WIRING CHANGE REQUIRED BEFORE CONVERSION FROM 115 TO 230-VOLT OPERATION IS MADE, USE OF 8-AMPERE LINE FUSES, AND CORRECTION TO INSTRUCTION BOOK DRAWINGS.

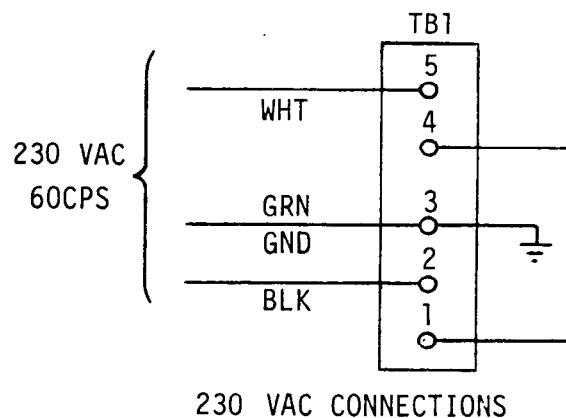
Figure 1

The procedure and schematic for converting operation of the unit from 115 to 230-volts, as detailed in the 5th edition of the 30L-1 R-F Linear Amplifier Instruction Book, dated 15 June 1962, is in error. These errors are corrected in the 6th edition of the above referenced instruction book, dated 15 June 1964. Before conversion is attempted the wiring changes detailed below must be made. After these changes have been made, the conversion can be made by changing the jumper wires on TB1 as shown in figure 1.

Termination of AC Power Cord at Terminal Strip TB1

1. Remove a-c power cord from the primary power source.
2. Lift the cabinet lid and remove the two Phillips-head screws located on the front panel rim.
3. Remove the four feet and the Phillips-head screw that is located between the rear feet.
4. Remove amplifier chassis from cabinet. The easiest way to do this is to place amplifier panel down on a padded surface.
5. Remove the screws from the bottom panel and both end panels of the amplifier. Lift out the bottom shield.
6. Move the white wire from the power cord from terminal 1 to terminal 2 on terminal strip TB1.
7. Move the lead of capacitor C4 from terminal 1 to terminal 2 of TB1.
8. Reassemble unit and return to operation. (Conversion from 115 to 230-volt operation and vice versa now can be made by connecting the jumper units on terminal strip TB1 as shown in figure 1.)

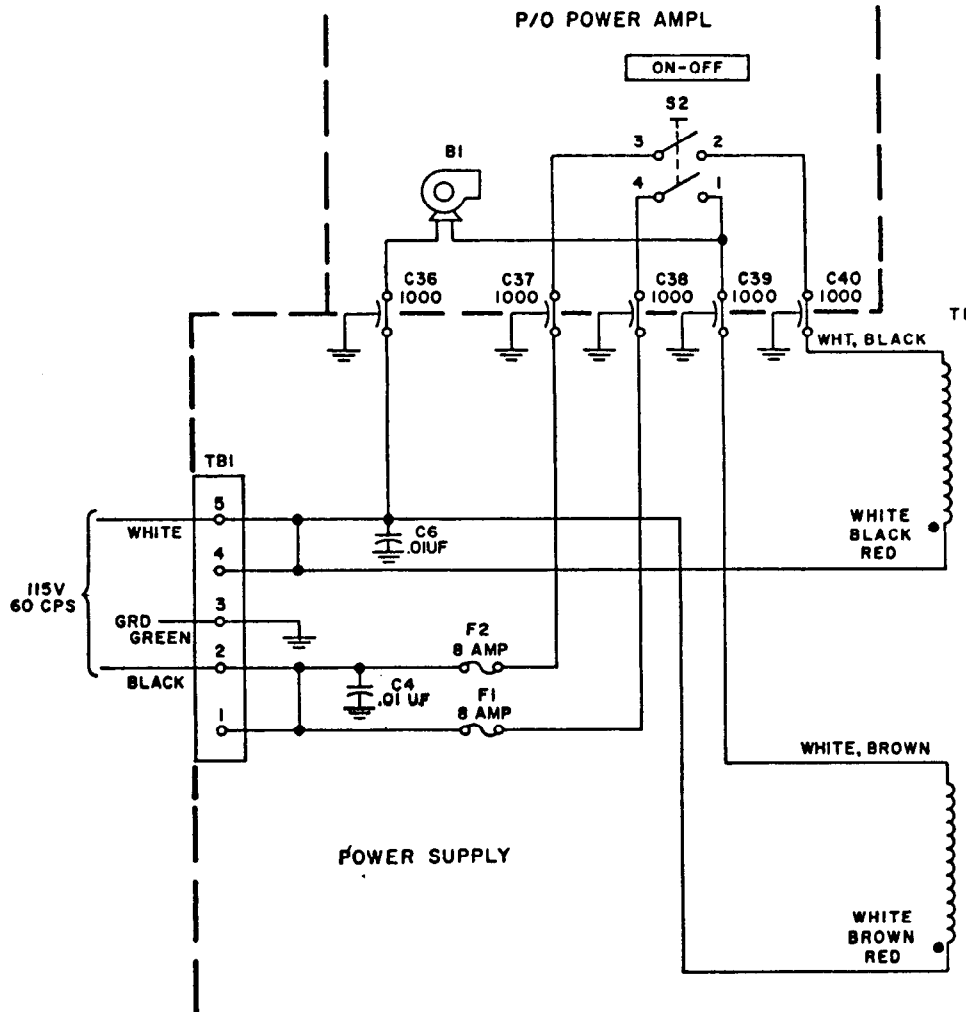
Figure 2

Figures 3-2 and 7-1 in the instruction book (up to and including the 5th edition) are in error and should be corrected as shown in figure 2. This correction applies only to the instruction book and does not involve changes to the equipment itself.

Corrected Partial View of Figure 7-1 in Instruction Book
