COLLINS RADIO COMPANY

30S-1 RF LINEAR AMPLIFIER

SERVICE BULLETIN NO 3

REDUCE EXCESSIVE ALC CONTROL

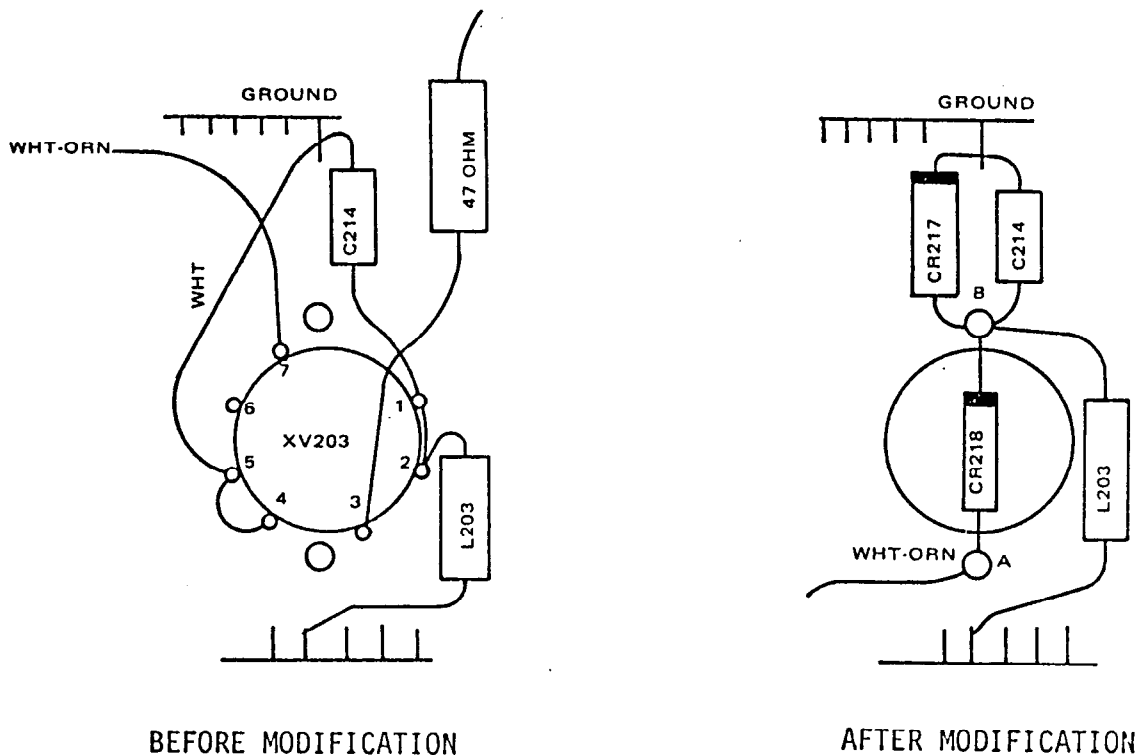
30S-1 SB 3 Modification, Components -- Wiring Locations
Figure 1

30S-1 units originally employed a 12AL5 dual-diode as the alc rectifier, V203. Some production runs of this tube exhibited high space-charge characteristics resulting in objectionable high standoff voltage on the alc line. The method recommended to ensure proper alc operating voltage is to substitute 1N457 silicon diodes for the tube.

NOTE: Refer to figure 1 for component and wiring locations in following steps.

3. Remove and discard white wire from XV203 pins 4 and 5 to terminal strip ground.
4. Remove securing hardware and lift socket XV203 out of the way.
5. Install two terminals A and B (306-0234-000) in removed XV203 socket mounting holes with screws (343-0285-000) and washers (373-8010-000).
6. Disconnect white-orange wire (from J202) at XV203-7 and reconnect it to terminal A.
7. Disconnect L203 lead from XV203-2 and reconnect to terminal B.
8. Disconnect C214 lead from XV203-1 and reconnect to terminal B. Discard XV203 that is now free of circuit.
9. Install 1N457 diode CR218 (353-0204-000) from terminal A to terminal B (banded end).
10. Install 1N457 diode CR217 (353-0204-000) from terminal B to terminal strip ground (banded end).

11. Replace shelf and R207 to unit and restore power removed in step 1. Check the amplifier for proper operation.
12. Mark SB 3 on information chart (280-3778-010) and apply to an appropriate location on the outside of the unit if it is your wish to identify unit as modified.
