#### **COLLINS RADIO COMPANY**

BULLETIN NO. 4A

EQUIPMENT TYPE: TRANSMITTERS 32S-1, 32S-2

SUBJECT: TO IMPROVE CW OPERATION

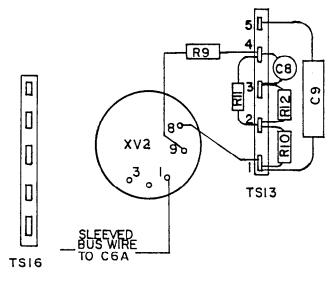
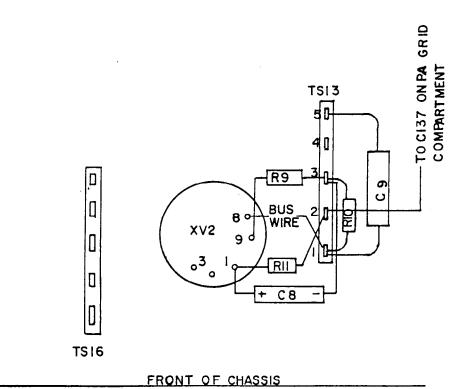
Figure 1. Physical Location of Cathode Follower Components Affected By This Modification.

The modifications described in this service bulletin are to provide improved CW operation of the transmitters. They consist of eliminating the spurious r-f signal that may be transmitted along with the main signal, and eliminating a short carrier "burst" that may occur immediately upon closing of the vox relay.

- 5. Change Cl15 from a 0.01- to a 0.05-uf capacitor (913-3679-00). This capacitor is located across the KEY jack on back of unit. (CW waveshape characteristics are affected by this capacitor, and the operator may change its value to suit his preference.)
- Remove 0.01-uf capacitor C8 which is connected between terminals 3 and 4 of TS13.
- 7. Remove 180K-ohm resistor Rll which is connected between terminals 2 and 4 of TS13.

- 8. Remove 15K-ohm resistor R12 which is connected between terminals 2 and 3 of TS13.
- 9. Remove 220-ohm resistor R10 which is connected between terminals 1 and 2 of TS13.

- 10. Remove wire which is connected from pin 1 of tube V2 to (+) side of 8-uf dual-section fixed electrolytic capacitor C6A. This capacitor is located adjacent to the BFO TEST.

- 11. Install new 10K-ohm resistor Rl1 (745-3394-00) from pin 1 of tube V2 to terminal 2 of TS13.
- 12. Install new 4-uf capacitor C8 (183-1783-00) from pin 1 of tube V2 to terminal 3 of TS13 with plus (+) lead connected to pin 1. It might be advisable to check if any possibility exists in which the (+) lead might short out to another component, if so, sleeve lead with insulation removed from lead of old C8.

- 13. Connect no. 22 AWG red (439-7068-00) from terminal 2 of TS13 to feed-through capacitor, C137, on PA grid compartment.
- 14. Install new 1K-ohm resistor R10 (745-1352-00) between terminals 1 and 3 of TS13.

- 15. Disconnect lead of 220K-ohm resistor R9 which is connected to terminal 4 of terminal strip TS13 and reconnect to terminal 3 of TS13. (The other end of R9 is connected to pin 9 of V2.)
