# SERVICE BULLETIN

COLLINS RADIO COMPANY

EQUIPMENT TYPE KWM-1

BULLETIN NO. 1

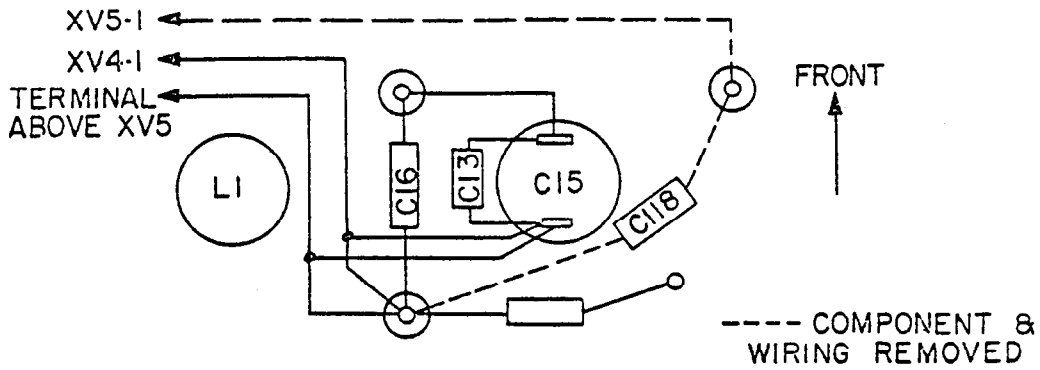
Figure 1. Wiring Location of L1 Shield Can

It has been noted that multiple beats are present in Calibrate position of the Emission Switch. The following modification will increase the strength of the correct calibration signal. Units using a type 6AU6 tube for V1 require this modification.

lead are connected to insulated terminal mounted on trimmer capacitor. Discard coax and capacitor. See figure 1.

7. Install a five inch length of coax cable (425 0926 00) from terminal directly over XV5 pin 9 (installed in step 5) to insulated terminal to which C16 and coax cable to XV4 pin 1 is connected. See figure 1. Ground coax shield to C15 as shown in figure 1. Ground shield at C15 end only.

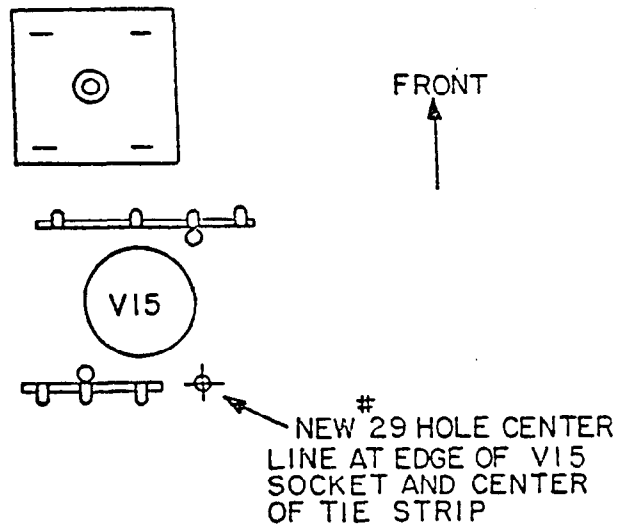
Figure 4. Location of Number 29 Hole for Installation of Insulated Terminal

In some KWM-1 transceivers a popping noise is evident when changing from receive to transmit. This noise may be greatly reduced by the following modification. Serial number effectivity 861.

1. Remove the 330K 1/2 watt resistor, R124, connected to terminal on terminal strip behind XV12. (See Figure 6). R124 should be removed by cutting from the strip and discarded.
2. Carefully drill a number 29 hole next to tie strip at rear of XV15 as shown in figure 4. Care should be taken not to damage cable harness.
3. Mount insulated terminal (306 0233 00) in hole drilled in step 2 using 4-40 x 3/16 screw (343 0284 00).
4. Connect a new 330K resistor, R124, (745 1457 00) from center terminal of terminal strip behind XV12 to insulated terminal installed in step 3.
5. Connect 330K resistor, R156, (745 1457 00) from insulated terminal installed in step 3 to
