KWM-2/2A TRANSCEIVERS (522-1611-000, 522-1792-000)

SERVICE BULLETIN NO 10

SUBJECT: Eliminate vhf parasitic oscillations in tone oscillator, V2B

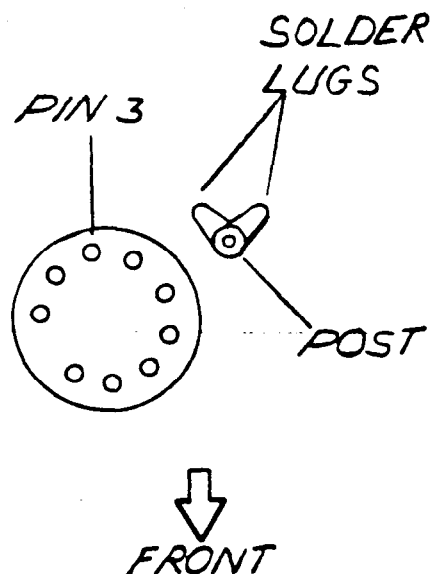
V2 Socket, Bottom View
Figure 1

Some units may have an audible 1000-Hz tone in CW mode with the key open. This is caused by vhf parasitic oscillations modulating the tone oscillator.

A 47-ohm resistor is added in series with the screen grid of tone oscillator V2B to act as a parasitic suppressor.

- c. Refer to figure 1 and perform the following:
1. Locate and disconnect the 0.1- μ F capacitor, C49, and the 100-k Ω resistor, R49, from pin V2-3 (leave other ends connected).
 2. Remove and discard hardware securing solder lugs (near V2) to chassis.
 3. Install new post (306-0977-000) on top of two solder lugs by V2, using new screw (343-0286-000).
 4. Connect one end of new 47-ohm resistor (745-1296-000), R215, to pin V2-3 and other end to new post.
 5. Connect R49 and C49 leads (disconnected in step c.1) to new post.
- d. Reassemble cabinet.
- e. Check transceiver for proper operation and verify that no audible tone exists in CW mode with the key open.
- f. Enter SB 10 on the information chart (280-3778-010); apply chart to convenient location on unit if one is not present.
