KWM-2/KWM-2A TRANSCEIVERS SERVICE BULLETIN NO 3 (REISSUE)

EQUIPMENT: KWM-2 Transceiver (522-1611-000)
KWM-2A Transceiver (522-1792-000)

SUBJECT: Correlation Between Frequencies on Different Bands

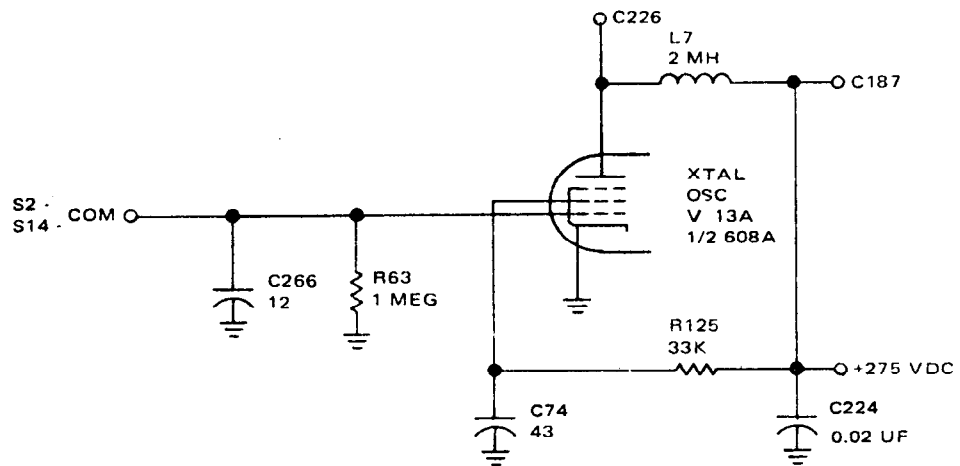
KWM-2 After Modification, Schematic Change

NOTE:
C266 NOT USED IN KWM-2A.

- c. Remove and discard 27-pF capacitor C266, if present, from XV13A pin 2 to the center shield of V13 (ground), and install at this location a 12.0-pF capacitor (912-2757-000), KWM-2 only.
- d. Remove and discard 47-k Ω resistor R125 from XV13A pin 2 to vector terminal board E100, and replace with 33-k Ω resistor (745-1415-000).
- e. Remove and discard 47-pF capacitor C74 from XV13A pin 3 to ground, and replace with 43.0-pF capacitor (912-2789-000).
- f. Inspect unit for damage incurred during modification, dress wires and cables, and remove debris.
- g. Reassemble unit by reversing step a.
- h. Check transceiver for proper operation.
- i. Mark information chart (280-3778-010) SB 3R. Apply chart to convenient location on unit if one is not present.
