REVISION TO  
32S-3 SERVICE BULLETIN NO. 1

## SERVICE BULLETIN NO. 1

EQUIPMENT TYPE: 32S-3 TRANSMITTER

SUBJECT: IMPROVE VOX CIRCUIT TO ELIMINATE INTERMITTENT DROPOUT, AND IMPROVE OPERATION OF FIRST AUDIO AMPLIFIER

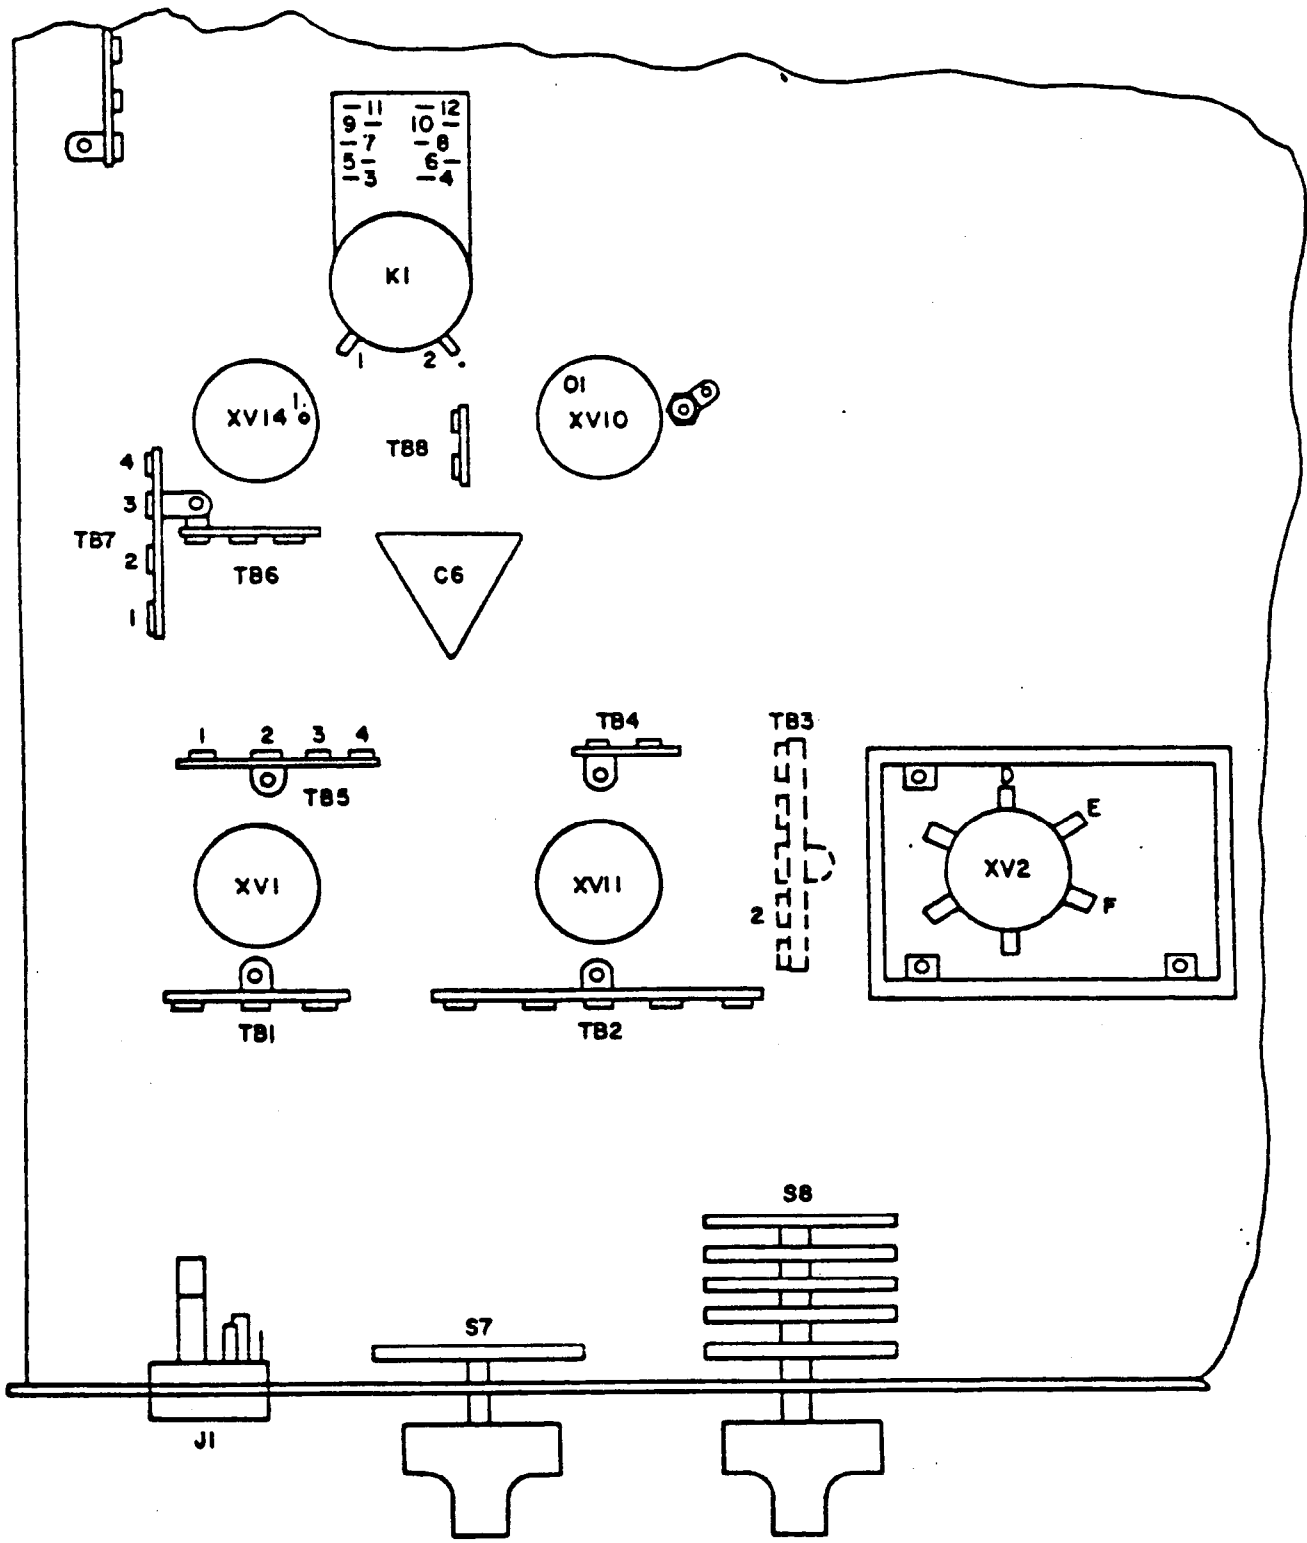
The modification described in this service bulletin has two purposes. First, an improvement is made to the vox circuit to eliminate intermittent dropout of the vox relay. For this modification, alteration of VOX/ANTI-VOX circuit gain, and changes in the associated time constants are required. It is suggested that this modification be made to all units experiencing vox relay dropout difficulties.

The second purpose of this modification is to improve the overall performance of the first audio amplifier. It has been established that choke L1 in the grid circuit of tube V1 is self-resonant at random frequencies, which sometimes results in various unrelated malfunctions. These malfunctions usually occur when accessories (phone patch, linear amplifier, etc.) are employed. Choke L1 is replaced with a resistor, and the circuit for V1 is altered to perform this modification.

32S-3 Chassis, Partial View Showing Location of Components Affected by This Modification

1. Substitute new 47K resistor R138 (745-1422-000) for choke L1. The choke is connected between tube socket XV1, pin 9, and terminal strip TB1.
3. Substitute new 100K resistor R101 (745-1436-000) for 1-megohm resistor R101. This resistor is located on terminal strip TB1.

4. Connect new 0.1-uf capacitor C188 (913-3152-000) between XV1, pin 8, and the ground terminal of terminal strip TB5.
5. Substitute new 0.02-uf capacitor C119 (913-2142-000) for 0.1-uf capacitor C119. Capacitor C119 is located between tube socket XV10, pin 5, and terminal 11 of relay K1.

6. Connect two new 0.1-uf capacitors C186 and C190 (both 913-3152-000) in parallel between XV10 pins 5 and 7.
7. Connect new 20-uf capacitor C184 (183-1165-000) between XV14, pin 8 (positive lead), and TB7, terminal 3 (negative lead).

8. Connect new 20-uf capacitor C185 (183-1165-000) between XV14, pin 3 (positive lead), and TB5, terminal 2 (negative lead).
9. Substitute a new 220K resistor (745-1450-000) for 680K resistor R73. Resistor R73 is connected between XV2, pin 9, and TB3, terminal 2. Transmitters that have a shield around XV2 do not have a terminal board TB3, and R73 is connected

between XV2, pin 9, and XV2, terminal F. To remove the shield, disconnect the choke L2 lead from XV2, terminal E, and the capacitor C92 lead from XV2, terminal D. Remove the three screws that secure the shield in place. These screws are removed from the top of the chassis. After R73 has been replaced, reconnect the component leads to the original terminals, and replace the shield.

10. Substitute new 6-pf capacitor (916-0122-000) for 3-pf capacitor C28 (see figure 6-8, fourth edition of 32S-3 Transmitter Instruction Book, for location of C28).
11. Locate and remove 20-uf capacitor C183 from FREQ CONTROL switch wafer S9F.
12. Replace transmitter chassis in cabinet and secure in place with the hardware removed in step 1.
