516F-2 AC POWER SUPPLY (522-1170-000)

SERVICE INFORMATION LETTER 1-76

PREVENT FUSE BLOWING CAUSED BY ARCING IN THE VACUUM TUBE RECTIFIERS

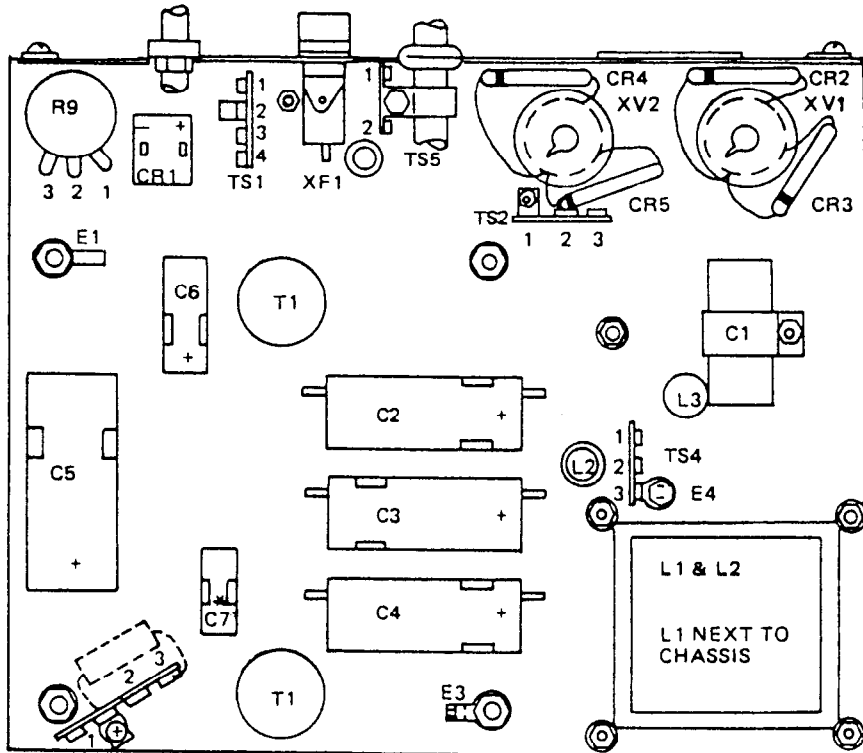
CR2, 3, 4, 5 Mounting Location
Figure 1

A few problems have been reported from the field concerning blown fuses in the 516F-2 power supply. Investigation has shown that the cause of the problem is arcing in rectifier tubes V1 (5R4GYA) and V2 (5U4GB). However, most of these tubes are performing satisfactorily so this service information letter is intended only for those power supplies that have a fuse blowing problem.

Vacuum tubes V1 and V2 should be removed and Semtech SCH-5000 solid state diodes (CPN 353-0425-010) should be installed as follows.

<u>DIODE</u>	<u>FROM</u>	<u>TO</u>
CR2	XV1-8 (cathode)	XV1-4
CR3	XV1-8 (cathode)	XV1-6
CR4	XV2-8 (cathode)	XV2-4
CR5	XV2-8 (cathode)	XV2-6

This change will increase the output voltage to the KWM-2/2A and 32S-() transmitters by approximately 12 percent. The respective bias must be adjusted using the transmitter instruction books as a guide. It is recommended that the transmitter final amplifiers be kept at resonance at all times and that the swr always be less than 2:1.
