# SERVICE BULLETIN

# No. SB-300-1-11

# Safety clamps on Garmin avionics units located in subpanels

Aircraft affected: EA 300 including models EA 300/S, EA 300/L, EA 300/200, EA 300/SC, EA 300/LT and EA 300/LC aircraft manufactured before July 2011 and equipped with optional Garmin avionics units (GNC 250XL, GTX 320, GTX 320, GTX 327, GTX 328, GTX 330, GNC 420[W], GNS 430[W], GNS 530[W]) within the instrument subpanel.

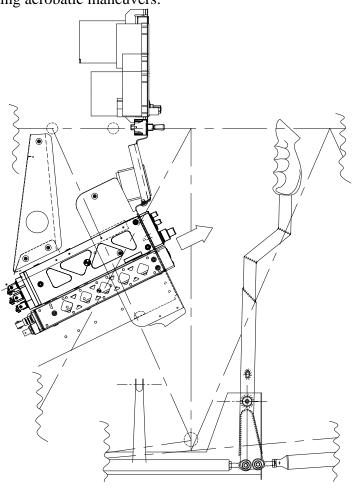
**Purpose:** It has been reported that a Garmin transponder GTX 328 slid out of its rack in a EA 300/L and jammed against the control stick while performing acrobatic maneuvers.

Figure 1: Slide out of units when not securely locked

Initial investigation showed that the front lobe of the locking mechanism was not in the full  $90^{\circ}$  vertical position to securely lock the unit in its rack. All above mentioned Garmin units feature the same locking mechanism.

As an unsecured Garmin unit could result in a restricted pitch down control input, appropriate action has to be taken to make sure that the units located in the subpanel are always secure.

Safety clamps are introduced to prevent the units to slide out when the Garmin locking mechanism fails or is improperly used.

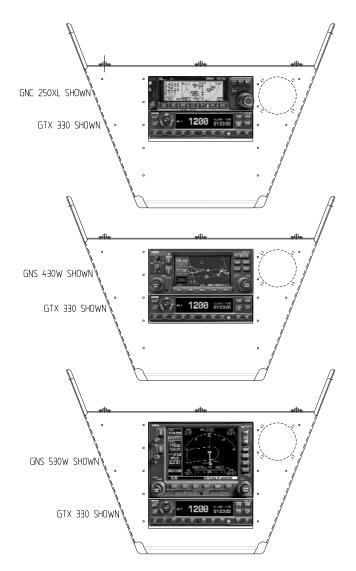
Figure 3: Typ. arrangements of Garmin avionics units within the EA 300/L instrument subpanel

Part II addresses the retrofit of two (2) safety clamps to the Garmin units installed in the instrument subpanel as an additional safety means to the locking device of the affected Garmin units. There are many different configurations/arrangements of Garmin avionics units within the instrument subpanel in the field. See figure 3 for typical installations.

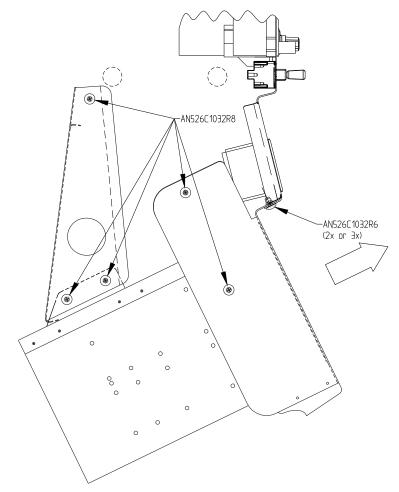
Figure 4: Attachment screws of the the instrument subpanel (EA 300/L shown)

- Disconnect wirings of electrical units located in the instrument subpanel (as required)
- Unscrew AN526 series attachment screws from the instrument subpanel and remove the subpanel in rearward direction to the pilots seat while the control stick is in the most LH or RH control input position (see figure 4). In some cases the LH and RH AN526 fuselage attachment screws of the instrument panel have to be unscrewed as well.

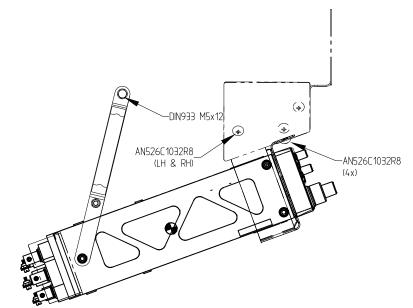
Figure 5: Attachment screws of the the instrument subpanel (EA 300/S shown)

- b) For single seater variants/models:
- Remove canopy per Chapter 53-00-10
- Remove the engine cowling and main fuselage cover 51-00-01 (as appropriate)
- Disconnect wirings of electrical units located in the instrument subpanel (as required)
- Unscrew AN526 and DIN 933 attachment screws of the instrument subpanel and remove the subpanel in rearward direction to the pilots seat while the control stick is in the most LH or RH control input position (see figure 5). In some cases the

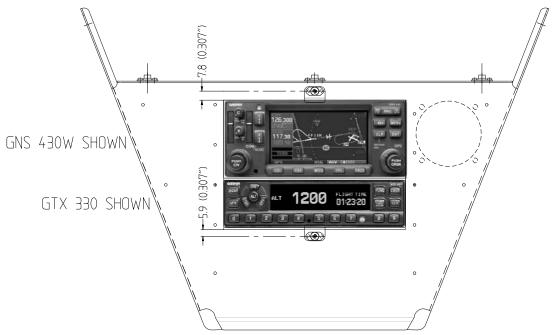
Figure 6: Position of safety clamps (EA 300/L shown)

The easiest way is to position one safety clamp in the center line on top and the second one below the units (see Figure 6.).

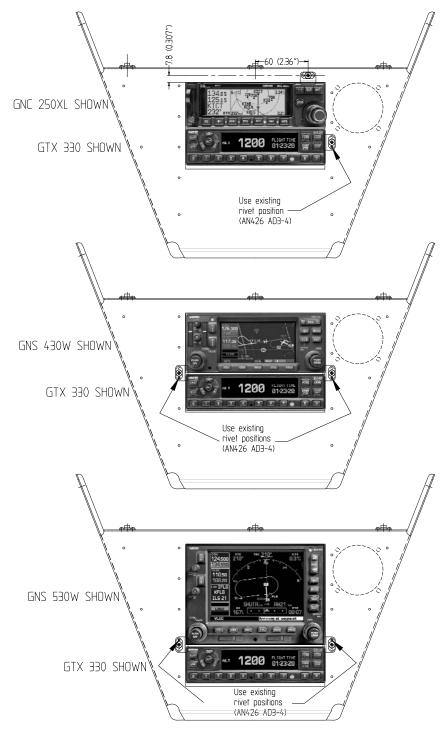
*Figure 7: Alternative position of safety clamps (EA 300/L shown)*

If the configuration prevents this a RH and LH position or a combination is appropriate. Positions for the LH and RH are established by existing rivets (refer to Figure 7). Other positions may also be appropriate. The solid aluminum countersunk rivet positions can be easily recognized from the rear.

- For LH and RH positioned safety clamps: Remove the two (2) identified solid aluminum countersunk rivets.
- Drill needed holes for the nutplates used to attach the two (2) safety clamps at the appropriate locations.

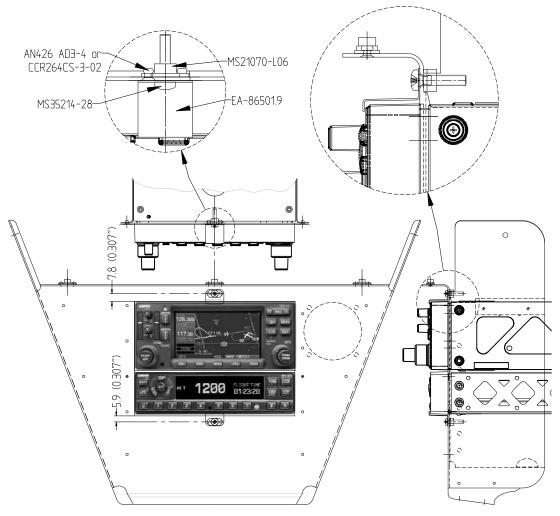
Figure 8: Typical installation of safety clamps (top/bottom)

- Install the nutplates using solid aluminum countersunk or nut plate flush head rivets (refer to figure 8. and 9.).

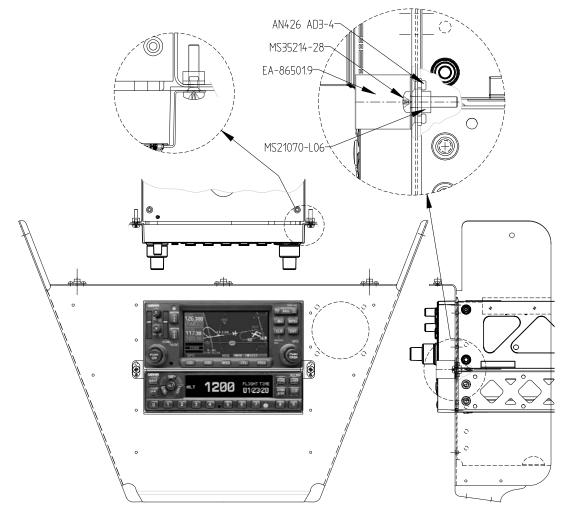
Figure 9: Typical installation of safety clamps (LH & RH)

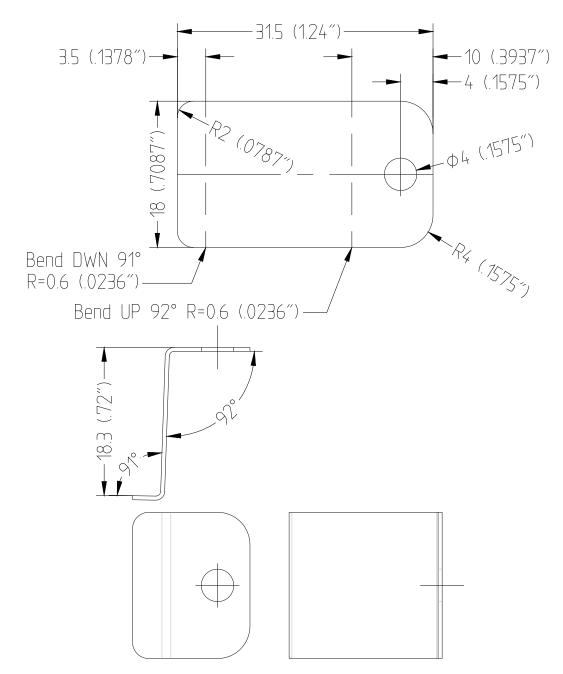
Figure 10: Suitable safety clamp made of stainless steel sheet, 0.5mm [0.015"] thick
