Service Bulletin EA-300 & EA-300/S Date : Doc.: SB-300-1-93 Issue: B 09.02.1993

SERVICE BULLETIN No. 300-1-93

Subject: Rudder Control Cable Compression Sleeve

Models affected: EA-300, EA-300/S

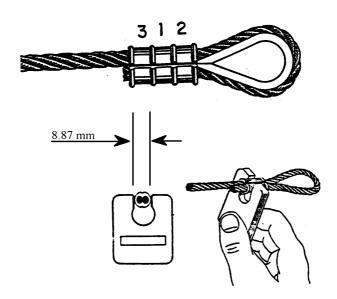
Figure 1. Correct width of sleeves after compression.

Note: Compression sleeves are used on both ends of both control cables.

The compression sleeves are Nicopress[®] plain copper 18-3-M type.

- Check rudder control cable compression sleeve according to AC 43.13-1A and Nicopress[®] Operating Instructions. Please refer to the attached sketch for the measurement.
- If change of compression sleeve is found to be necessary, change entire control cable. In any case use correct aligned Nicopress[®] tool and compression sleeves only.
- Make appropriate entry of compliance with this Service Bulletin in aircraft logbook.
