Service Bulletin EA-300/200 Inspection/Repair Landing Gear Mounting Attachment

No. 300-2-04

Subject: Inspection/Repair of Main Landing Gear Mounting Attachment

Affected Aircraft: EA-300/200 S/N 1 through 31 and 1032 through 1034

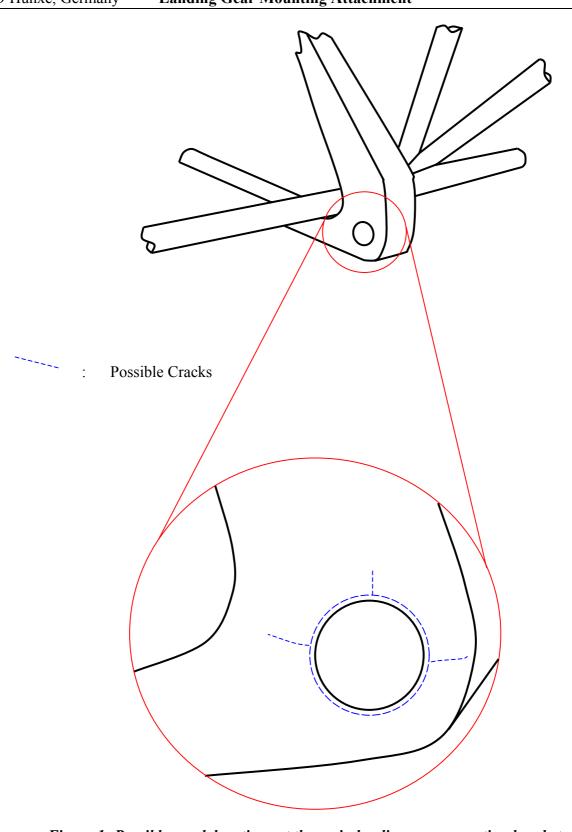
Figure 1: Possible crack locations at the main landing gear mounting brackets

Purpose: Cracks have been reported around the bushings of the main gear

- 5. Inspect the bushings of the fuselage landing gear attachment fittings for damage. The circular welding connecting the bushing to the bracket is suspected to show first signs of hairline cracks. From here, cracks in the radial direction could be initiated. If necessary, remove paint at suspected areas and use dye penetrant check, refer to AC 43.13-1B, Chapter 5, Section 5. Visually check for cracks at the bracket locations indicated by dotted lines in Figure 1. Perform this on both sides of the front and rear brackets on both sides of the aircraft (i.e. 8 locations).
