## SERVICE BULLETIN

### No. SB-300-2-97

**Subject:** Fuselage structure / tail spring support

**Aircraft affected:** Following models and SN  
EA-300/L: S/N 01-170, 172, 173 and  
1171, 1174-1299

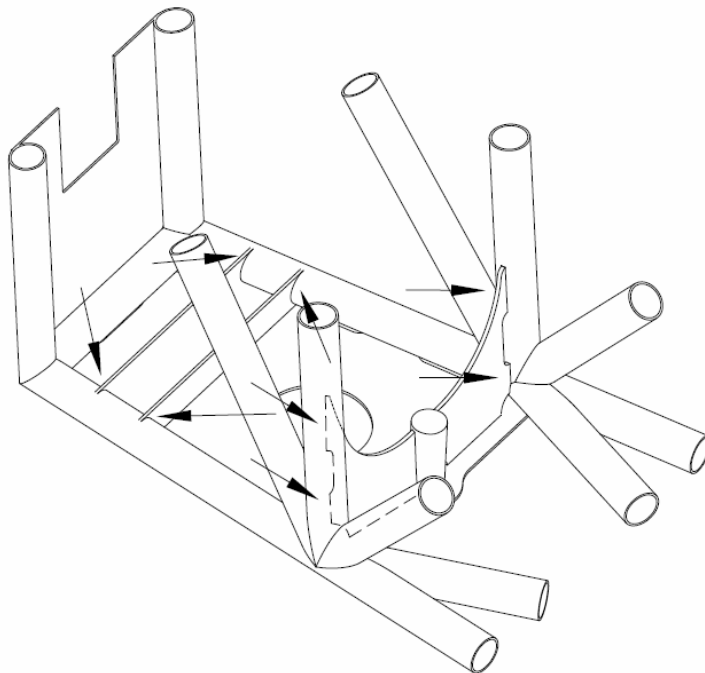
**Purpose:** The combination of a redesigned tail spring support, a stiffer tail spring and rough field operations has led to cracks in the tail spring support mounting base.

- Remove elevator control inspection window
- Visual inspection of tail spring mounting along welds to fuselage tubing. Cracks have been reported at the spots marked in figure 1. Investigate these areas carefully. To assist the visual inspection it is helpful to use a torchlight and a magnifying glass.
- In case cracks are found proceed with the instructions of PART II.
- In case no cracks are found reinstall elevator control inspection window and make appropriate entry of compliance in aircraft logbook.

*Figure 1: Possible crack locations in the area of tail gear spring attachment (retrofit plates of SB-300-2-97 issue A installed)*

- Inspect tail spring mounting base for previously unnoticed cracks, especially at the spots marked in figure 1.
- Remove paint from fuselage tubes and tail spring mounting plate for welding in cracked areas and installation of the retrofit plates.

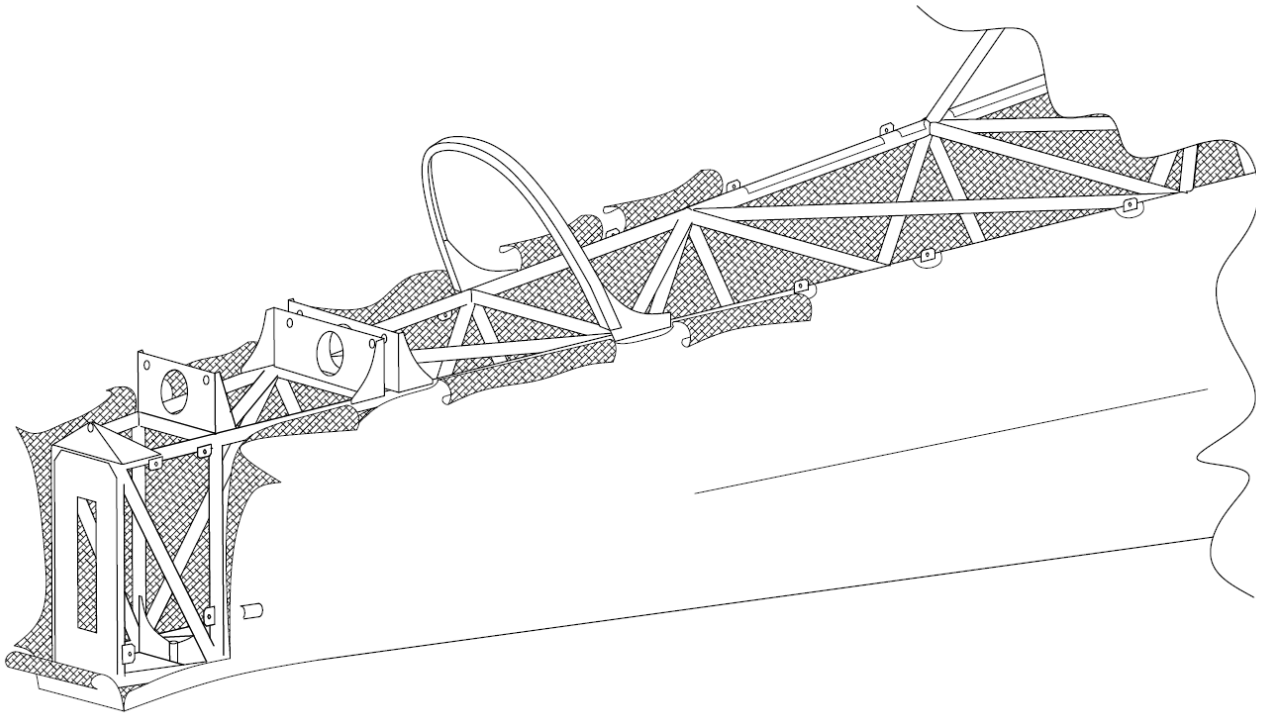
*Figure 2: Removing the fabric*

- Remove tail spring assembly, according Chapter 32 of the Service Manual.
- Disconnect battery ground wire and engine ground wire to firewall.
- Peel off fabric from upper L/H and R/H longeron, from rear facing fuselage surface and R/H lower longeron in the area of the inspection window (refer to figure 2 for detailed sketch). Do not use sharp objects that could damage the fabric while peeling it off. Fold the fabric far enough forward to have sufficient access to the area for welding. Make sure to work gently in order not to introduce cracks in the fabric paint coat finish.

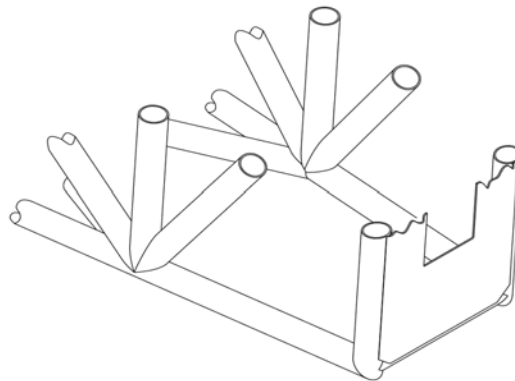
*Figure 3: Cutout for crack repair and retrofit*

- Cut out tail spring mounting plate including front and rear stiffener (figure 3 shows detail of rear truss after cutting). Proceed with caution. Avoid damaging any truss tubes (except those tubes that are replaced).

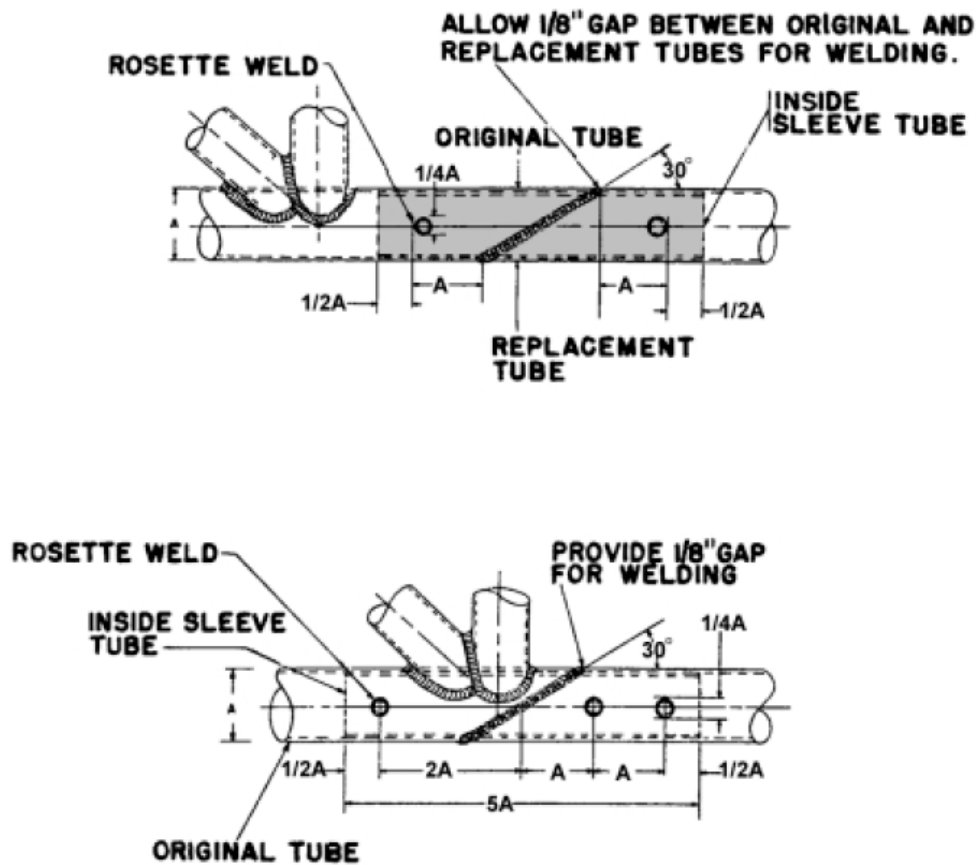
Figure 4: Method of inner sleeve splicing, recommended for tubing crack repair  
(ref. AC 43-13-1B, Aircraft Inspection and Repair, Chapter 04)

- Repair any cracks found. Refer to Chapter 51-70-05 "Structural Repair of Steel Components" of the Service Manual and figure 4.
- Weld retrofit plates in place, refer to figure 5 for correct position of plates and welds.

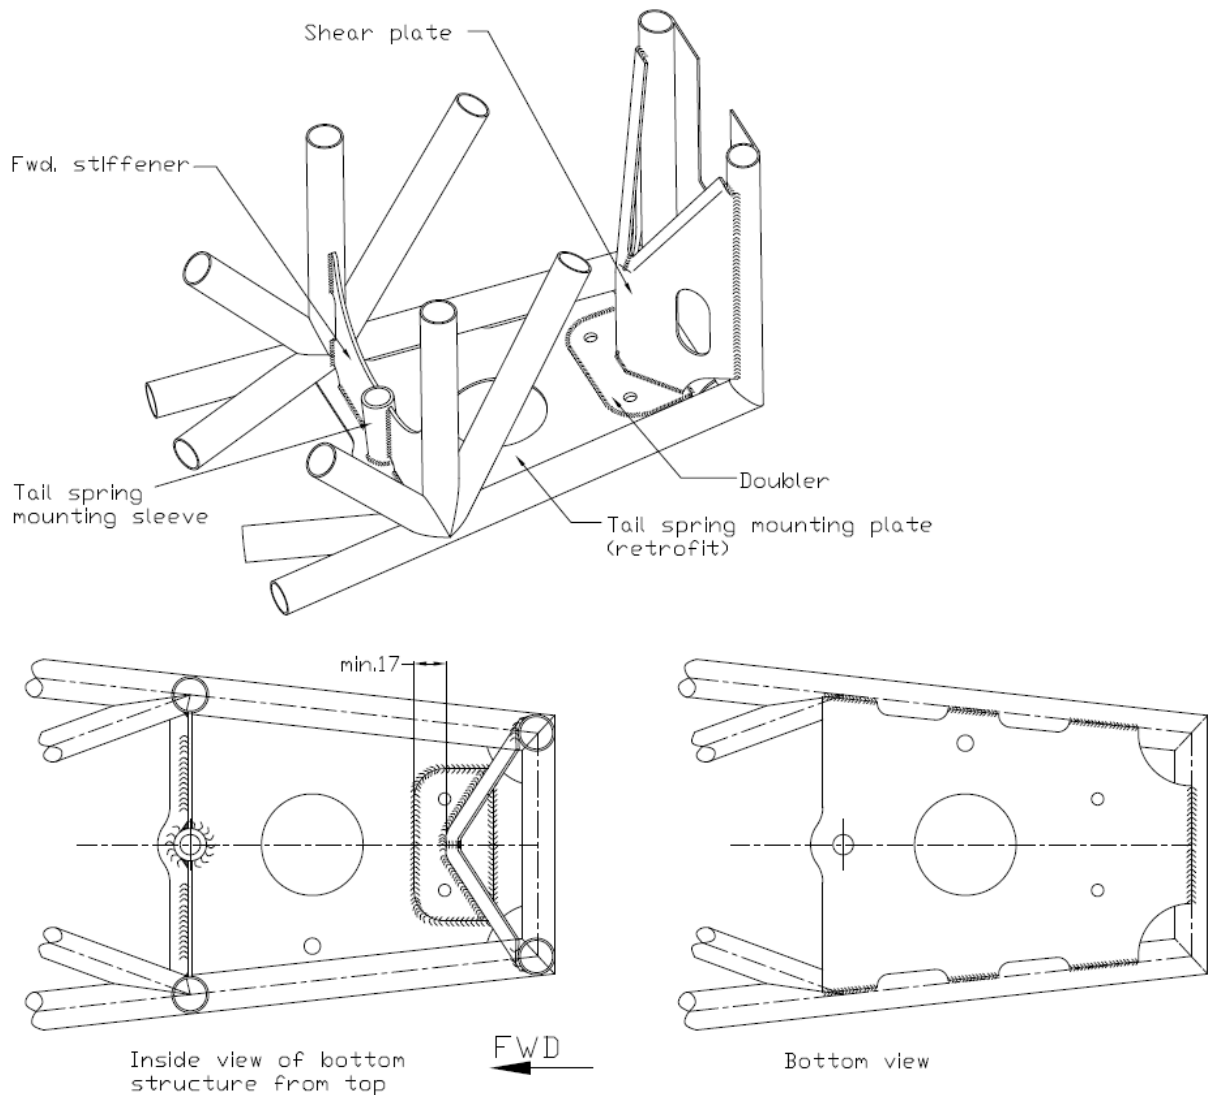
Figure 5: Position and welds of retrofit kit
