Service Information

Product **Colour television receivers with Digi 6 chassis CUC 1842, 1894, 1952, 1962 and 1983, e.g. M 72-410 Ref., Denver SE 8216/9 PAL Plus, M 70-269/9 Ref.**

Serial No 15/97

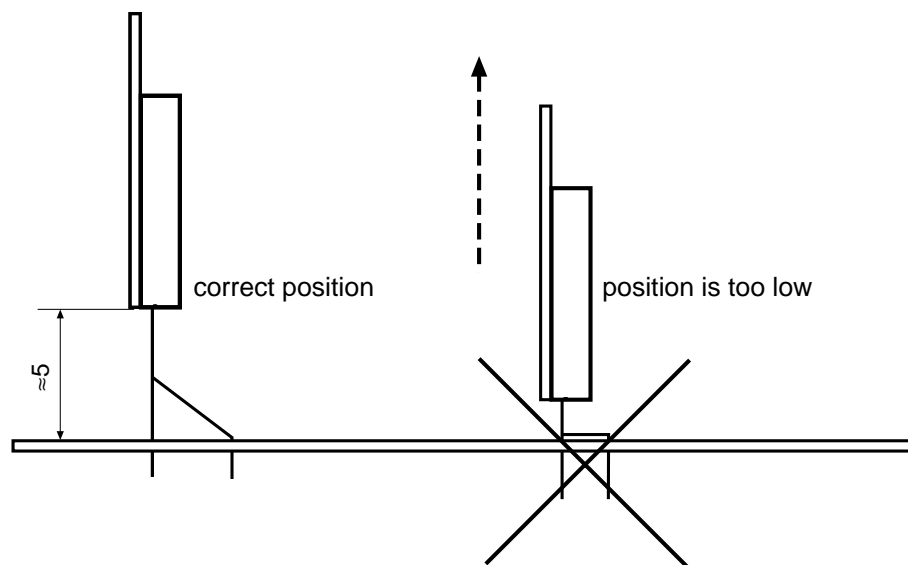
Vertical output stage TDA 4173 fails or thin white lines similar to retrace stripes are visible.

Inherent instability of the vertical output stage IC TDA 4173 AF.

- Should above mentioned symptoms appear do not fail to exchange TDA 4173 AF and solder additionally a 1 nF foil capacitor from pin 1 and from pin 7 each to pin 4 (-K voltage) on the copper side.
- Check the mounting position of the vertical output-IC. If the position of the IC is too low, the pins may temporarily come into contact with the chassis connection on the upper side causing the IC to fail. Additionally, the circuit may already be damaged by the building up force of pressure resulting in a long-term failure. Therefore replace TDA 4173 AF also if it has not been fitted correctly!

When fitting the new IC TDA 4173 AF take care of the correct position of the holding clamp and solder in the additional capacitors!
This change has been generally introduced.
