LaserJet / LJ2000 Troubleshooting Guide

Classic Printers

Volume 1
April 1995
Revision 13

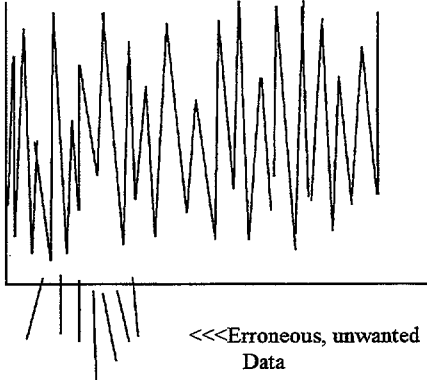
<p>Eroneous lines appearing on XY Chart, printing in HPGL2, see example opposite. The problem appears the more complex the XY Chart plot is.</p> <p style="text-align: center;"><i>(LJIII)</i></p>	<ol style="list-style-type: none"> 1. Use latest revision of firmware (DC 19900430) on the Formatter PCA.

<p style="text-align: right;"><<<Erroneous, unwanted Data</p>
<p style="text-align: center;">LJIII Intermittently drops OFF-LINE?</p> <p style="text-align: center;"><i>(G. Clark - Leeds - Jan 94)</i></p>	<p style="text-align: center;"><i>Replacing Formatter PCA seem to resolve this pfm.</i></p>
<p>COMPLETELY DEAD? No Display, ERROR 12, this fault could be Intermittent.</p> <p style="text-align: center;"><i>(Updated)</i></p>	<ol style="list-style-type: none"> 1. <i>Replace DC Controller PCA.</i> 2. <i>Replace Formatter PCA</i> 3. Remove any PCA installed in the Optional I/O (JetDirect XIO, i-Data, etc), is fault resolved? If not <i>replace this PCA.</i> 4. <i>Replace DC Power Supply.</i> If the DC Controller & Formatter PCA are removed you can check DCPS by grounding pin 7, <i>Remote Enable line</i>, on the DC Power Supply, if the supply is OK the +/- 5v & 24v should come up. If not replace DC Power Supply Module. <p><i>See Flow Diagram towards beginning of this section</i></p>

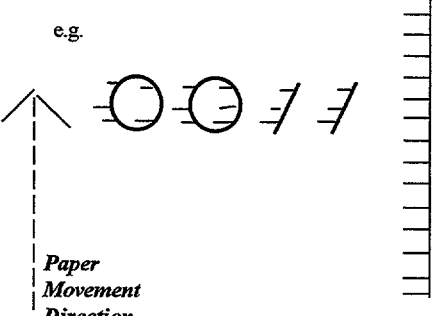
<p>Intermittent DARK 2 inch Wide BAND OF Toner in Laser Scan direction. Occurs every 20-50 pages, edges of band are blurry and extends across the entire length of drum.</p>	<p><i>Faulty POTENTIAL CONTROL PCA.</i> The "ES LOOP" was running out of control causing the Primary Corona current to increase until it began to arc. TIP: Set SW1 on the mode select switches (P 6C-33) to OFF (right). This sets the Primary Corona control to NON-AUTOMATIC" mode, which keeps the current fixed at the initial (Vdark target) value.</p>
<p>STREAKY BACKGROUND Faint lines across page, approx 1/2mm apart. These lines appear in scan direction, but are not straight lines. They are slightly uneven and looks very much like background.</p>	<ol style="list-style-type: none"> 1. Worn/dirty cleaner blade - reverse edge or replace. 2. Replace Cleaner Station Assy.
<p>HORIZONTAL Displacement LH PARTS OF ALL CHARACTERS (LANDSCAPE MODE). Chars are clearly formed (i.e. NOT fuzzy) but have distinctive LH tails (in this case a row at the top and bottom, and one in the middle). See Example opposite.</p>	<p><i>Faulty SCANNER MOTOR assembly.</i></p>

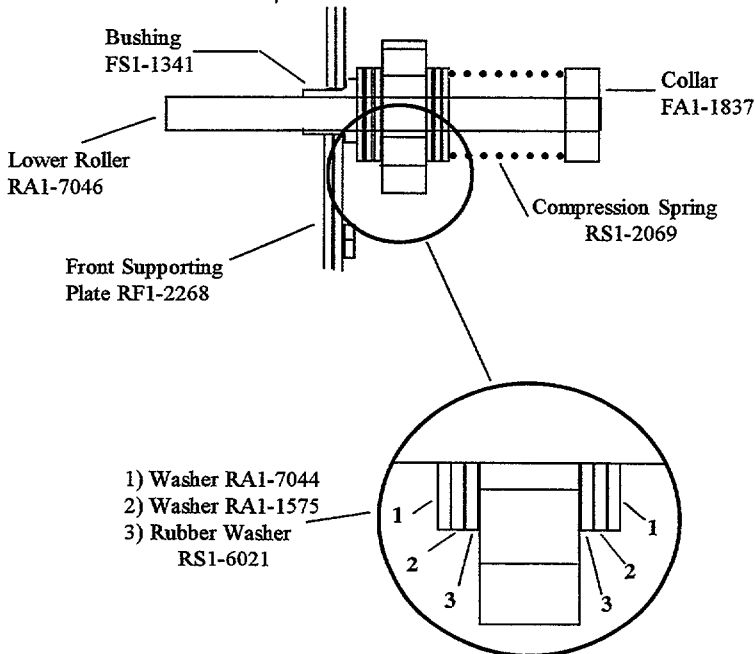
13.2 PAPER JAMS in Switchback (Positive Drive).
 Seemingly insufficient friction as it passes through 3 driven Rollers.
 (Tim Webster Cen-Lon)

The fix was due to a disintegrating washer, refer to page 8b-22 item 67 (Roller Shaft/Roller), it can be seen it consists of 2 rubber washers & 4 carbon keyed washers and 1 free running gear, a compression rollers spring & a retaining collar (This assy acts as a clutch). This disintegrating washer causes this clutch to slip, thus 13.2 paper jams. *Replace rubber washers, see below: NOTE the diagram below does not appear in Service Manual.*

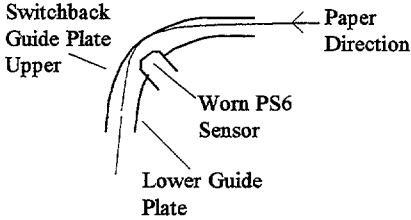
<p>ERROR 13.1, paper intermittently will not enter switchback from Fuser. It is observed that when this condition exists, none of the rollers in the switchback move. <i>(Dave Malone - Manchester)</i></p>	<p>The 24v in FDS(stacker) was measured at 20v. <i>Replacing Stacker Power Supply fixed this problem.</i></p>
<p>13.2 then 13.1 Paper Jam (double ping) in switchback. <i>(Lee Williams - Billerica)</i> <i>(New Info)</i></p> <p><i>Diagram opposite shows how the paper can bypass PS6 sensor when the sensor flag is worn. Stiffer paper can also contribute.</i></p>	<p>To troubleshoot disable Paper Jam on Stacker Control PCA, if jam does not occur then electrical/sensor problem. In this case no paper jams occurred when PJ occurred. It was found that PS6 sensor flag was worn. As paper moved downwards into the switchback intermittently the paper would miss PS6 sensor flag due to the combination of wear of the flag and the bend the paper is trying to negotiate. This LJ2000 had printed 4 million images. Check also that SL5 deflector gap is set to approx 2mm. <i>To resolve this problem PS6 sensor/flag was replaced.</i></p>

<p>The diagram illustrates the switchback area where paper enters from the right, moving left as indicated by the 'Paper Direction' arrow. The paper path is guided by an 'Upper Guide Plate' and a 'Lower Guide Plate'. A 'Worn PS6 Sensor' is positioned to detect the paper's presence. The diagram shows the paper's path curving downwards and then back up, with the sensor flag being worn and unable to detect the paper as it passes.</p>
