INSTRUMENTS: -hp- Model 8690A Sweep Oscillator  
Serials Below 636-00211

SUBJECT: Diode Change

TO: All Service Departments

INSTRUMENTS: HP 8690A Sweep Oscillator Serials, See Text

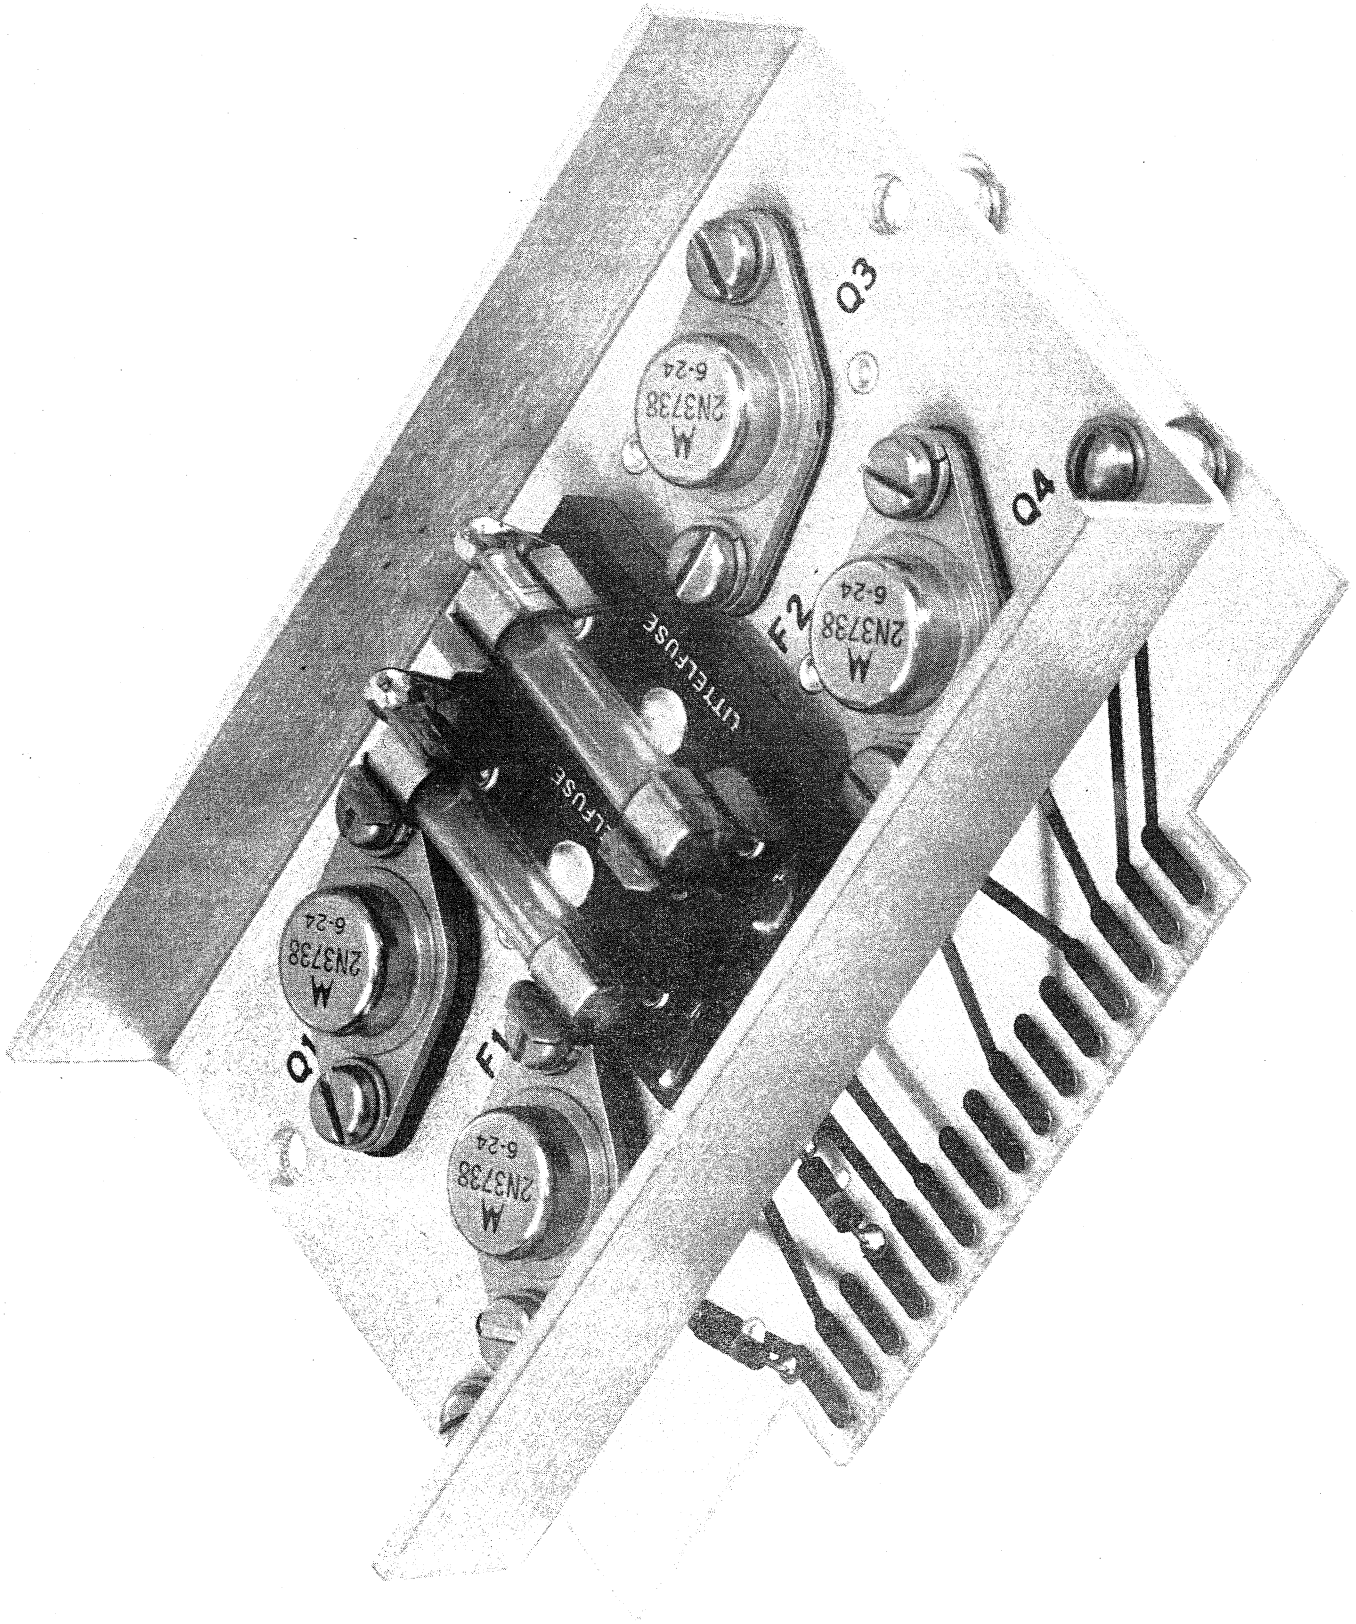
Some 8690A's have had 10 MHz oscillations in the + 275 volt power supply. The problem is caused by parasitic oscillations in A6Q1 and A6Q2. The fix is to add a 100 ohm  $\pm 10\%$ , 1/4 watt resistor, HP Part Number 0684-1011, in series with the base of each transistor.

The 100 ohm resistors are connected between PIN 12 on A6 and the base of A6Q1 and between PIN 15 and the base of A6Q2.

The conductor between the PINs and the bases of the transistor can be opened by drilling through the foil. Also, two mounting holes must be drilled for each resistor.

All the drilling can be done from the soldered side of the board. Note that the resistors are mounted on the other side of the board as close to PINs 12 and 15 as possible.

Figure 1. A6 Assembly After Modification

To do this you have to modify the A6 regulator board assembly, HP Part Number 08690-6024 as shown in Figure 1. The board can be modified without disassembling.
