BENCH BRIEFS

SERVICE INFORMATION FROM HEWLETT-PACKARD

January-February 1986

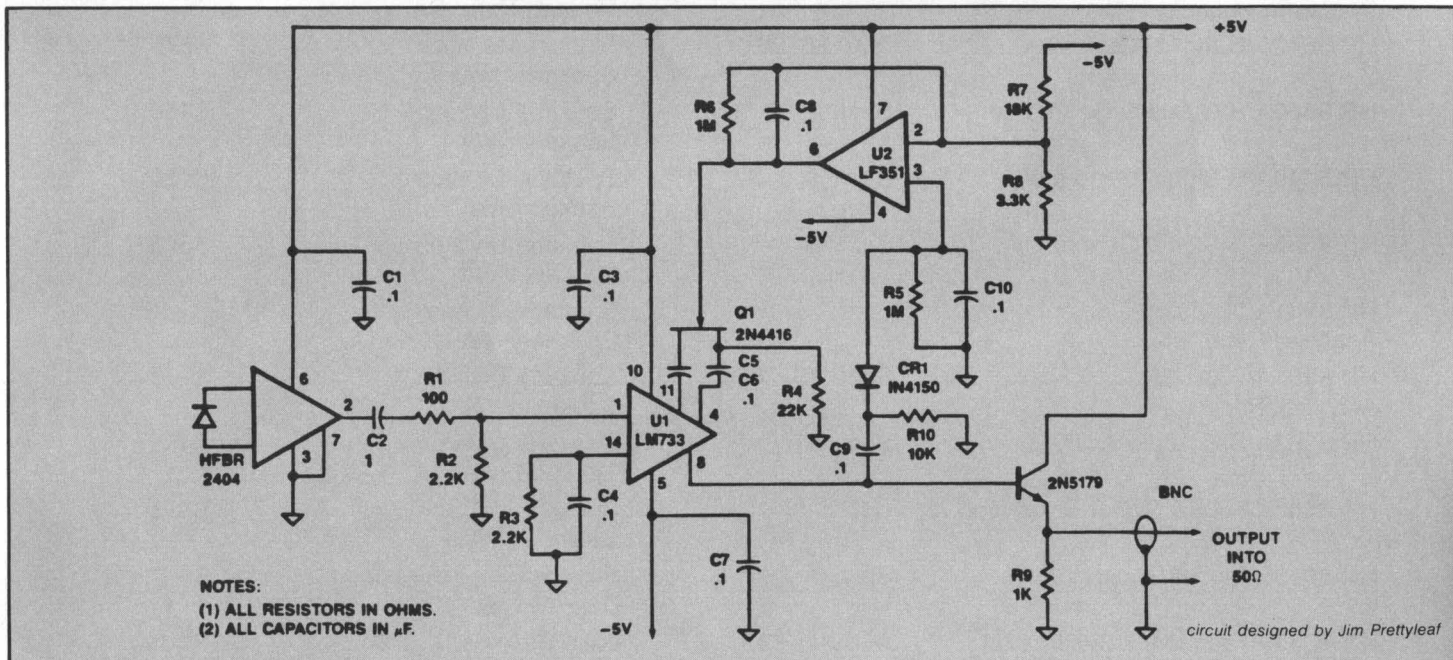
Figure 1. Fiber optic receiver.

In the receiver schematic shown in Figure 5 on page 7 of the June/August 1985 issue of Bench Briefs, pins 4 and 10 on U1 (LM733) were switched. Pin 10 should have been connected to +5V and pin 4 should have been connected to the source of the FET. The revised drawing is shown in Figure 1.

I would like to recommend that when constructing the circuits for the transmitter and receiver, you use a ground-plane type of circuit board due to the high frequencies involved. I would also recommend that, in a high noise environment, you place the receiver in a shielded metal box.
