## **SERVICE INFORMATION for SW upgrade with Service Pack for 81200 and 81250**

IMPORTANT: The installation of a Service Pack can only upgrade a specific SW rev.  
e.g.: **Service Pack 3.11SP1 can only upgrade an existing SW rev 3.11**

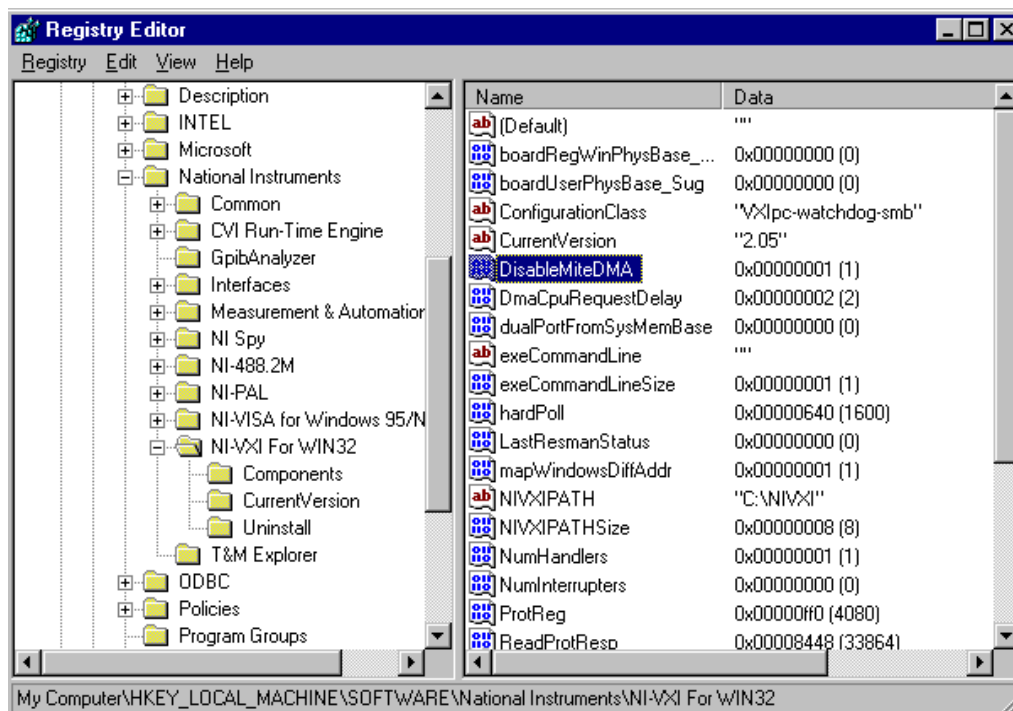
In order to upgrade the current SW rev on an embedded PC it is helpful to optimize the PC speed.

- 1) Go to start ->RUN-> regedit->
- 2) HKEY\_LOCAL\_MACHINE \ SOFTWARE \ National Instruments \ NI-VXI For WIN32 \
- 3) **DisableMiteDMA** and change the value from **0** to **1**
