E4356A-04

S E R V I C E N O T E

E4356A - TELECOM DC POWER SUPPLY 0-80V, 0-30A,
2100 W. GPIB

Serial Numbers: MY41000101/ MY41000708 SG41000101/ SG41000270

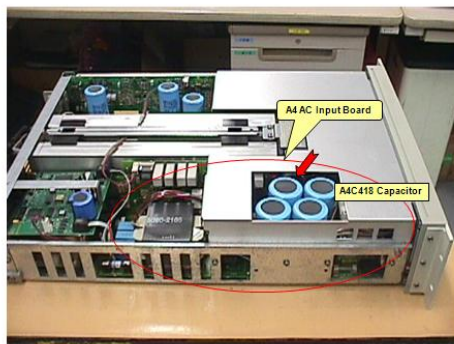
The four filter capacitors circuit reference (C416-C419) on the A4 AC input board starts leaking electrolyte - not through the pressure valve in the bottom as one would expect but through one of the terminal screw bushings.”

The screw P/N 2680-0217 length currently being used was not considered and the length was overlooked. The screw length is 0.375 inches long. We have found that the screw can be 0.055 inches too long and may bottom out causing the tapped hole in the header of the capacitor to become cracked or become broken.

When this happens the electrolyte will slowly leak out over time, and cause the defect described. This situation is even worse due to the capacitor is mounted with the header face down. If the capacitor was mounted header face up a cracked or broken header would not have caused this problem, the electrolyte could not leak out.

1. All affected models and tested assemblies WIP (Work In Process), FGI (Finished Goods Inventory) at SPO (Support Parts Organization) & AMC (Asian Manufacturing Center) has been inspected for capacitors with damaged headers due to the incorrect screw
2. When this repair is being done all of the hardware described above should be replaced (It is NOT recommended that any of the hardware be reused)
3. The following figures can be used when doing the repair.
4. Inspect the assembly as described below.
5. The last figure will aid in the reassembly of the hardware and the capacitors.
