# SCMVX008-01A

## S E R V I C E N O T E

### SCMVX008 Option 040 or VX008-66501 4 Channel DDC TIM Module (PAWN)

**Descriptive title:** SCMVX008 Option 040 High LO Feed thru - Spur at CF

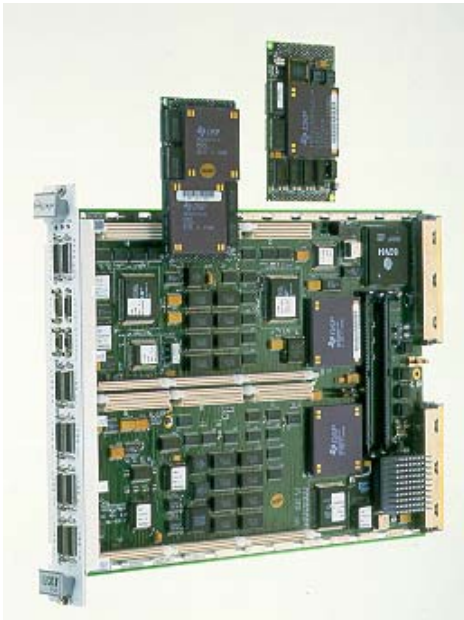
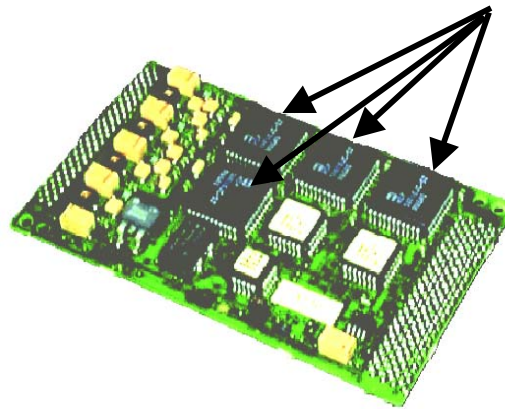
4 Harris chips can be found on the VX008-66501 DDC TIM Module:

Customer may complain of high LO feed thru (spur at CF) or about a steady tone when demodulating signals of interest. There are 4 Harris Chips used on the VX008-66501 DDC module. Earlier date codes of these Harris chips had a LO feed thru problem. Agilent compensated for this problem with software patch. Now Harris has fixed this LO feed thru spur and Agilent's software patch cause this LO feed thru spur to re-appear. Most customers do not care about LO feed thru because of the demodulation algorithm used. Only customers performing USB or LSB demodulation will notice this, so very few customers should report this as a problem.

If customer calls and complains of high LO feed thru spurs, spur at center frequency or a steady tone after USB/LSB demodulation. Replace customers VX008-66501 - 4 channel DDC TIM Module. Module replacement can be done by the customer or by an Agilent service center.
