MODIFICATION RECOMMENDED –
CORRECTS MANUFACTURING OR DESIGN DEFECTS

SCMVX008-02

S E R V I C E N O T E

SCMVX008 TI Based DSP VXI Module

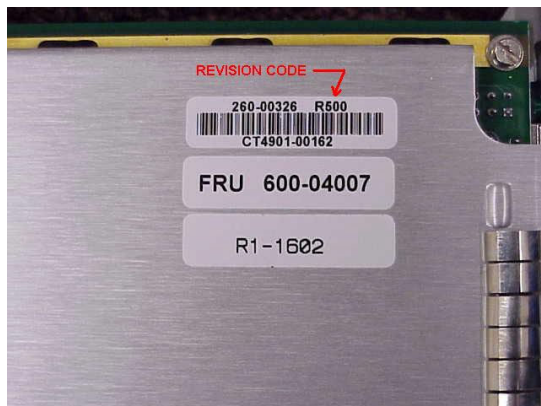
Figure 2

SCMVX008 Main Board revision

1. SCMVX008 modules with revision codes under R5.00 should be replaced with modules with revision code R5.00 and above; see Figures 2 and 4.
2. Option 012 (C44) TIM modules with revision codes under R2.20 should be replaced with modules with revision codes R2.20 and above; see Figure 3.
3. Option 011 (C40) and Option 040 TIM modules should be moved to the exchange SCMVX008 according to the instructions given in [VX008-90012, SCMVX008-TIM Module Insertion/Extraction Procedure](#).

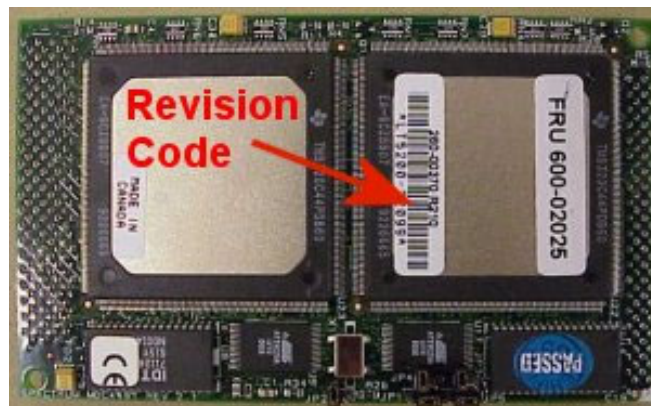
Figure 3

C44 TIM Module revision

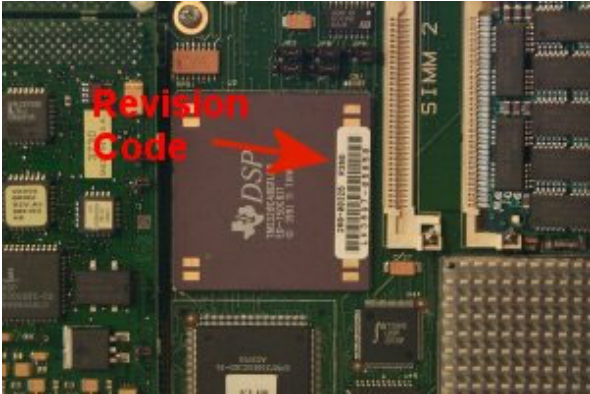
Figure 4

SCMVX008 Main Board Revision – Alternate location
