SERVICE INFORMATION for SW upgrade with Service Pack for 81200 and 81250

81250 rev 4.50 SP3 (14.10.2002)

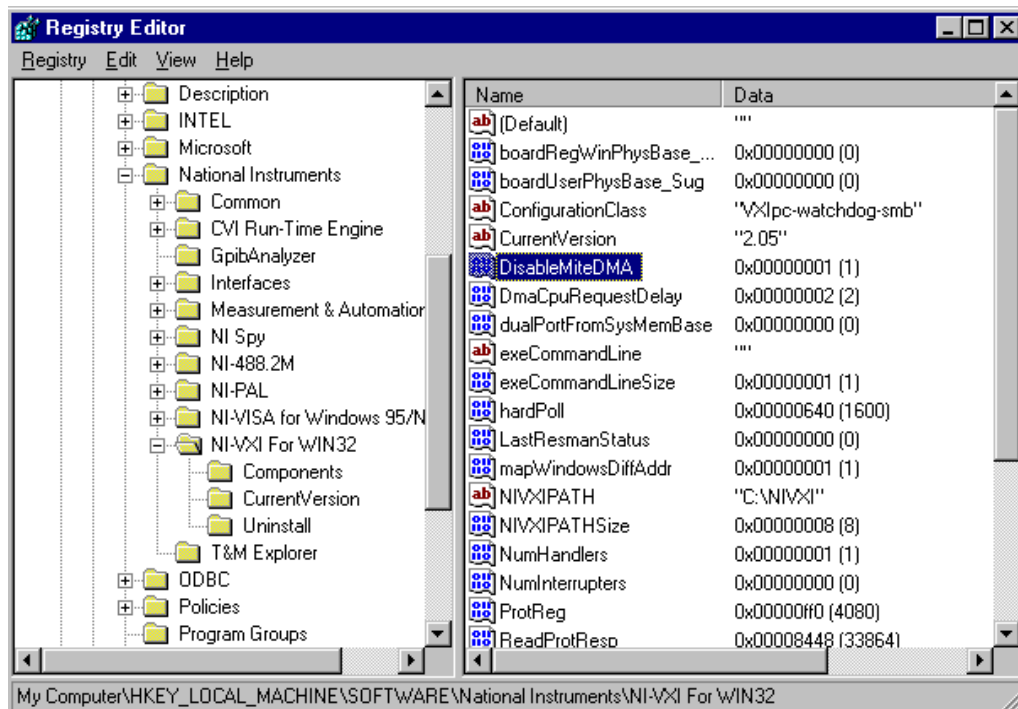
In order to upgrade the current SW rev on an embedded PC it is helpful to optimize the PC speed.

- 1) Go to start ->RUN-> regedit->
- 2) HKEY_LOCAL_MACHINE \ SOFTWARE \ National Instruments \ NI-VXI For WIN32 \
- 3) **DisableMiteDMA** and change the value from **0 to 1**
