Fiber Optic Connectors

Agilent Technologies

Qualitative Assessment on the Effects of Damaged Connectors and Optical Interfaces in Fiber Optic Measurements

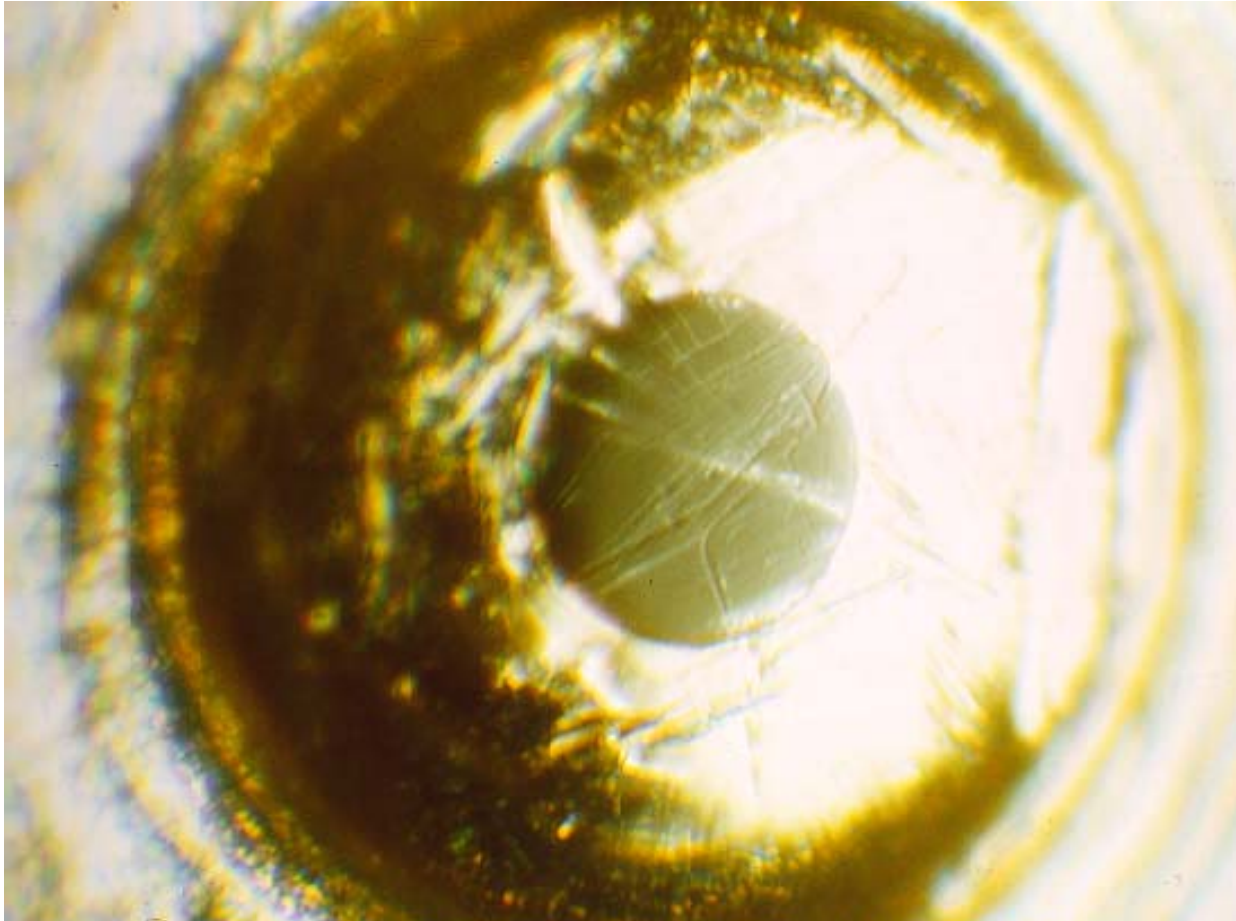
Feel of Dimensions ... (6)

125 μ m fiber and
scratches;

elbow scratch
approx. 3 μ m wide

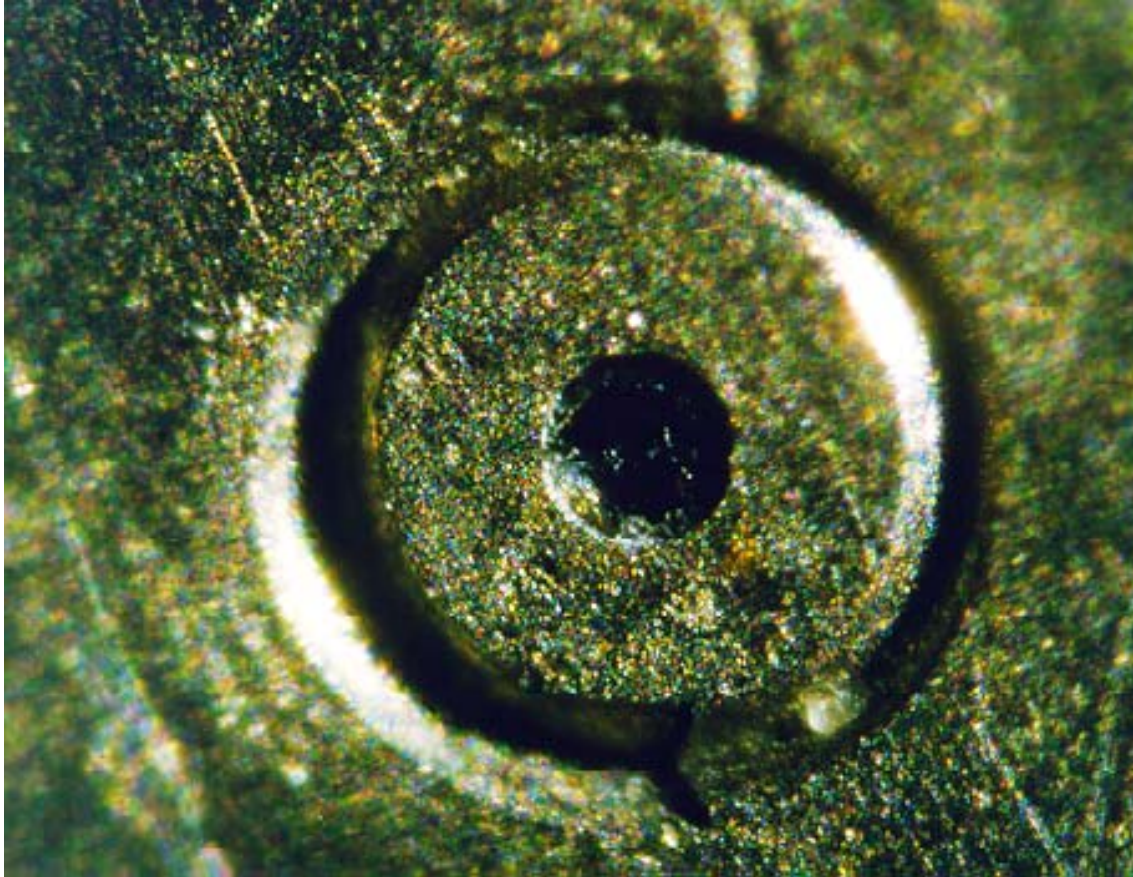
HMS-10

Extreme fiber
damage on
connector.

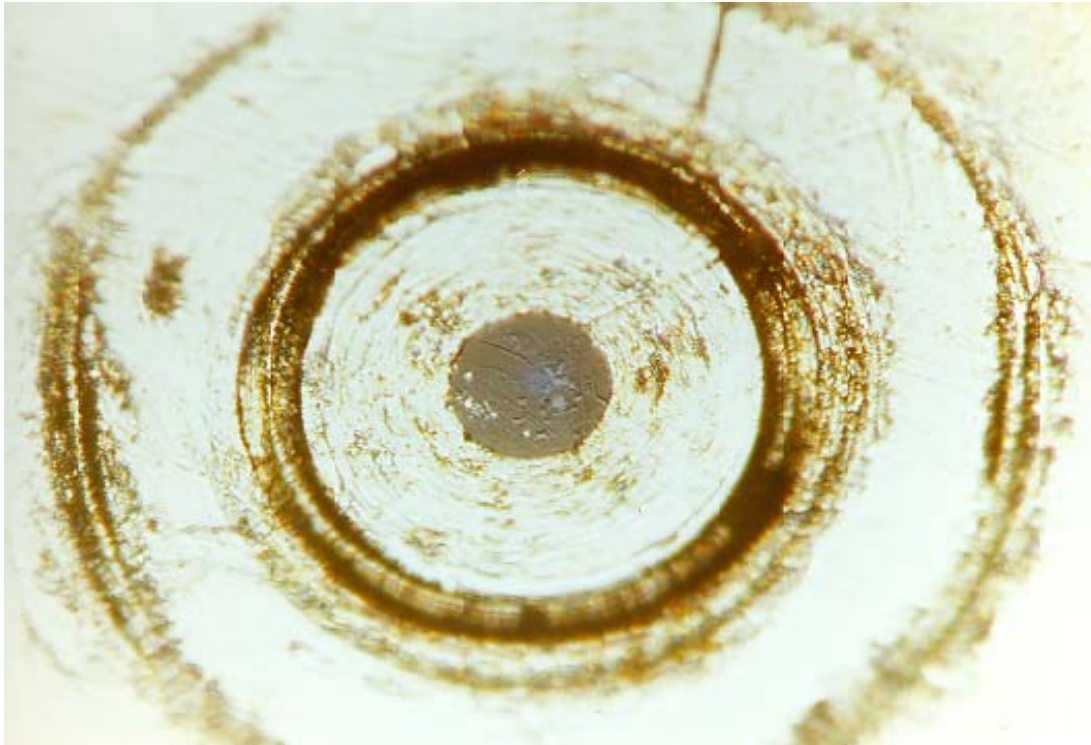
General example of damage:

- Scratches
- White objects are metallic particles embedded in fibre
- Pits are where metallic particles have fallen out

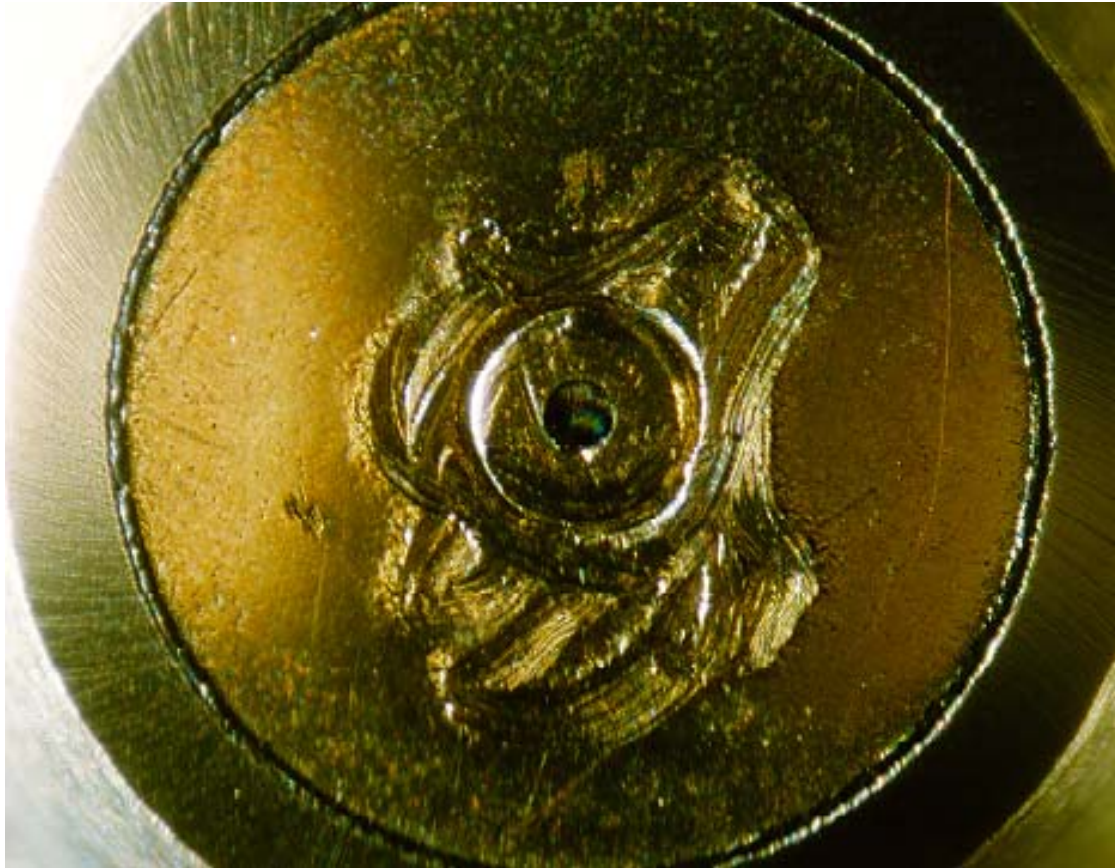
2.5 mm Ferrule

Assume that ferrule end was 'cleaned' by probing with pin.
Nickel/silver insert within Tungsten carbide ferrule easily scratched with pin.
Insertion loss was approx. 8 dB.

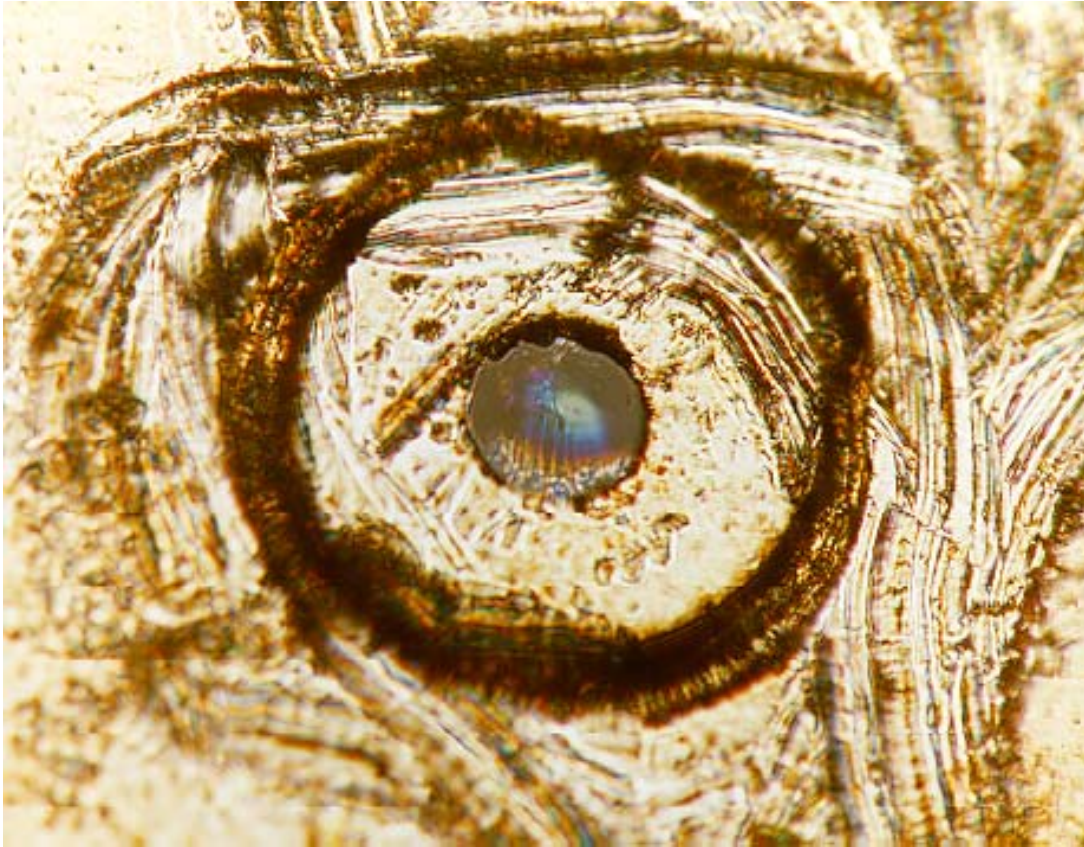
Fibre within 2.5 mm Ferrule

Previous slide magnified.

- Note where scratch leads to broken fiber edge
- Crescent mark across bottom of fiber is where metallic disposition has taken place when pin was drawn across surface of fiber

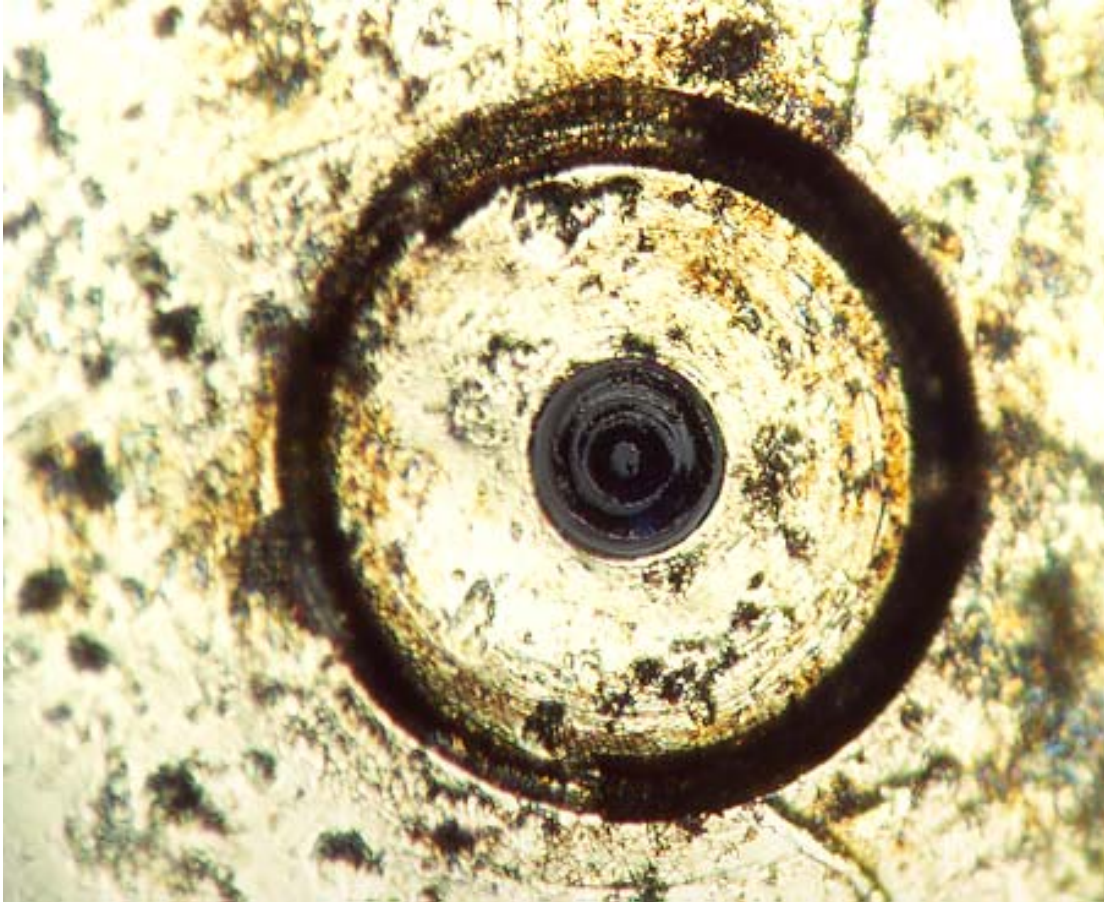
Fibre within 2.5mm Ferrule

OTDR front panel
connector/ferrule

Recessed ring effect either
due to incorrect fiber inserted
and rotated or missing key on
correct connector.

This caused extreme multiple
reflections between this and
the fiber

See page 24 for effects on
OTDR measurement.

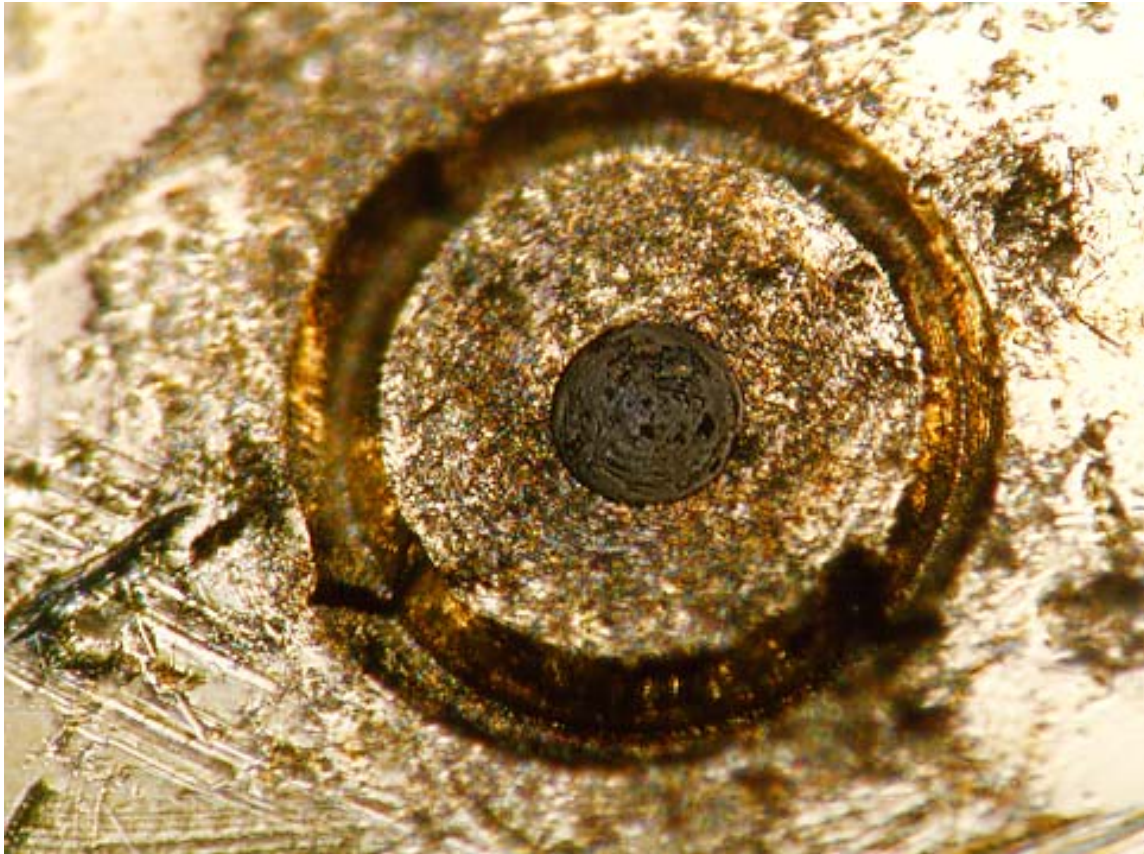
Fibre within 2.5 mm Ferrule

After seeing this unit over a period of 1 year, the connector finally gave up.

See page 24 for effects on OTDR measurement.

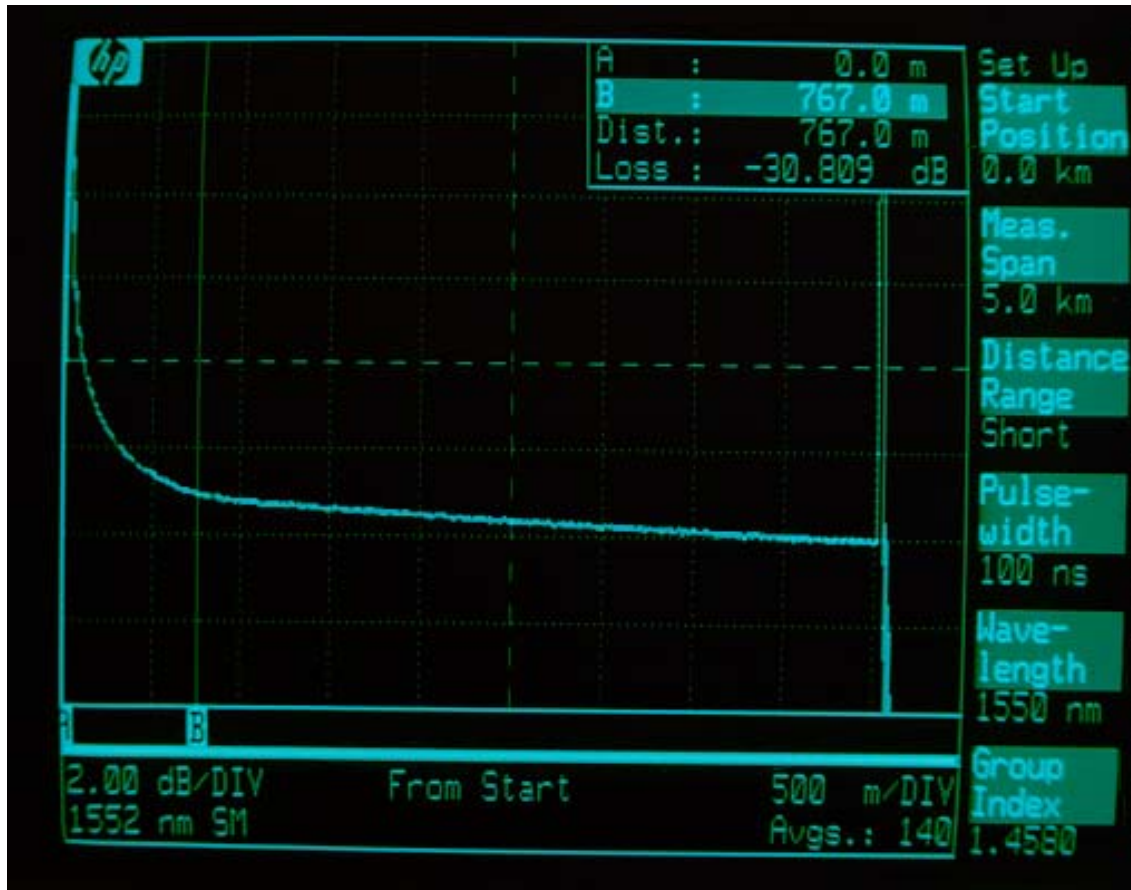
OTDR Trace

Typical result of damaged front panel connector

Note!
Extreme backreflection at pulse launch and loss of 0.75km before useable measurements can be made.

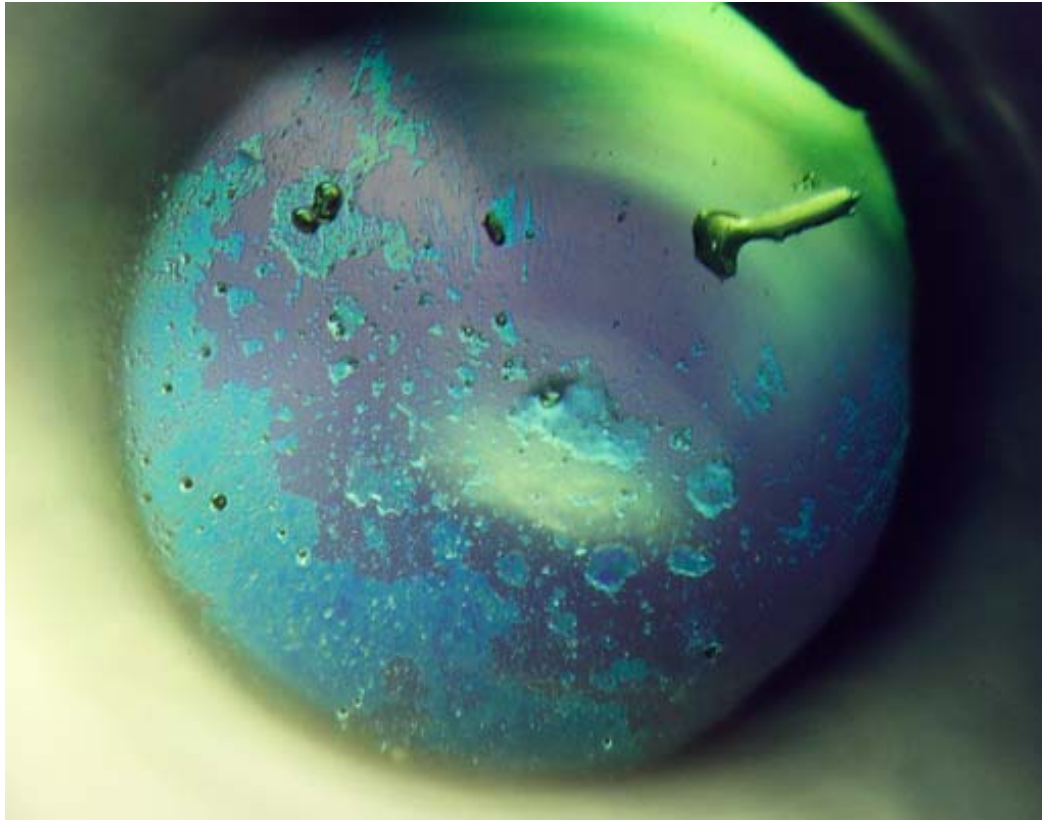
Optical Attenuator

Picture through front panel connector of collimating lens.

- Lens coated with Refractive Index matching (RI) liquid which has collected particles of dust and grit
- This unit showed approx. 10dB insertion loss.

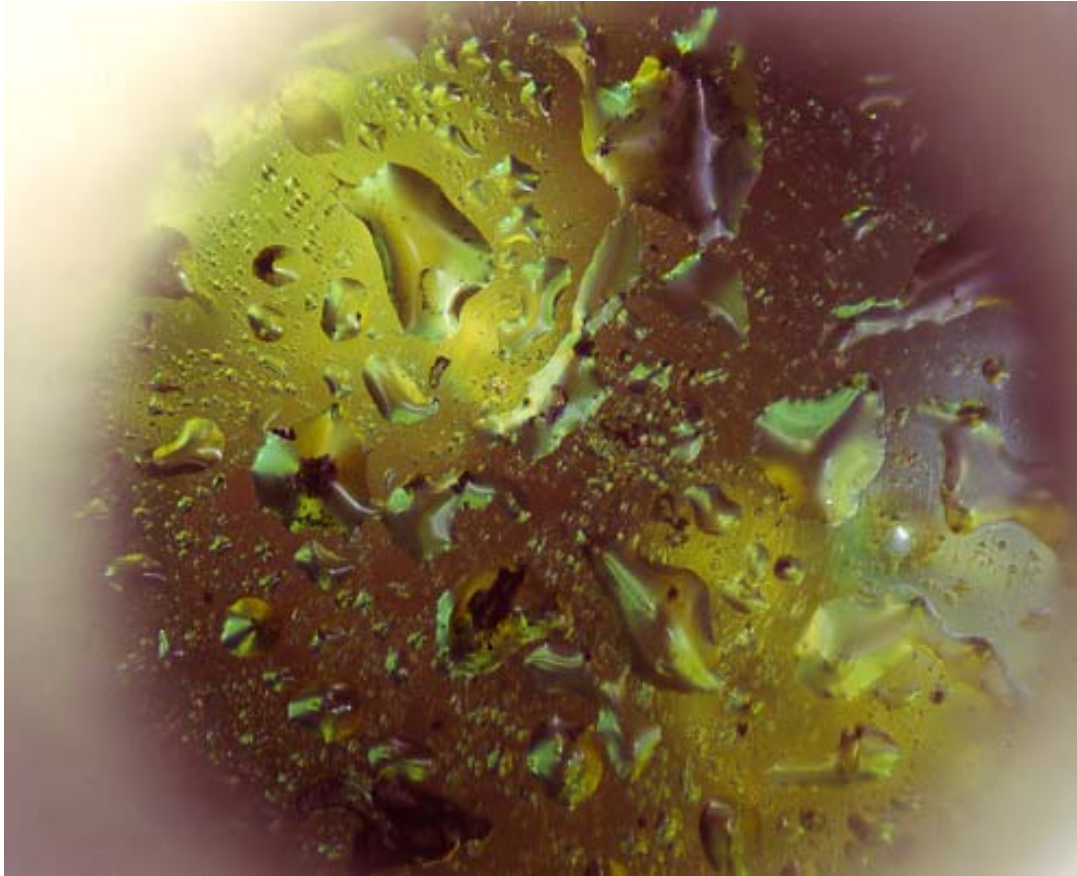
Optical Attenuator

Picture through front panel connector of collimating lens.

- User has attempted to remove RI liquid with solvent.
- Typical globular RI liquid pattern results when solvent has evaporated.
- This unit showed approx. 20dB insertion loss.

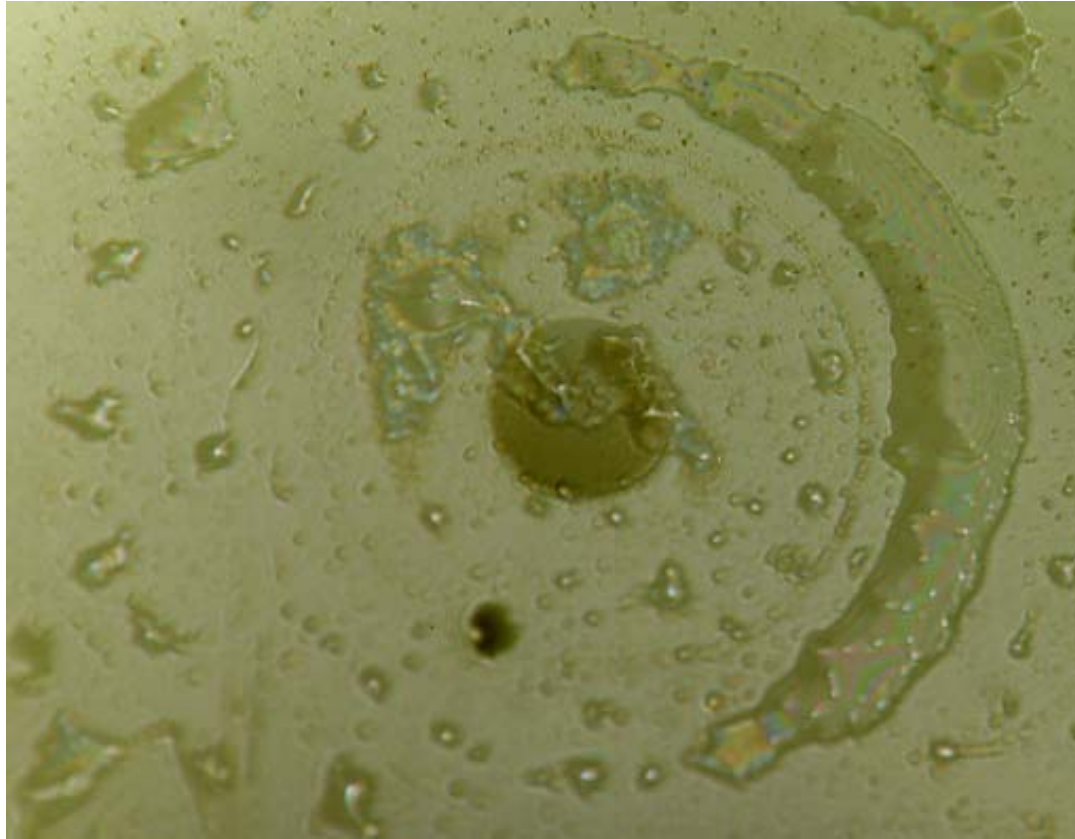
FC/PC Connector

Ceramic ferrule showing
RI liquid contamination

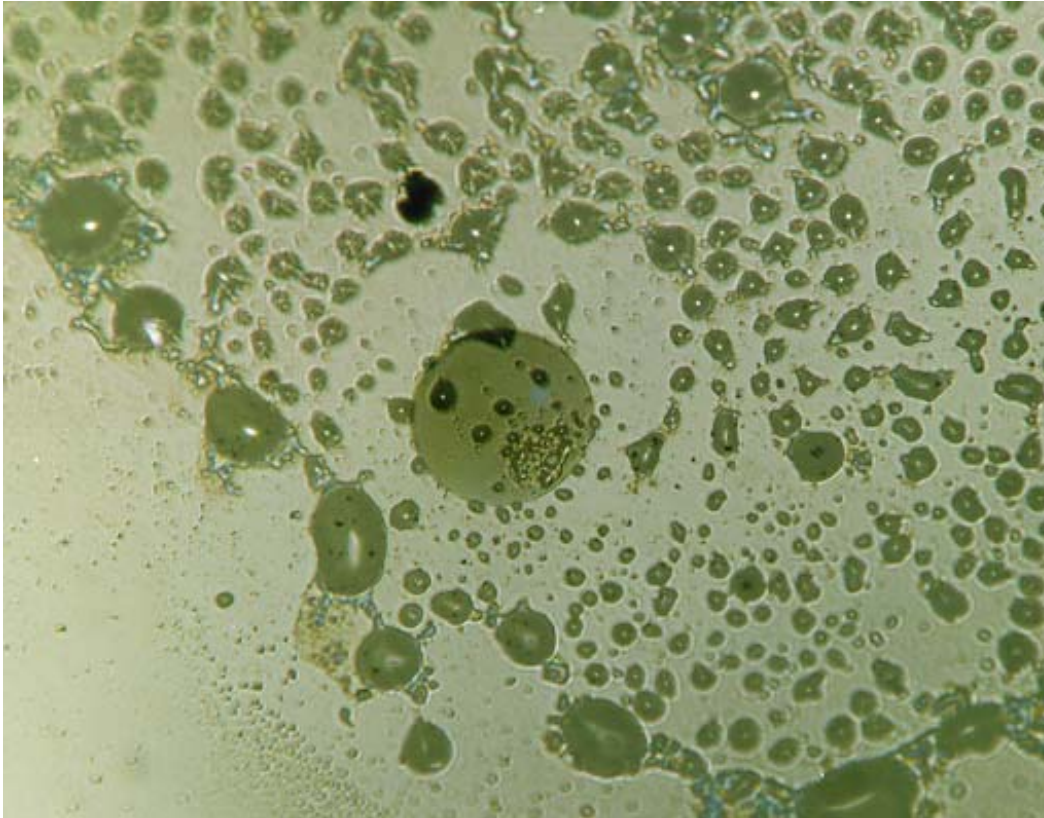
FC/PC Connector

Isopropyl alcohol (IPA)
applied with cotton bud and
cleaned, waved in air to
evaporate IPA.
Result: RI liquid reforms into
globules.

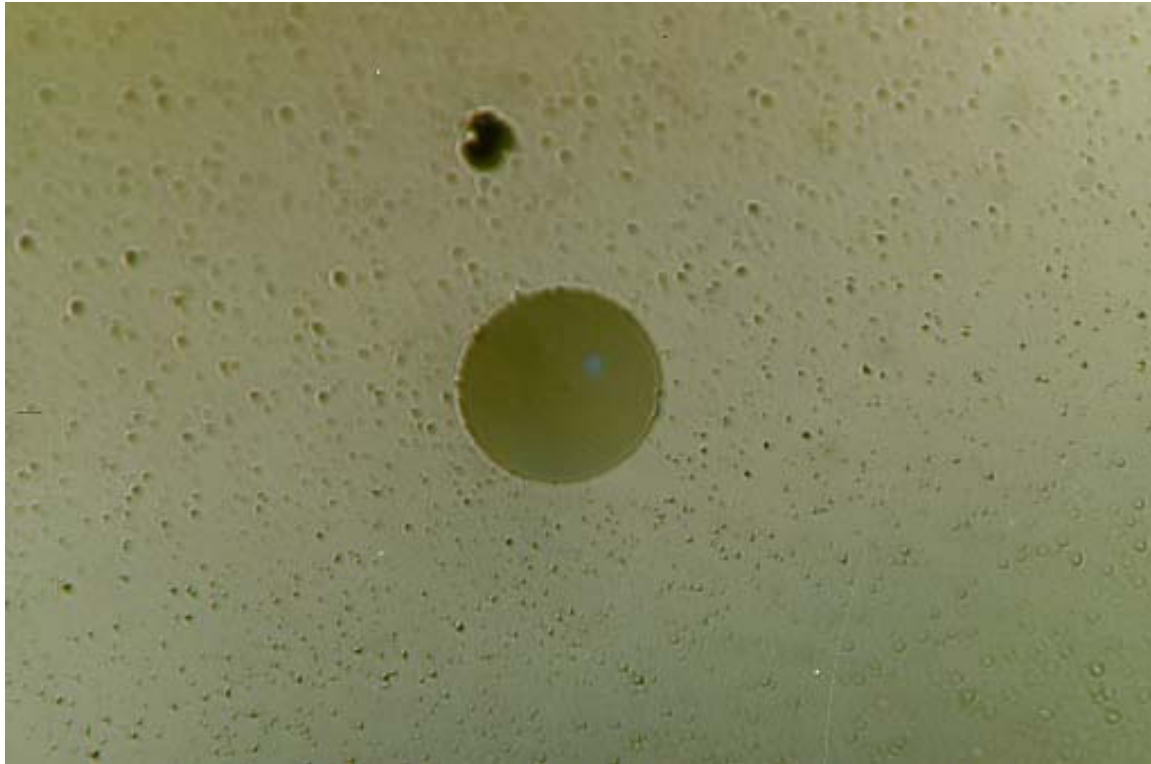
FC/PC Connector

Result: clean connector / ferrule. Marks on ferrule end are part of the ceramic material.

Again cleaned with isopropyl alcohol in some way but compressed air blown over ferrule end.

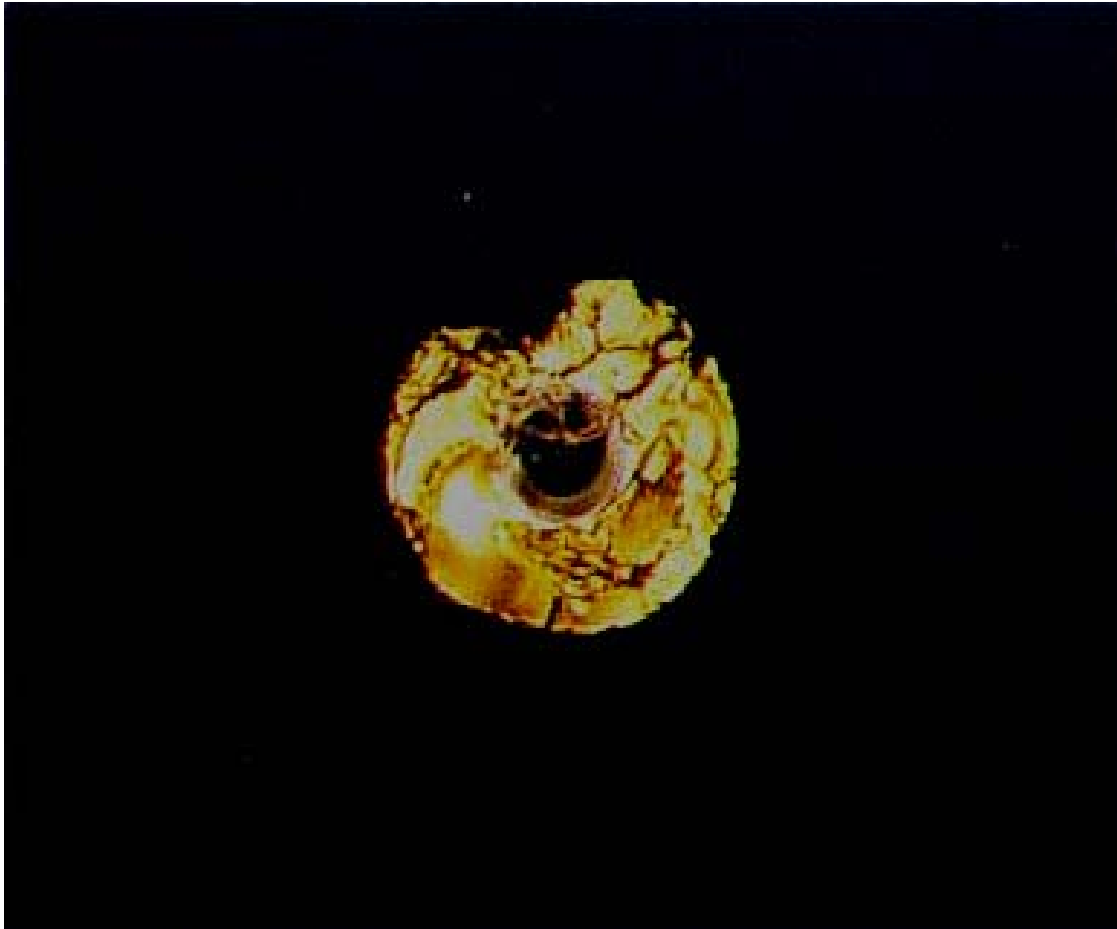
OSA Input Connector

from previous slide, back illuminated now.

Light is traveling through the cladding, where the center of the core is nearly without any light.

Note the scratches on the core and chipped effect across the entire surface of the fiber end face

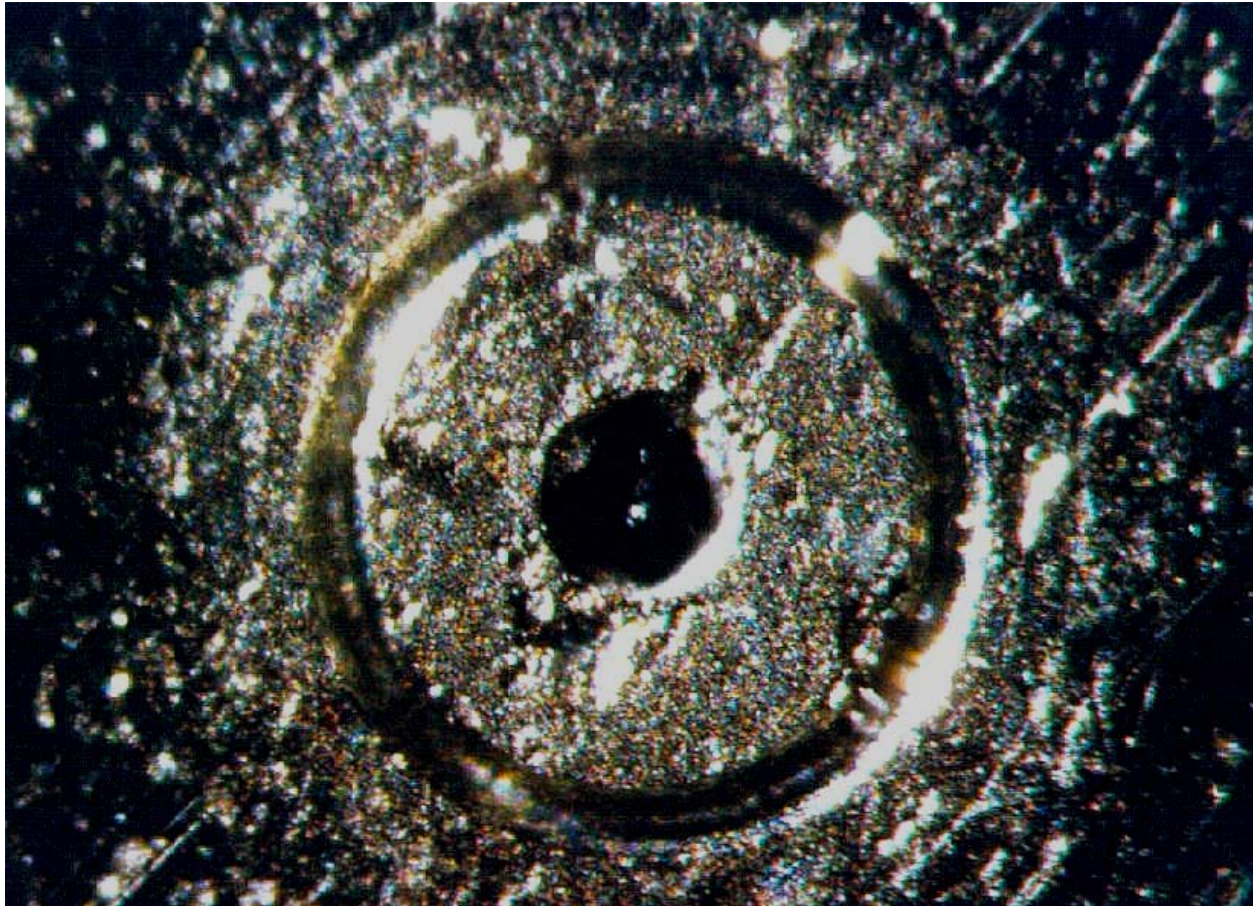
OSA Input Connector

Front illumination.

Scratches on the core or cladding and chipped fiber end face are hard to see.

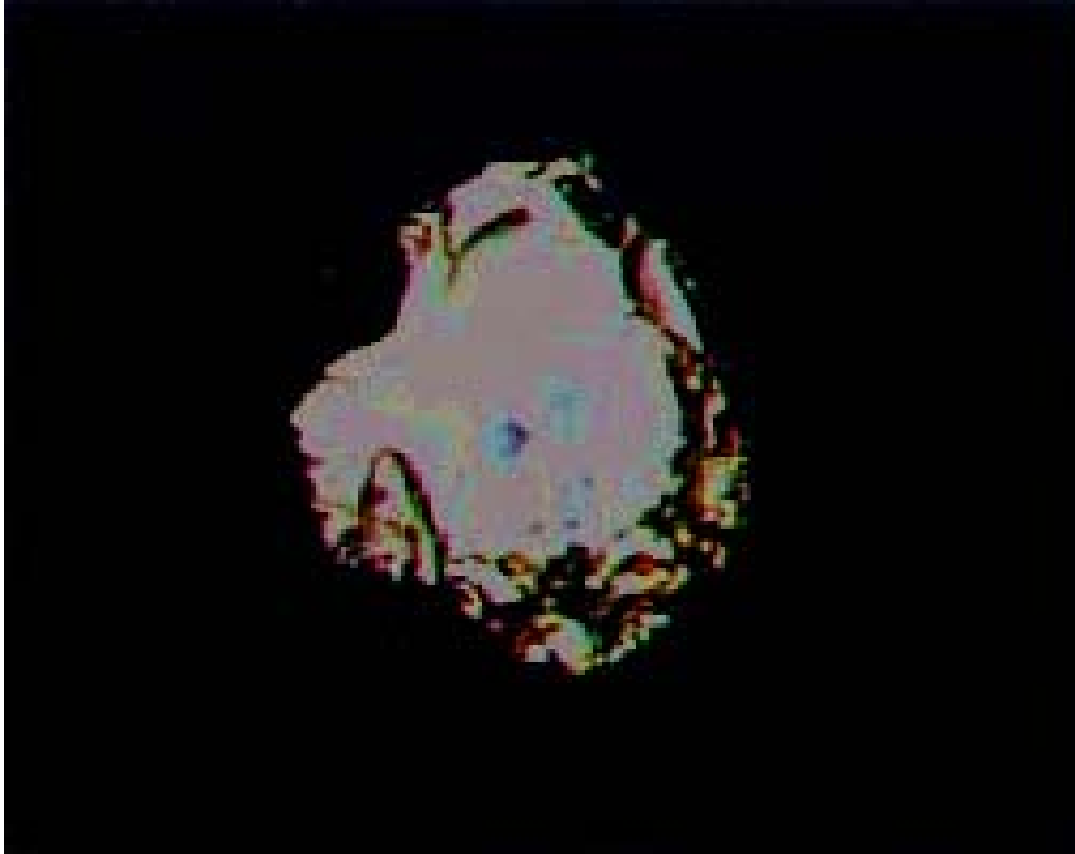
OSA Input Connector

same connector as previous slide, back illuminated now.

Clearly recognizable are the deep scratches and chipped edges on the outer cladding.

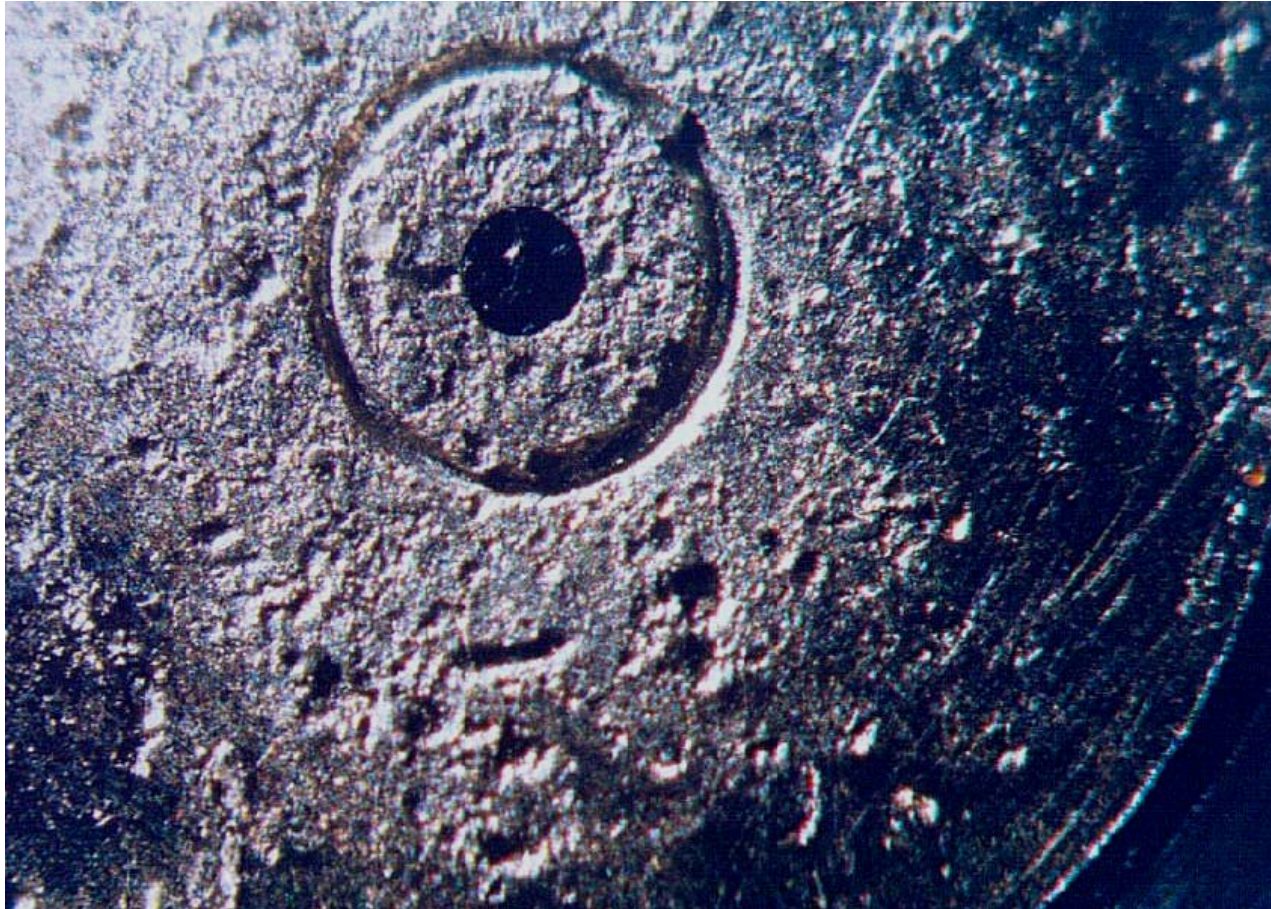
OTDR Input Connector

Singlemode Fiber

with even distributed dirt and dust.

Note the fine scratches at the edge of the ferrule.

They are generated by scrubbing the connector with other tools than lint-free cotton swabs or lens papers.

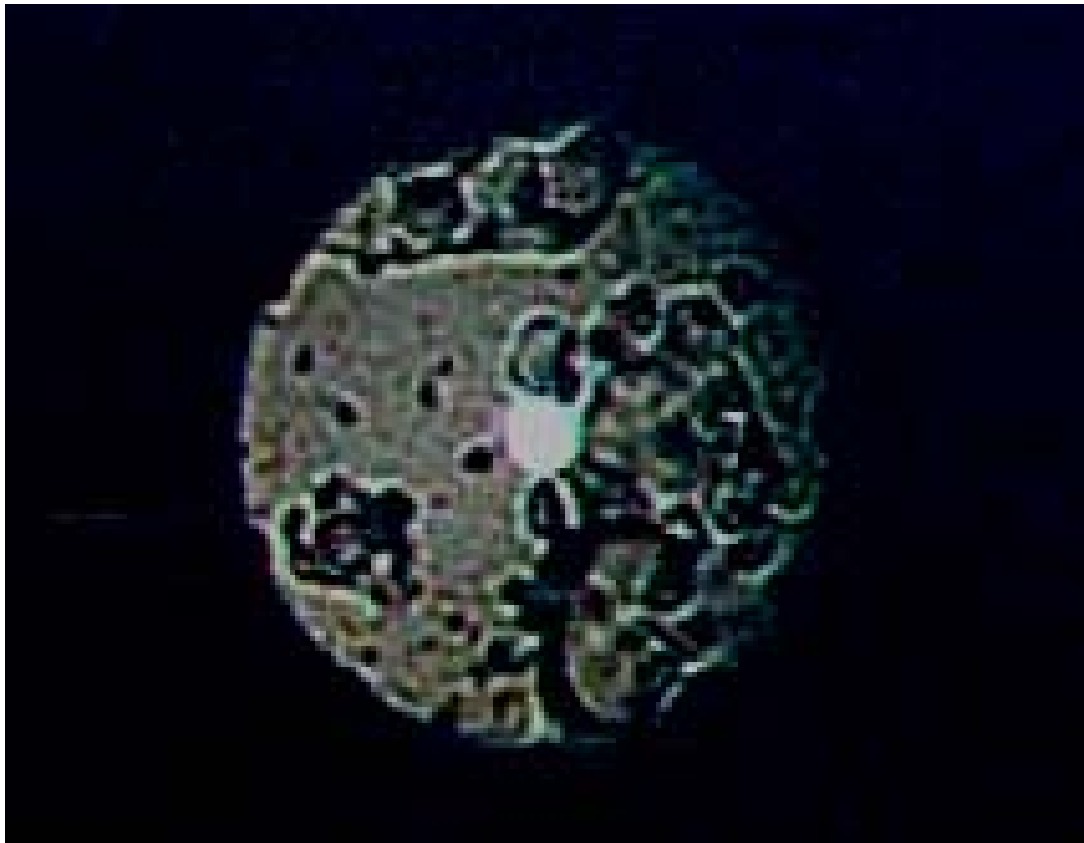
OTDR Input Connector

Singlemode Fiber

cladding and core of the previous slide (black) are now both visible (back illuminated).

The core guides the most light.

Damage is primarily on the cladding, but also on the edge of the core.

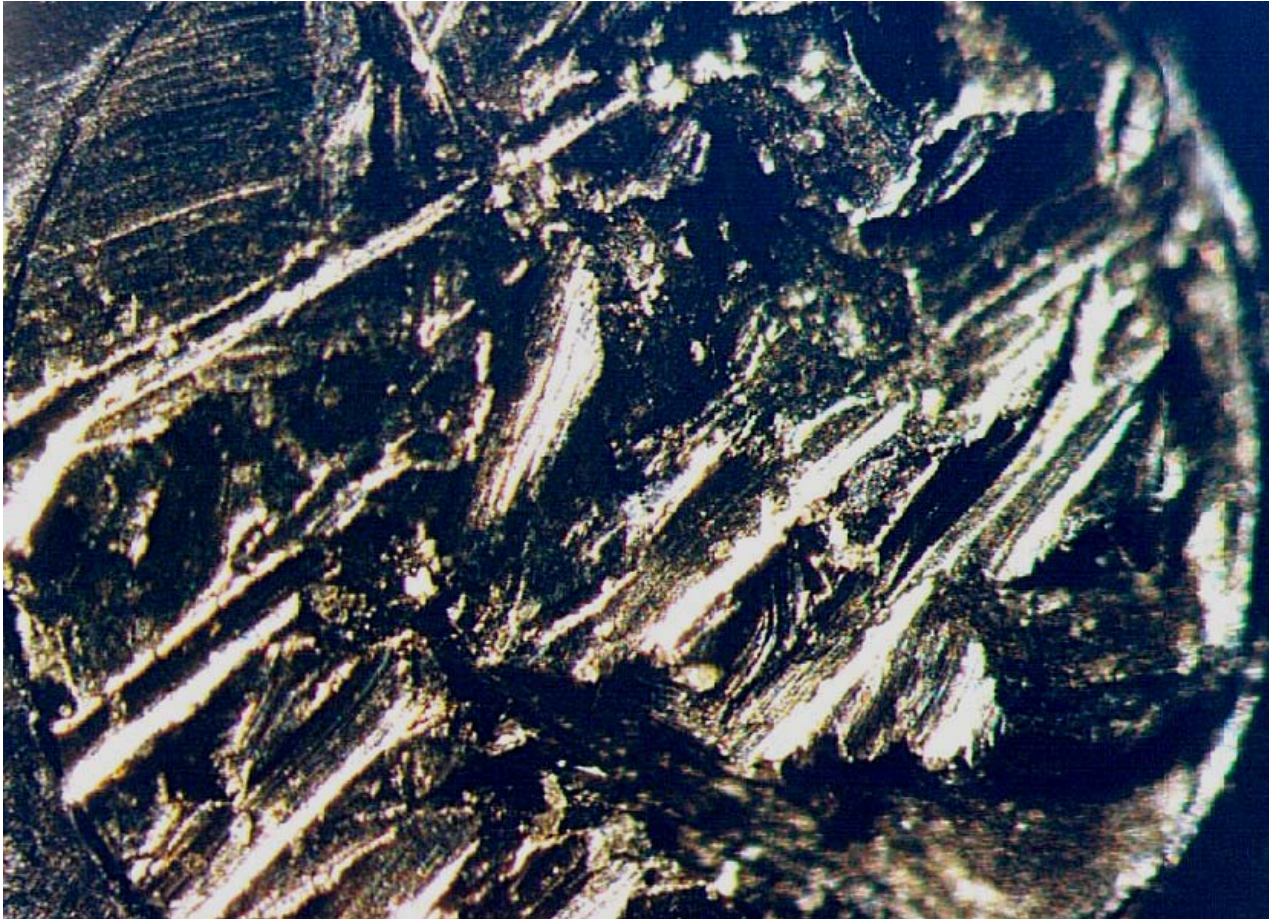
A completely damaged connector...
