S E R V I C E N O T E

**4263A LCR Meter**

**Modification to eliminate CPU hang up due to defective X'tal oscillators**

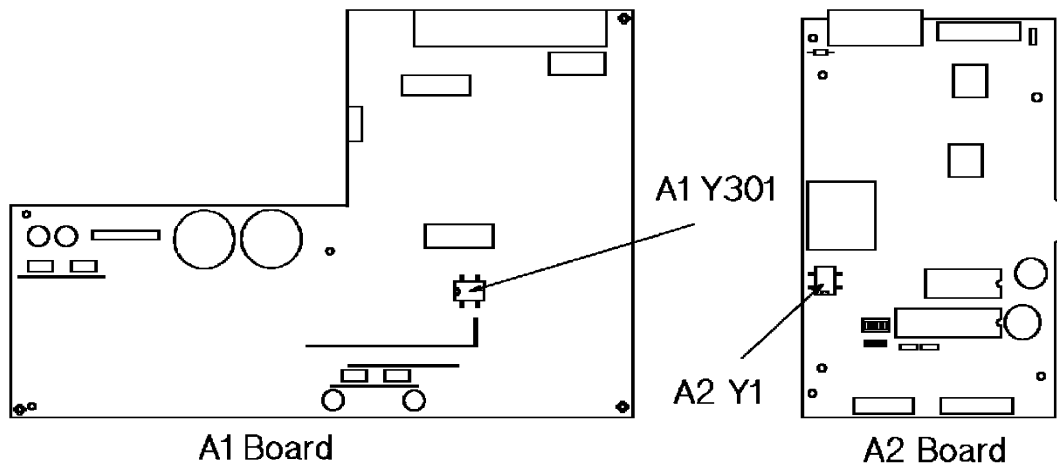
The 4263A units with serials given above may hang up intermittently. This is caused by the X'tal oscillator chip which has a problem in its manufacturing process. Two oscillator chips are used in the 4263A.

Figure 1. shows the X'tal location.

If the unit exhibits the symptom given above, try replacing the two X'tal oscillator chips with new ones. These components are SMD (Surface Mounted Devices) but don't require any special tools or techniques to replace them. Their pin pitch is wider than the general SMD.
