4278A-08

S	Е	R	V	I	С	Е	Ν	0	Т	Е
							SUPERSEDE	ES: None	)	
4278	8A 1kF	Iz/1M	Hz Ca	pacita	ance M	eter				
Seria	l Numbo	ers: 000(	000000	/ 2936J	02833					
Mod	lificatio	on prev	ents c	loggin	ig mem	ory car	d socket			
Dupl	icate Sei	rvice No	tes: Nor	ne						
To B	e Perfor	med By:	Agilen	t-Qualif	ied Perso	onnel				
Parts	Requir	ed:								
Part	No.	Qty.	D	escripti	ion					
0427	8-66510	1	Ν	lemory	Card Soc	eket Assy				
0427	8-00637	1	Р	Plate						
0427	8-01205	1	А	Angle						
0515	-1550	2	S	crew						
0535	-0004	2	Ν	ut						
					Not					
							hat do not yet ha	ave		
	-	the dust-	prevent	ve cove	er installe	ed.				
								C	Continued	
							DATE: 04 Jun	o 1002

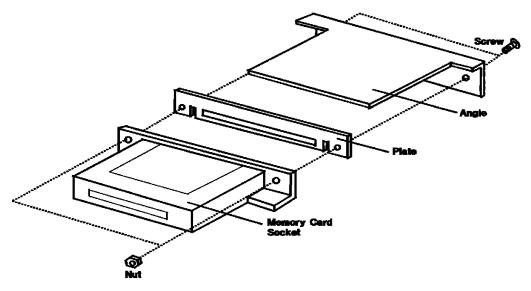
Figure 1. Dust-Preventive Cover Assembly

The memory card socket of 4278A which used in a production line may clog up with dust.

Replace the defective memory card socket assembly by installing the new one with the dust-preventive cover, refer to Figure 1.
