S E R V I C E N O T E

Agilent 4294A Precision Impedance Analyzer

Serial Numbers: JP1KG00101 / JP1KG00350

DATE: September 2000

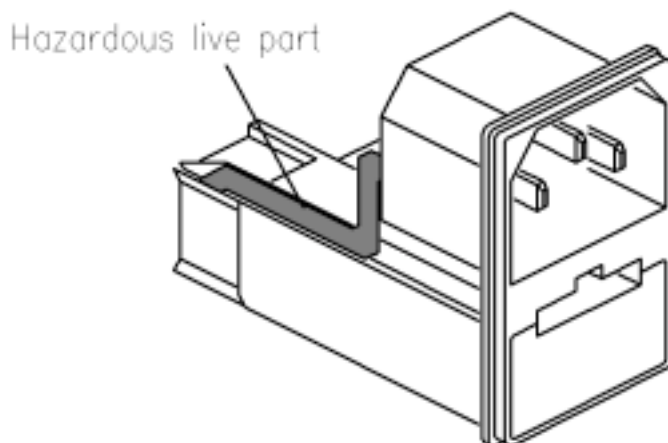
The AC inlet (P/N 1252-6951) has the potential to slip out of the instrument's rear panel slot if the AC power cord is forcefully pulled in a diagonal direction. When this happens, an exposed connection on the AC inlet module may touch the rear panel of the instrument and cause an electrical short if the AC power cord is still connected to the AC power outlet. See Figure 1.

Figure 1. AC Inlet Connector

In the worst case, there is also a possibility of an electric shock hazard to the user if the user completes a circuit between the instrument panel and another grounded connection while the AC power cord is still connected to the AC power outlet.

Solution 1. AC Inlet Still Intact.

- Remove the AC power cable from the AC power outlet and the product.
- Remove the top, bottom, and side covers.
- Seal the hot line terminal on the AC inlet with silicon paste (P/N 5183-4112).
- Reinforce the connection between the AC inlet and the rear panel with silicon paste.
- Perform Self Test to verify instrument operation.

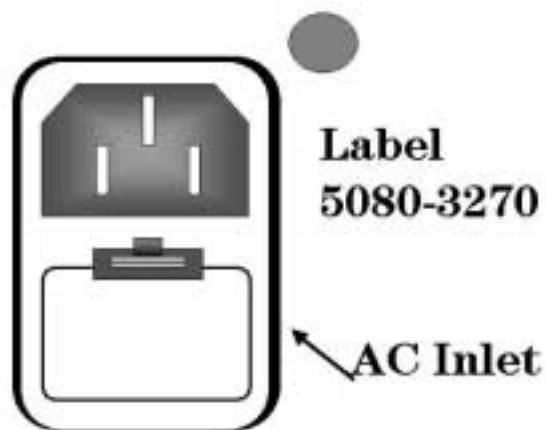
Fig. 2

Figure 2. Repair Completed Label

After completing the above instructions, stick the label (P/N 5080-3270) next to the AC Inlet on the rear panel as a mark that this repair has been completed. See Figure 2.
