S E R V I C E N O T E

4338A Milliohmeter

Modification to eliminate CPU hang up due to defective X'tal oscillators

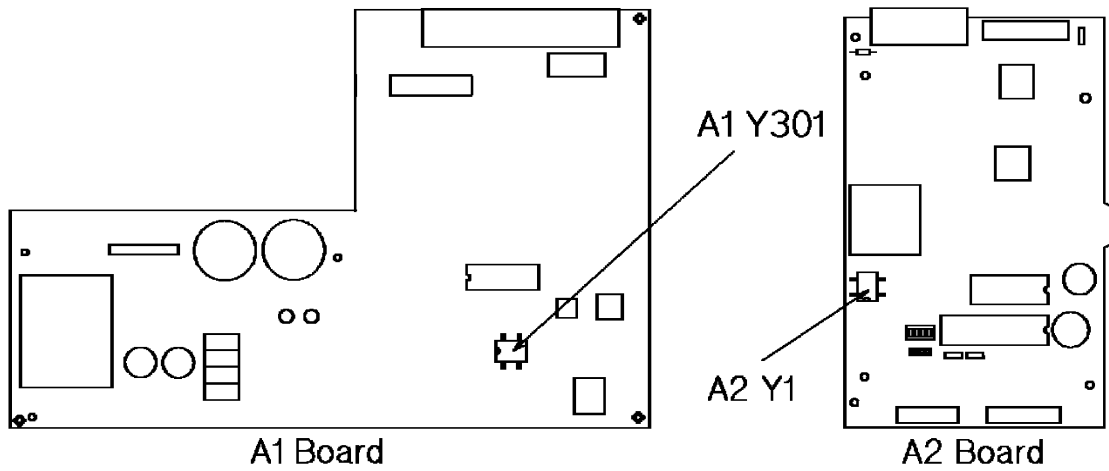
The 4338A units with serials given above may hang up intermittently. This is caused by the X'tal oscillator chip which has a problem in its manufacturing process. Two oscillator chips are used in the 4338A.

Figure 1. shows the X'tal location.

If the unit exhibits the symptoms given above, try replacing the two X'tal oscillator chips with new ones. These components are SMD (Surface Mounted Devices) but don't require any special tools or techniques to replace them. Their pin pitch is wider than the general SMD.
