S E R V I C E N O T E

4349A 4-Channel High Resistance Meter

Serial Numbers: 0000J00000 / 3237J00238

Modification to eliminate CPU hang up due to defective X'tal oscillators

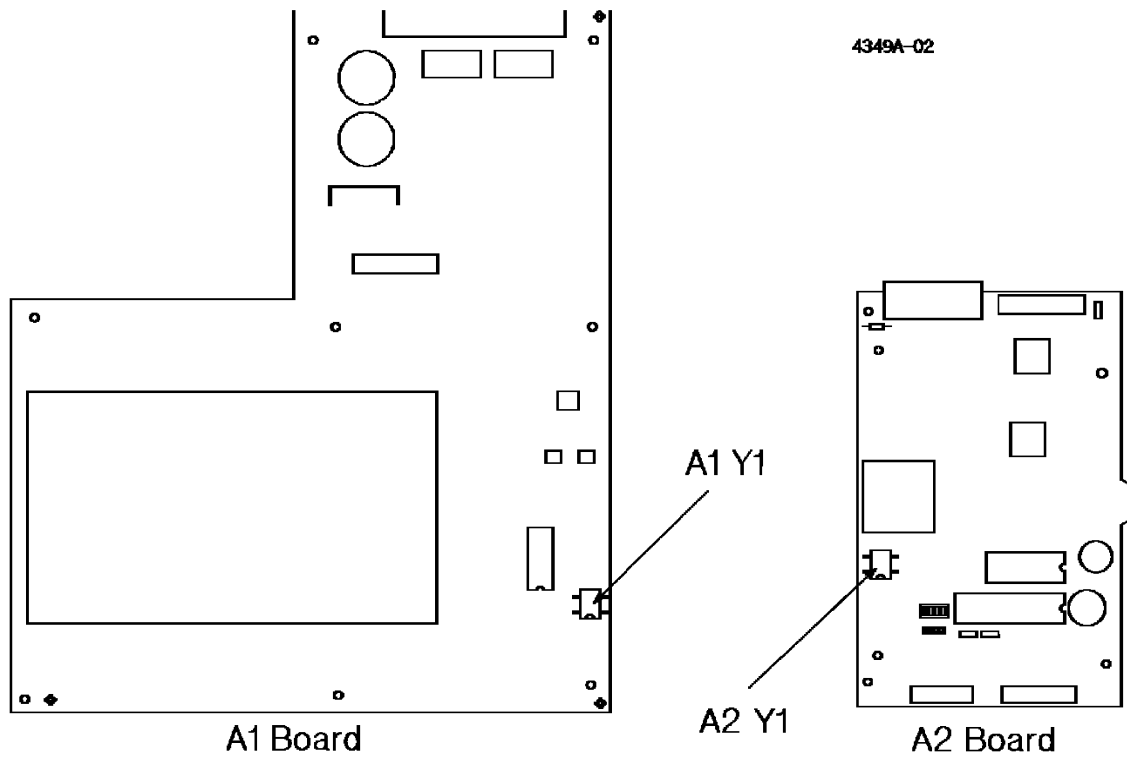
The 4349A units with serials given above may hang up intermittently. This is caused by the X'tal oscillator chip which has a problem in its manufacturing process. Two oscillator chips are used in the 4349A.

Figure 1. shows the X'tal location.

If the unit exhibits the symptoms given above, try replacing the two X'tal oscillator chips with new ones. These components are SMD (Surface Mounted Devices) but don't require any special tools or techniques to replace them. Their pin pitch is wider than the general SMD.
