S E R V I C E N O T E

3577B Network Analyzer

A18 modification improves source distortion at 1 kHz

Page 2 Service Note 3577B-08

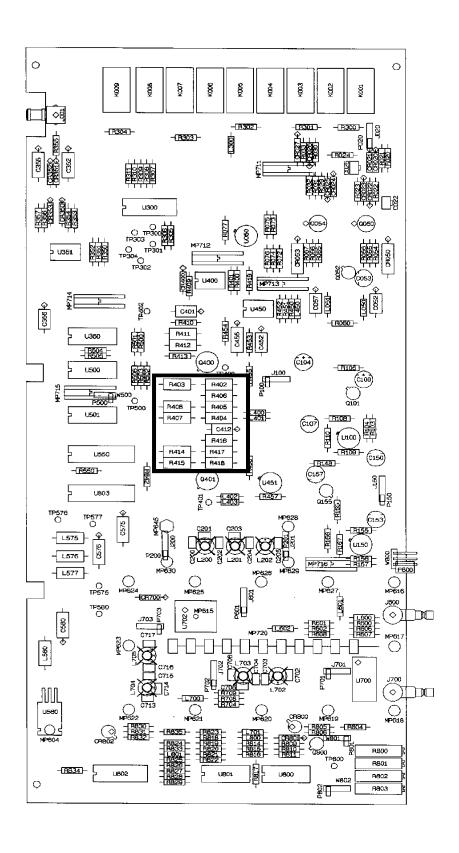
Source distortion, resulting from poor regulation of the +5V and -5V "private" supplies on the A18 board, is causing the source signal to be severely distorted in the region around 1000 Hz, which results in source flatness failures. Removing resistors R407, R408, R417 and R418 so that each regulator transistor must pass an increased amount of current, ensures that the circuit is truly operating as a voltage regulator.

- 3. Remove the A18 source board from the cardnest.
- 4. Remove A18 R407, R408, R417 and R418 (refer to figure 1 for location).
- 5. Return the instrument to its original state.
- 6. Run self tests to verify proper operation.
