S E R V I C E N O T E

6012B Autoranging DC Power Supply

Serial Numbers: 3104A03481 / 3139A03760

Modification using RTV to prevent W8 Ribbon Cable disconnect.**Duplicate Service Notes:**

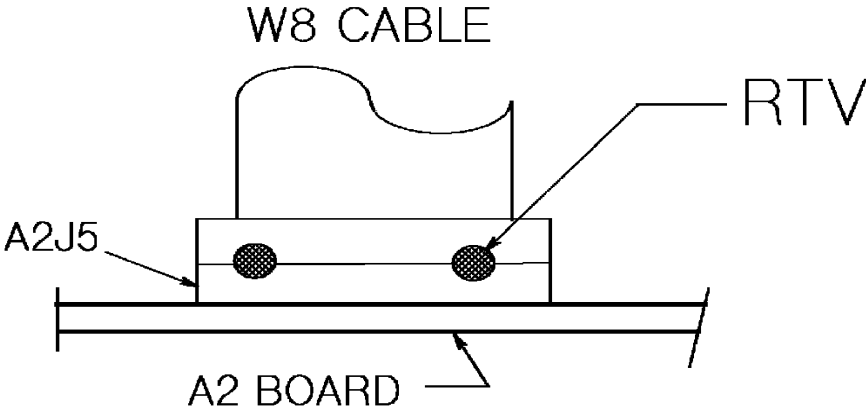
Figure 1

The W8 ribbon cable connecting the A1 main board assembly to the A2 Control board assembly may vibrate loose during transportation. This only involves units with serial numbers inclusive of those listed above.

Reconnect the W8 ribbon cable. Use RTV to secure the W8 connector to the J5 mating connector on the A2 assembly. Put a 8 mm (0.313 in) size spot bridging the W8 / J5 connectors. Bridge the connectors with an RTV spot at each end as shown in figure 1.
