**6571A-06A**

**S E R V I C E N O T E**

**6571A DC POWER SUPPLY MANUALLY CONTROLLED**

**The Current Shunt (Circuit Reference “R907”) may have intermittent sense wires, which may cause Instability of Current regulation, Current read back and current programming may become unstable.**

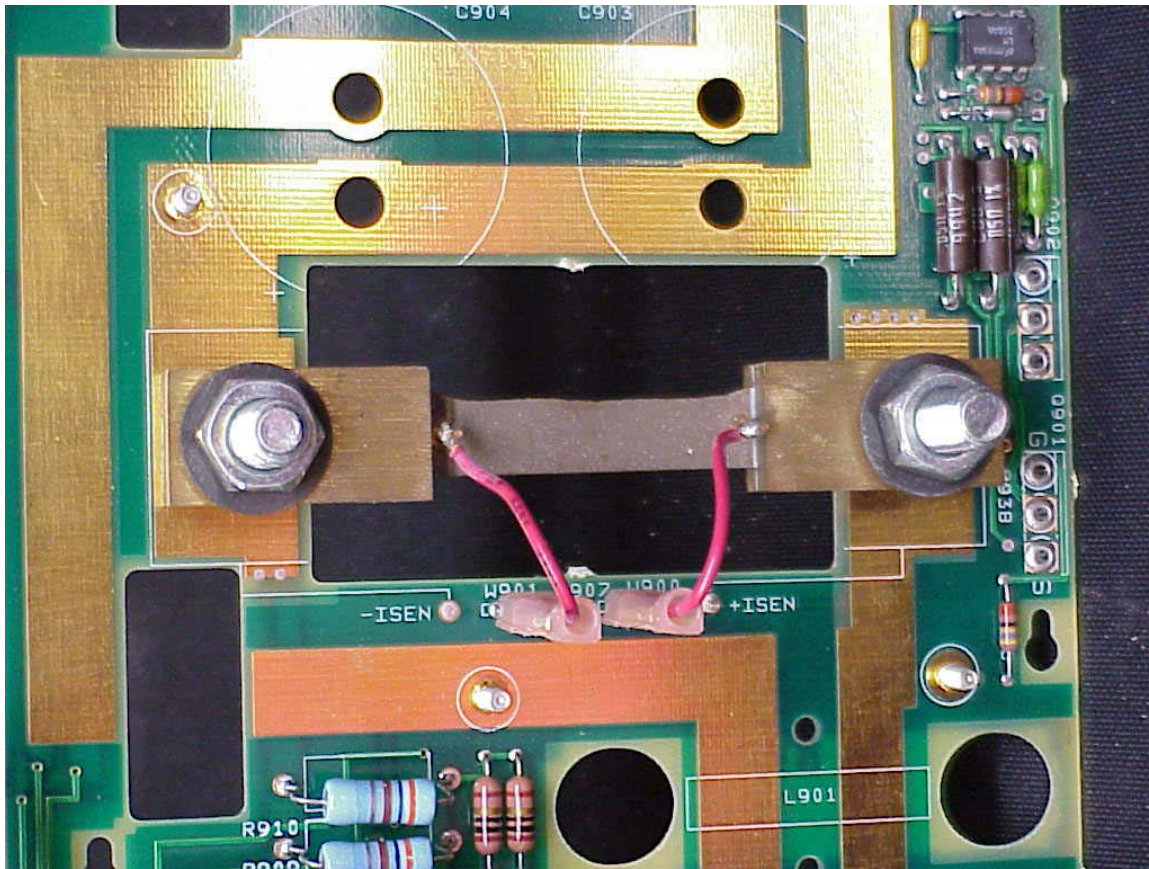
When the push-on connectors become intermittent the output current will become unstable. Loose push-on connectors can cause the output current to change dramatically. The current can change from any set current, and may go to the maximum rated output current of the instrument.

This picture shows how the Shunt R907 is connected using the term-crimp connectors.

The Shunt R907 is connected to "W900" & "W901"
