66000A-06

S E R V I C E N O T E

66000A DC Power Supply Main Frame

The modules or the Mainframe will not communicate or will not complete self test.

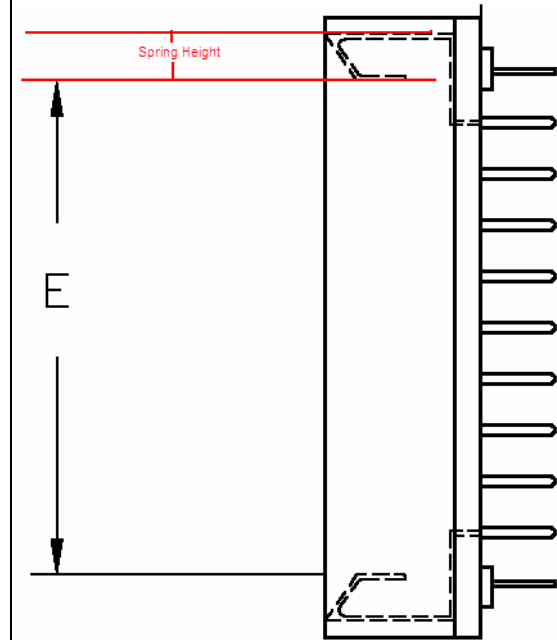
The condition of the recessed beams has been corrected by a design enhancement implemented in production. This design enhancement increased the spring height dimension by 0.04mm and decreased the spring height tolerance by 40%. The spring height dimension is shown in the drawing below.

This design enhancement is intended to position the contact beams closer to the middle of the socket and increase the normal force exerted on the contacts of the chips mated to the socket.
