# 66101A-09

# SERVICE NOTE

## 66101A DC Power Supply

The instrument will not communicate or will not complete self test.

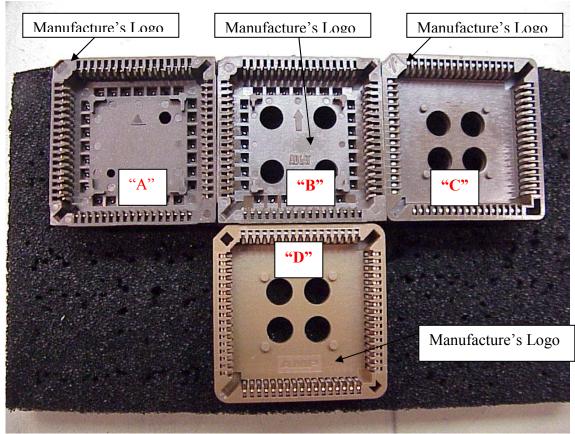
Figure 2
This figure should be used to identify **GOOD** sockets and a potential defective socket. The **16-Bit MCU 16 MHZ 68PLCC CMOS IC (**P/N 1821-1479) is <u>NOT</u> pictured.

Socket "A" is a sample of a GOOD AMP socket.

Socket "B" is a sample of a GOOD Tyco/Augit socket.

Socket "C" is a sample of a GOOD FCI socket.

Socket "D" is a sample of a DEFECTIVE Tyco socket.

The sockets above labeled "A", "B" or "C are good and should NOT be replaced. The socket above labeled "D" is considered defective should replaced.

Any Model having a serial number starting and ending with the serial numbers shown in the chart below should have the socket 68-PIN PLCC SOCKET - P/N 1200-1274 (Circuit Reference "U001") **REPLACED!**

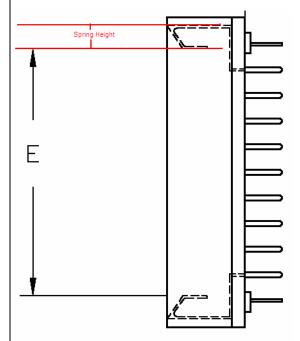
The condition of the recessed beams has been corrected by a design enhancement implemented in production. This design enhancement increased the spring height dimension by 0.04mm and decreased the spring height tolerance by 40%. The spring height dimension is shown in the drawing below.

This design enhancement is intended to position the contact beams closer to the middle of the socket and increase the normal force exerted on the contacts of the chips mated to the socket.
