# 66102A-08

## S E R V I C E N O T E

### 66102A DC Power Supply

**The instrument will not communicate or will not complete self test.**

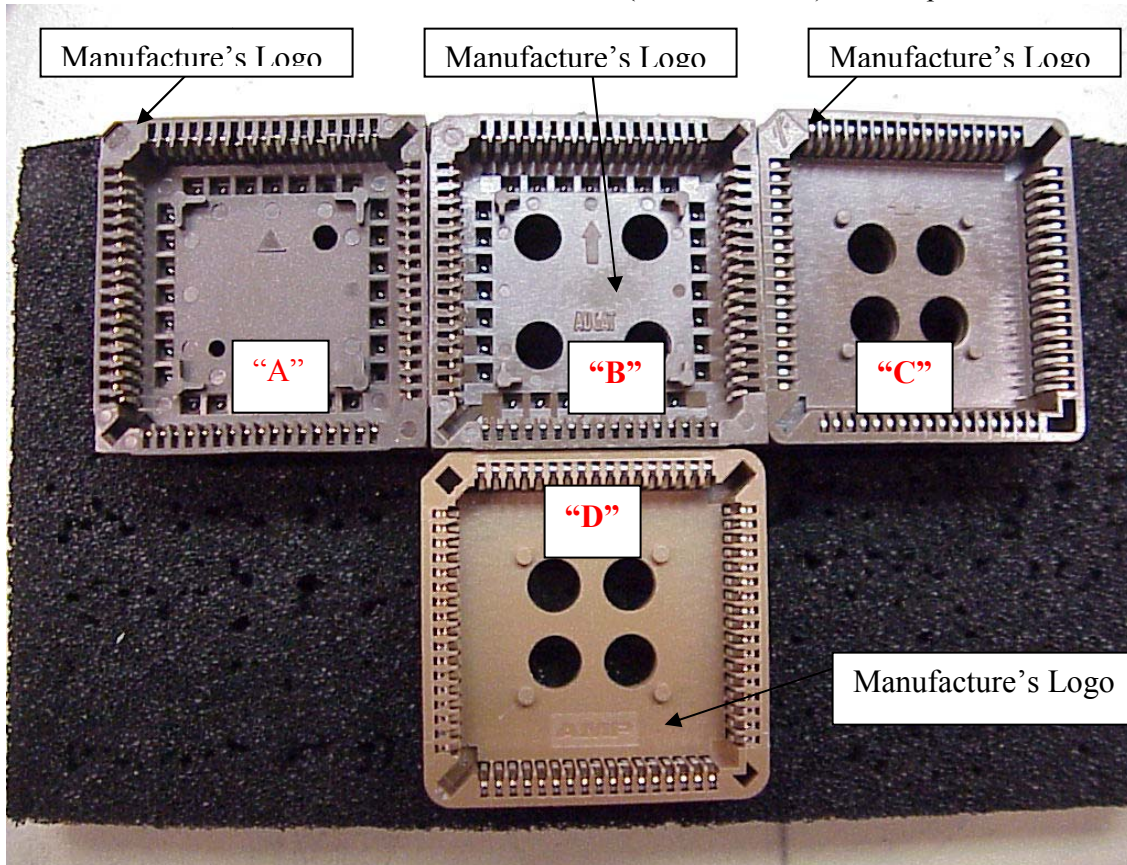
This figure should be used to identify **GOOD** sockets and a potential defective socket. The **16-Bit MCU 16 MHZ 68PLCC CMOS IC** (P/N 1821-1479) is **NOT** pictured.

The following information will help identify each socket type and manufacturer. The manufacturer's logo can be identified as shown. After the **16-Bit MCU 16 MHZ 68PLCC CMOS IC** has been removed there are also mold markings that can be easily viewed these markings should be used to identify a **Good or Defective socket**.

- Socket **"A"** is a sample of a GOOD AMP socket.
- Socket **"B"** is a sample of a GOOD Tyco/Augit socket.
- Socket **"C"** is a sample of a GOOD FCI socket.
- Socket **"D"** is a sample of a DEFECTIVE Tyco socket.

The sockets above labeled **"A", "B" or "C"** are good and should NOT be replaced. The socket above labeled **"D"** is considered defective should be replaced.

Any Model having a serial number starting and ending with the serial numbers shown in the chart below should have the socket 68-PIN PLCC SOCKET - P/N 1200-1274 (Circuit Reference "U001") **REPLACED!**
