**66104A-09**

**S E R V I C E N O T E**

**66104A DC Power Supply**

**The instrument will not communicate or will not complete self test.**

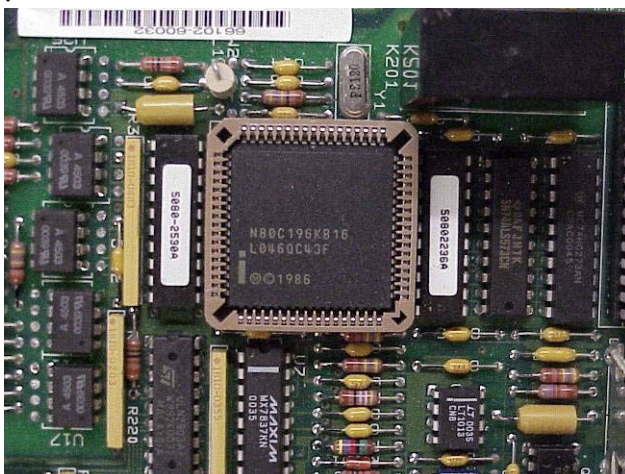
**Figure1**

Figure 1 will help to identify the **68-PIN PLCC SOCKET location** - P/N 1200-1274 (Circuit Reference “U001”)

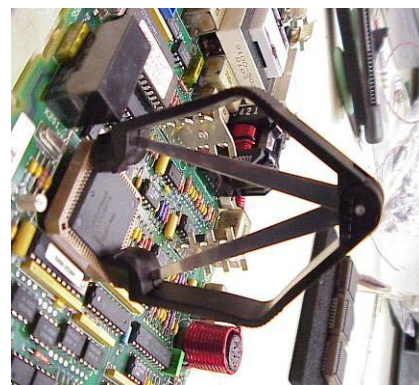
**Figure 2**

This picture shows the required tool used to remove the processor.

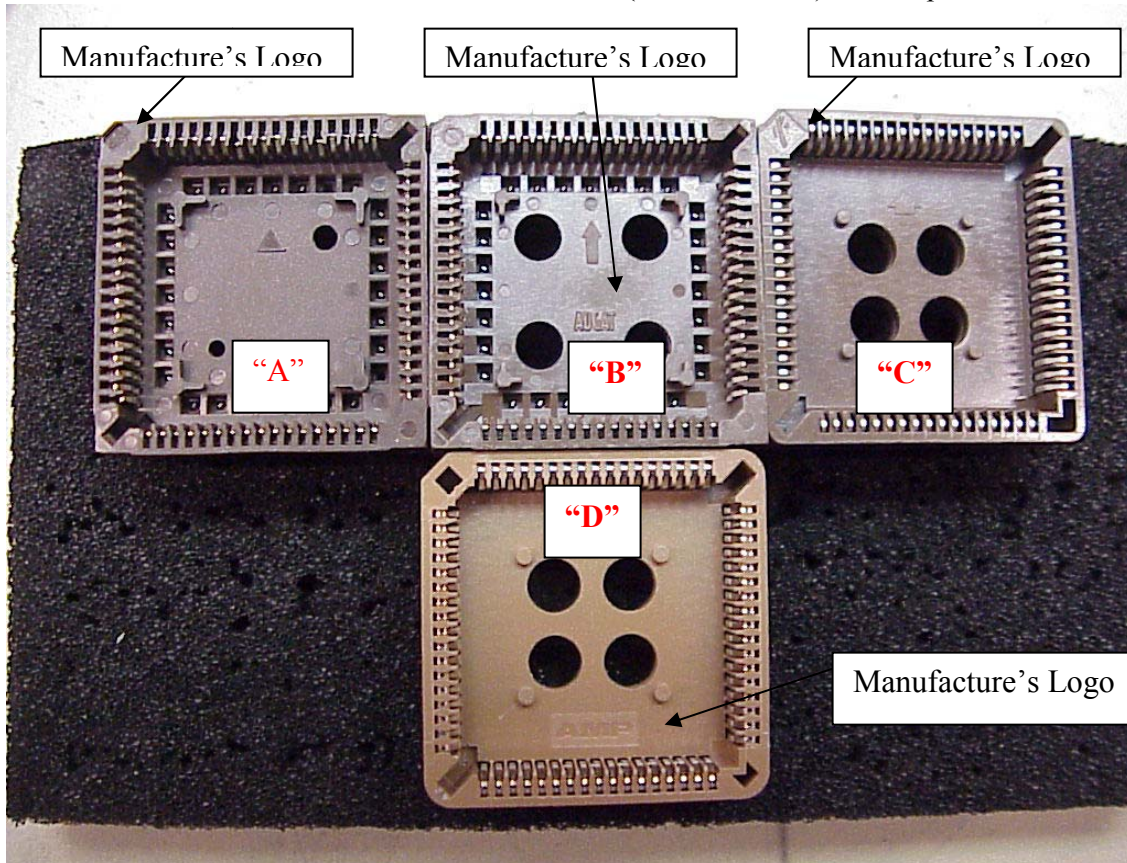
This figure should be used to identify **GOOD** sockets and a potential defective socket. The **16-Bit MCU 16 MHZ 68PLCC CMOS IC** (P/N 1821-1479) is **NOT** pictured.

The following information will help identify each socket type and manufacturer. The manufacturer's logo can be identified as shown. After the **16-Bit MCU 16 MHZ 68PLCC CMOS IC** has been removed there are also mold markings that can be easily viewed these markings should be used to identify a **Good or Defective socket**.

- Socket **"A"** is a sample of a GOOD AMP socket.
- Socket **"B"** is a sample of a GOOD Tyco/Augit socket.
- Socket **"C"** is a sample of a GOOD FCI socket.
- Socket **"D"** is a sample of a DEFECTIVE Tyco socket.

The sockets above labeled **"A", "B" or "C"** are good and should NOT be replaced. The socket above labeled **"D"** is considered defective should be replaced.

Any Model having a serial number starting and ending with the serial numbers shown in the chart below should have the socket 68-PIN PLCC SOCKET - P/N 1200-1274 (Circuit Reference "U001") **REPLACED!**

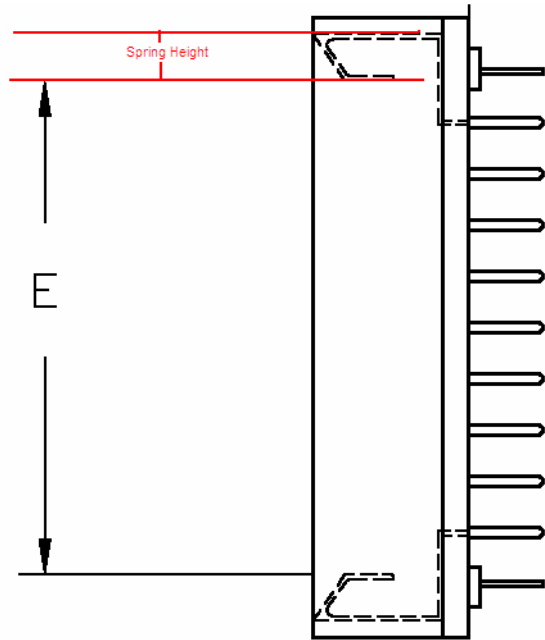
The condition of the recessed beams has been corrected by a design enhancement implemented in production. This design enhancement increased the spring height dimension by 0.04mm and decreased the spring height tolerance by 40%. The spring height dimension is shown in the drawing below.

This design enhancement is intended to position the contact beams closer to the middle of the socket and increase the normal force exerted on the contacts of the chips mated to the socket.

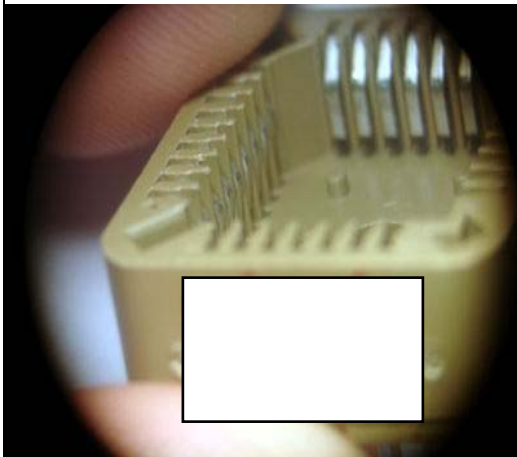
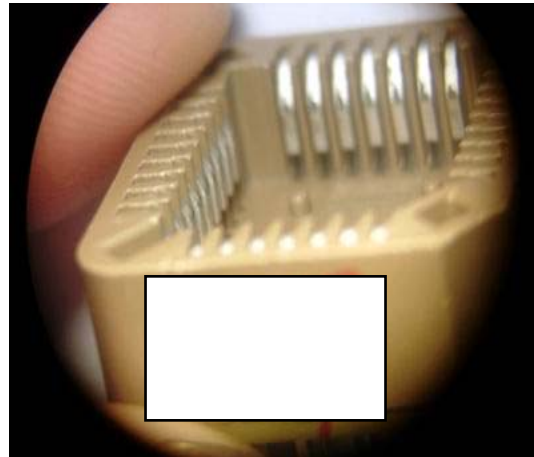
The effectiveness of this design enhancement was tested by comparing the mating and un-mating forces on the older and newer designs. The test results for sockets with the increased spring height (newer design) showed an increase in the mean mating force of 18.9% and an increase in the mean un-mating force of 23.4%. The increase in the un-mating force test results between the old design and the new design indicate that a greater normal force is being exerted on the test chip contacts by the socket contact beams. The two revisions of this contact beam design were visually examined after the mating and un-mating force testing. Photos of the two sockets are shown below. The photo on the left shows the older version socket prior to the enhanced contact beam design. The photo on the right shows a socket with the design enhancement. The contacts with the older design appear to be recessed farther into the housing after un-mating.
