# 66106A-08

## S E R V I C E N O T E

### 66106A DC Power Supply

**The instrument will not communicate or will not complete self test.**

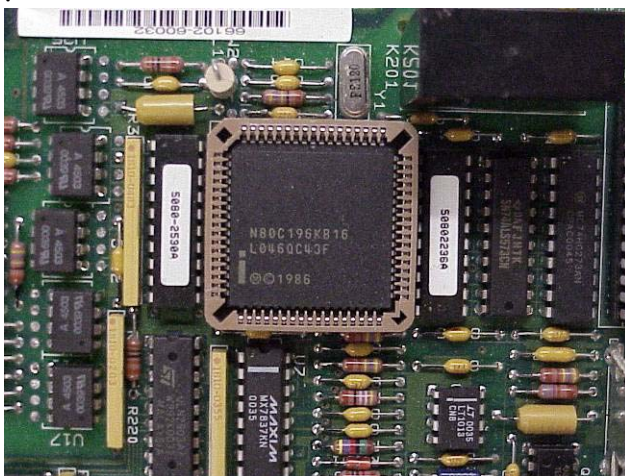
**Figure1**

Figure 1 will help to identify the **68-PIN PLCC SOCKET location** - P/N 1200-1274 (Circuit Reference “U001”)

Any Model having a serial number starting and ending with the serial numbers shown in the chart below should have the socket 68-PIN PLCC SOCKET - P/N 1200-1274 (Circuit Reference "U001") **REPLACED!**

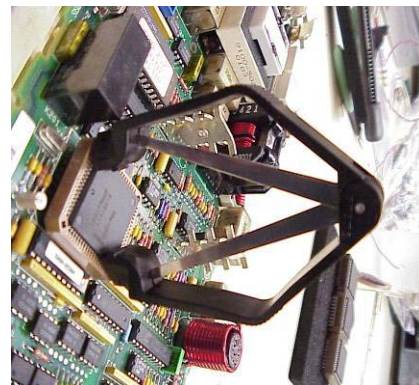
**Figure 2**

This picture shows the required tool used to remove the processor.

Remove the 16-Bit processor p/n1821-1479 from the socket before the 68 pin PLCC socket p/n 1200-1274 is replaced.

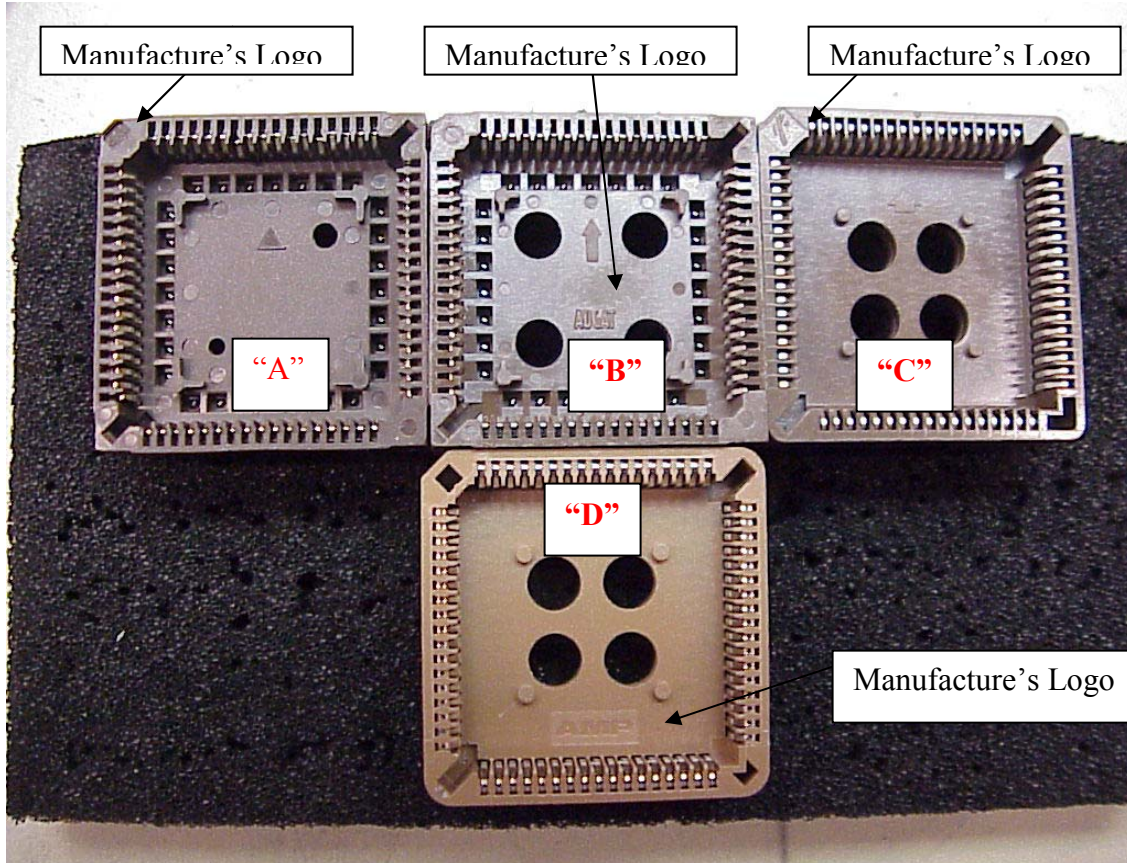
This figure should be used to identify **GOOD** sockets and a potential defective socket. The **16-Bit MCU 16 MHZ 68PLCC CMOS IC** (P/N 1821-1479) is **NOT** pictured.

The following information will help identify each socket type and manufacturer. The manufacturer's logo can be identified as shown. After the **16-Bit MCU 16 MHZ 68PLCC CMOS IC** has been removed there are also mold markings that can be easily viewed these markings should be used to identify a **Good or Defective socket**.

- Socket **"A"** is a sample of a GOOD AMP socket.
- Socket **"B"** is a sample of a GOOD Tyco/Augit socket.
- Socket **"C"** is a sample of a GOOD FCI socket.
- Socket **"D"** is a sample of a DEFECTIVE Tyco socket.

The sockets above labeled **"A", "B" or "C"** are good and should NOT be replaced.  
The socket above labeled **"D"** is considered defective should be replaced.

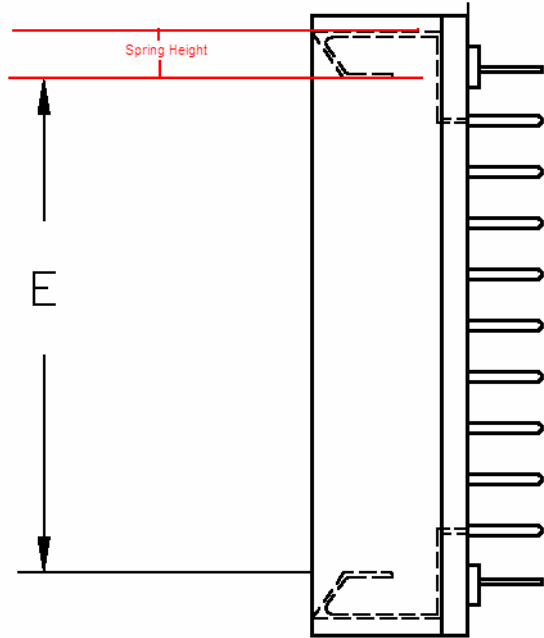
The condition of the recessed beams has been corrected by a design enhancement implemented in production. This design enhancement increased the spring height dimension by 0.04mm and decreased the spring height tolerance by 40%. The spring height dimension is shown in the drawing below.

This design enhancement is intended to position the contact beams closer to the middle of the socket and increase the normal force exerted on the contacts of the chips mated to the socket.

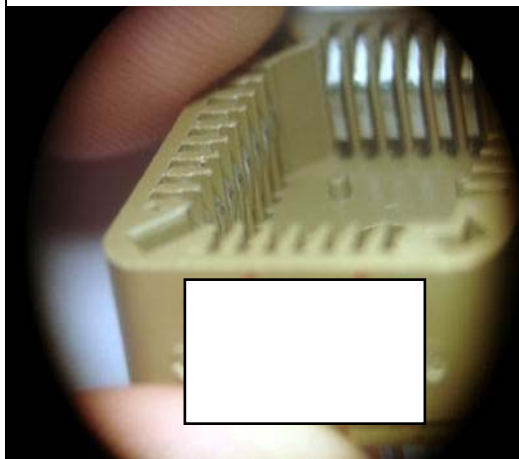
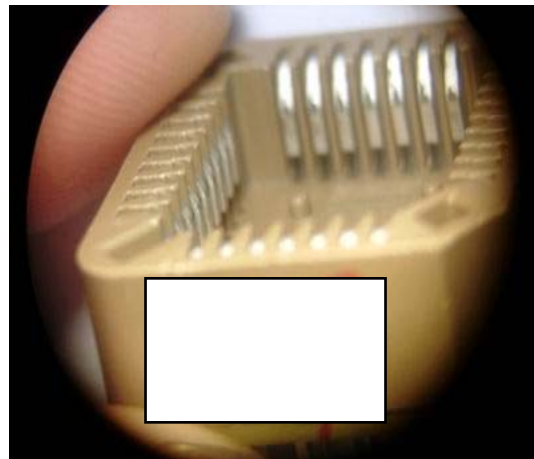
The effectiveness of this design enhancement was tested by comparing the mating and un-mating forces on the older and newer designs. The test results for sockets with the increased spring height (newer design) showed an increase in the mean mating force of 18.9% and an increase in the mean un-mating force of 23.4%. The increase in the un-mating force test results between the old design and the new design indicate that a greater normal force is being exerted on the test chip contacts by the socket contact beams. The two revisions of this contact beam design were visually examined after the mating and un-mating force testing. Photos of the two sockets are shown below. The photo on the left shows the older version socket prior to the enhanced contact beam design. The photo on the right shows a socket with the design enhancement. The contacts with the older design appear to be recessed farther into the housing after un-mating.

Material with this design enhancement will be labeled with a 2007 date code
