66319D-05

S E R V I C E N O T E

66319D

Reliability Improvement of Instrument

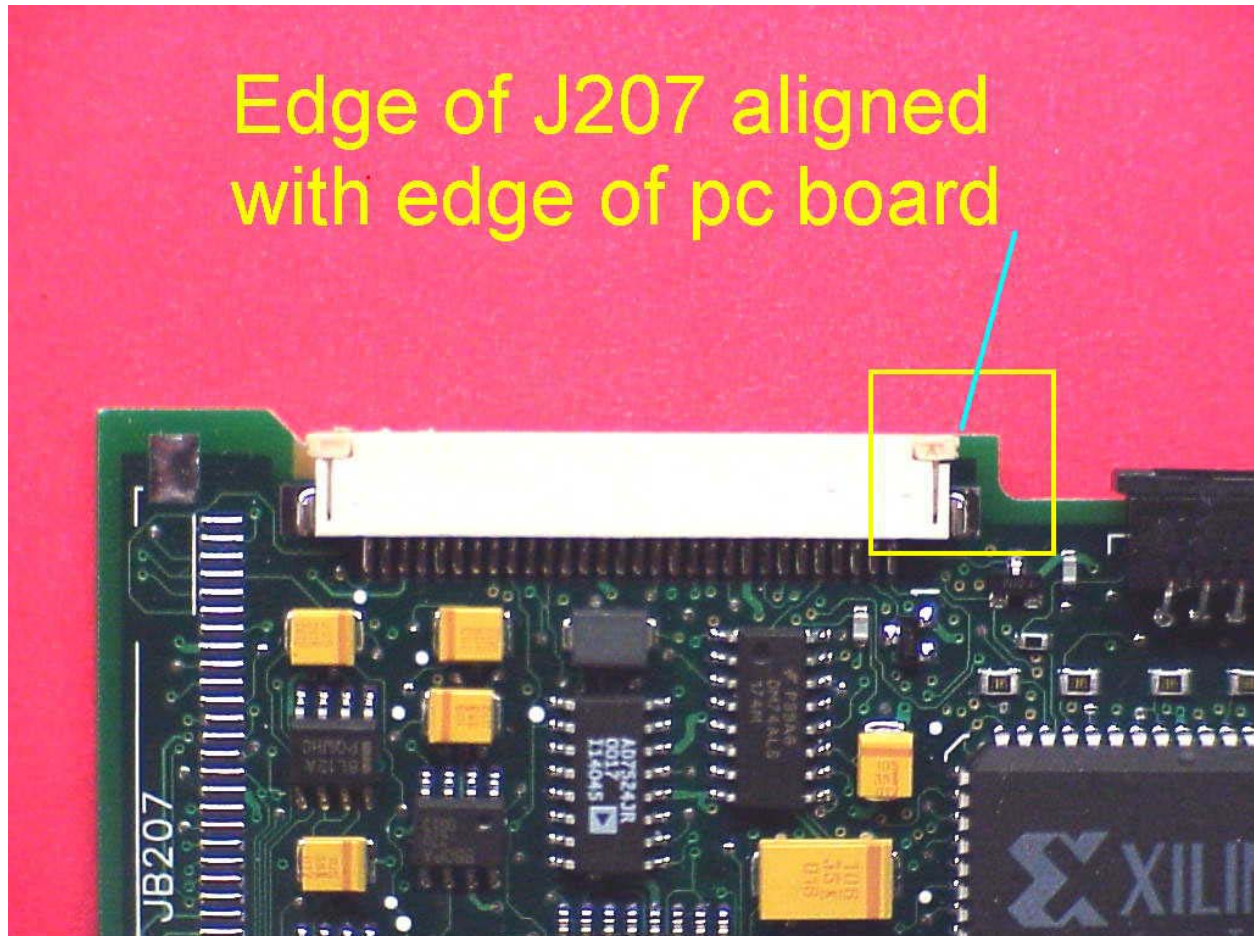
CORRECT J207 PLACEMENT – alignment to within $< 0.3\text{mm}$

Picture shows connector aligned to edge of SMT board to within $< 0.1\text{mm}$

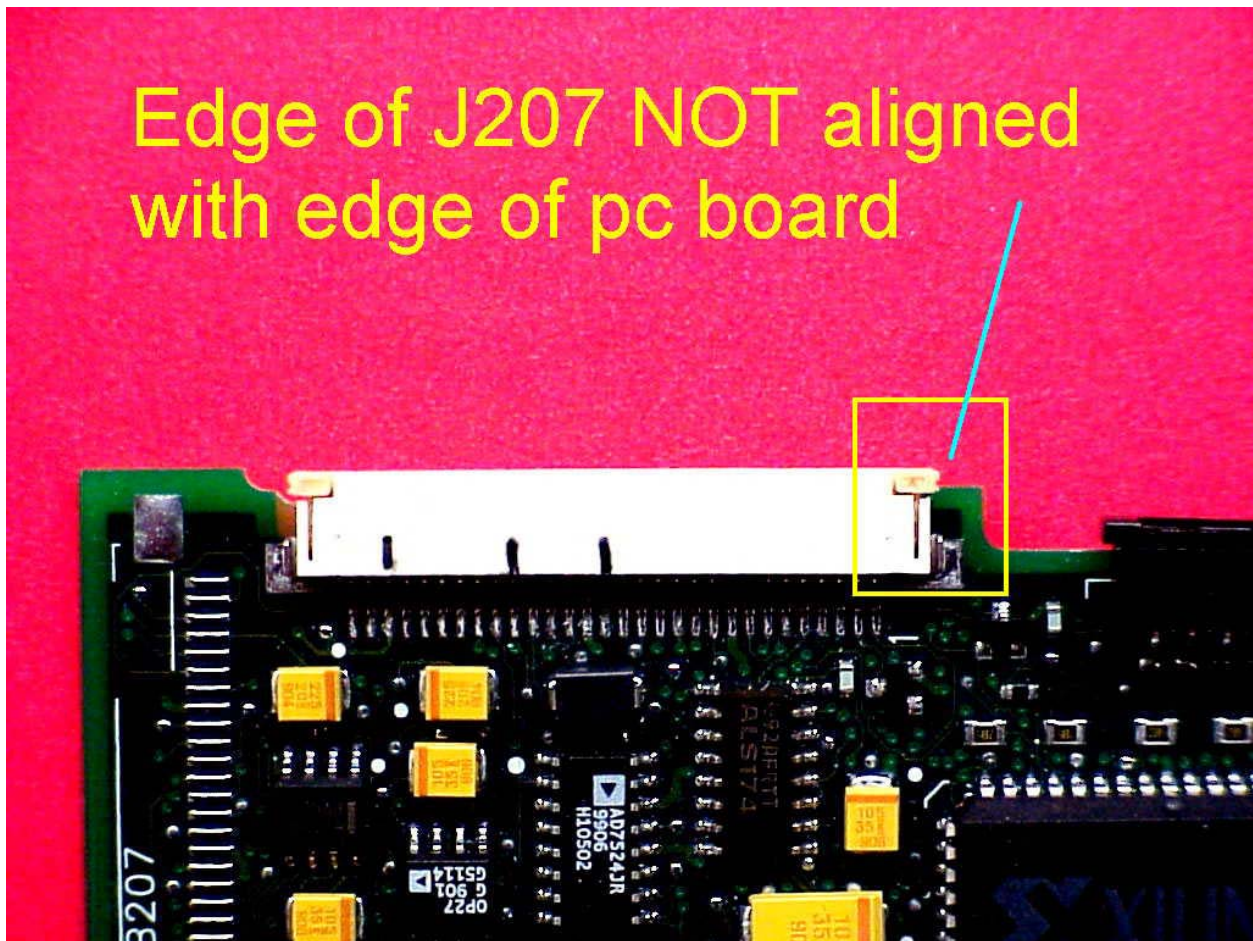
Latent product failure due to misplaced connector J207 on SMT assembly 5064-0018 (GPIB/RS232 interface). Misplacement of J207 could lead to inadvertent contact/shorting of exposed feed-throughs on SMT board. Ultimately, resulting in over-stress of components of damage to SMT board components. Resulting contact could degrade useful life of instrument.

INCORRECT J207 PLACEMENT – misaligned by $> 0.3\text{mm}$
Picture shows connector extending past edge of SMT board by $>1.2\text{mm}$

- 1) Compare placement of J207 to attached photos. Instruments with a “misplaced” J207 should be returned to Agilent for warranty repair.
- 2) Instruments returned to the Service Center for routine calibration should be inspected for this potential defect. Defects should be addressed using Agilent’s unit exchange process with costs being charged to warranty.
- 3) The factory has modified production documentation to include visual inspection and specific electrical testing for this potential short.
- 4) Factory is maintaining feedback to SMT board supplier regarding quality of assembly.
