**66321D-05**

**S E R V I C E N O T E**

66321D

**Reliability Improvement of Instrument**

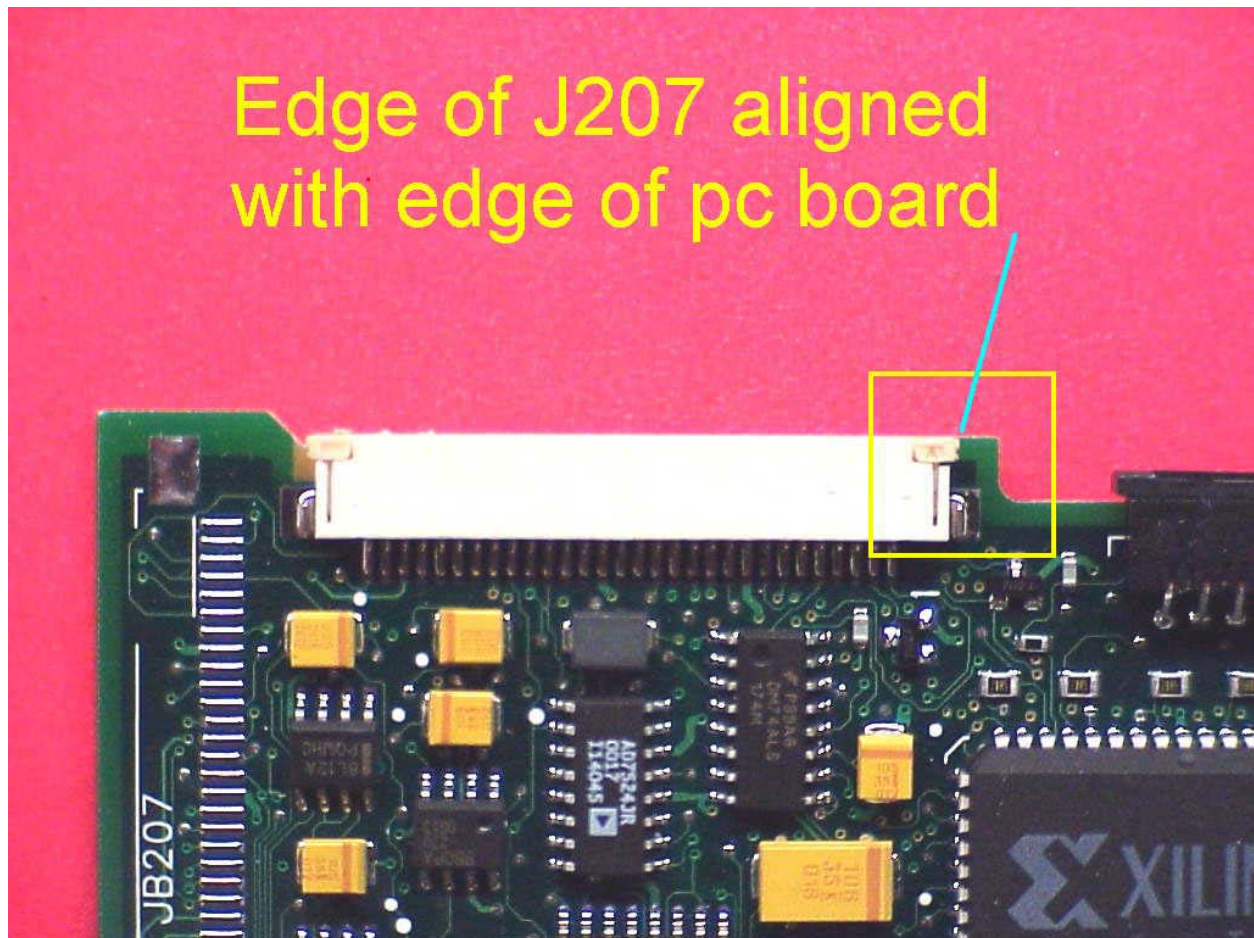
**CORRECT J207 PLACEMENT** – alignment to within  $< 0.3\text{mm}$

Picture shows connector aligned to edge of SMT board to within  $< 0.1\text{mm}$

- 1) Compare placement of J207 to attached photos. Instruments with a “misplaced” J207 should be returned to Agilent for warranty repair.
- 2) Instruments returned to the Service Center for routine calibration should be inspected for this potential defect. Defects should be addressed using Agilent’s unit exchange process with costs being charged to warranty.
- 3) The factory has modified production documentation to include visual inspection and specific electrical testing for this potential short.
- 4) Factory is maintaining feedback to SMT board supplier regarding quality of assembly.

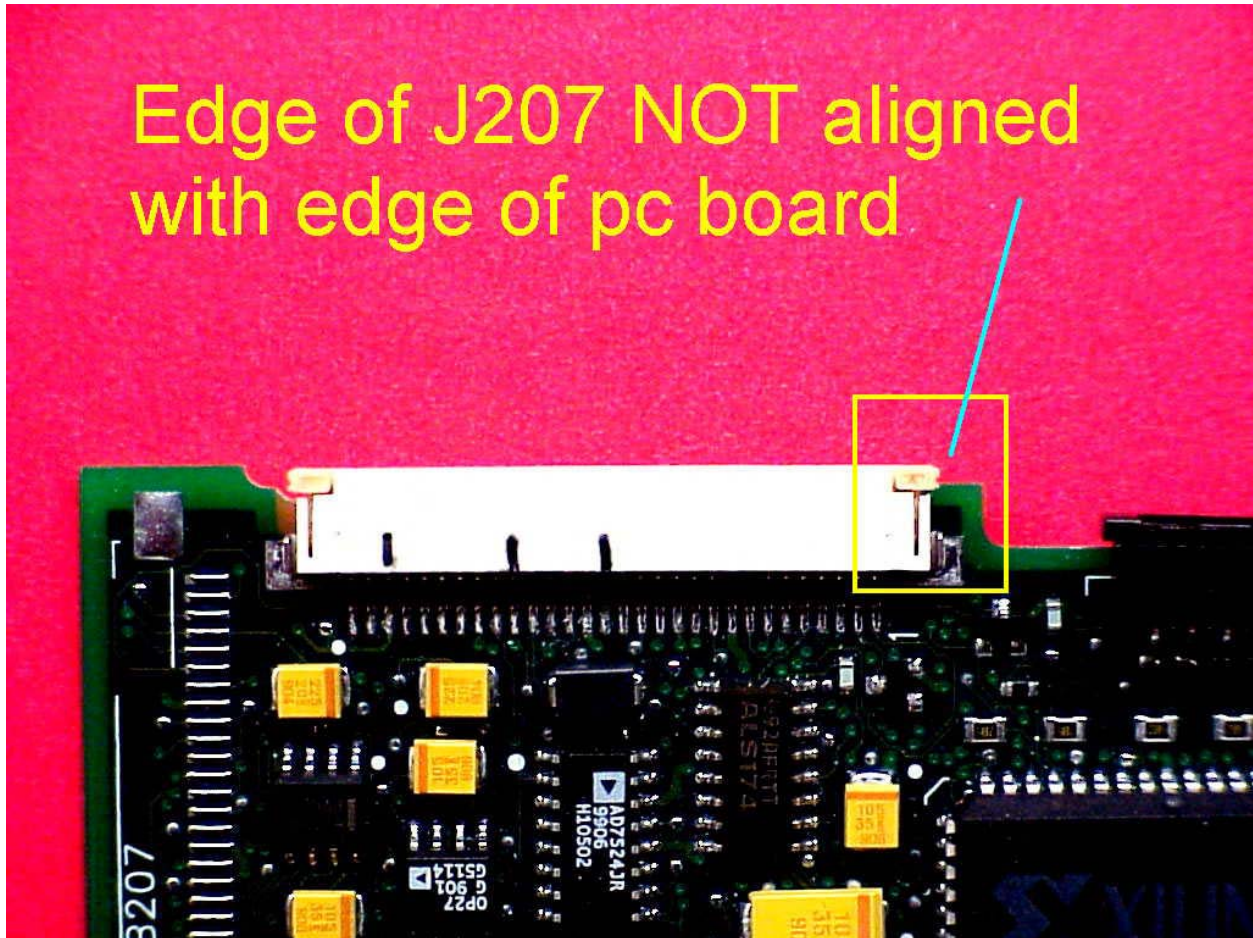
Latent product failure due to misplaced connector J207 on SMT assembly 5064-0018 (GPIB/RS232 interface). Misplacement of J207 could lead to inadvertent contact/shorting of exposed feed-throughs on SMT board. Ultimately, resulting in over-stress of components of damage to SMT board components. Resulting contact could degrade useful life of instrument.

**INCORRECT J207 PLACEMENT** – misaligned by  $> 0.3\text{mm}$

Picture shows connector extending past edge of SMT board by  $>1.2\text{mm}$
