6671A-08A

S E R V I C E N O T E

6671A DC POWER SUPPLY GPIB CONTROLLED

**Serial Numbers: US366400345/US365400554 MY41000101/MY41000681 &
SG41000101/SG41000263**

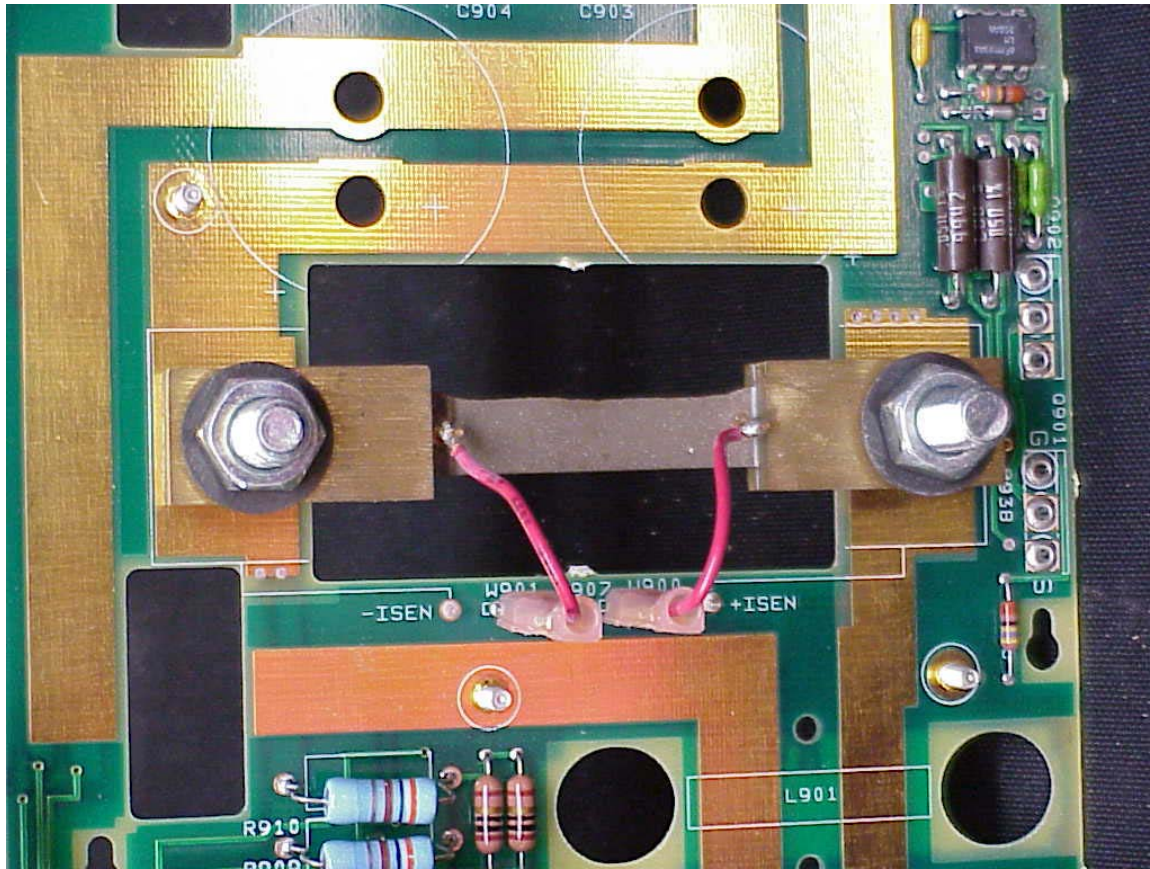
A6 Output Assembly for Models (65/6671A, 65/6672A)

The Current Shunt (Circuit Reference “R907”) may have intermittent sense wires, which may cause instability of Current regulation, Current read back and Current programming.

When the push-on connectors become intermittent the output current will become unstable. Loose push-on connectors can cause the output current to change dramatically. The current can change from any set current, and may go to the maximum rated output current of the instrument.

This picture shows how the Shunt R907 is connected using the term-crimp connectors.

The Shunt R907 is connected to "W900" & "W901"
