6674A-09A

S E R V I C E N O T E

6674A DC POWER SUPPLY GPIB CONTROLLED

**Serial Numbers: US36372417/US36372617 & MY41000101/MY41000766 &
SG41000101/SG41000520**

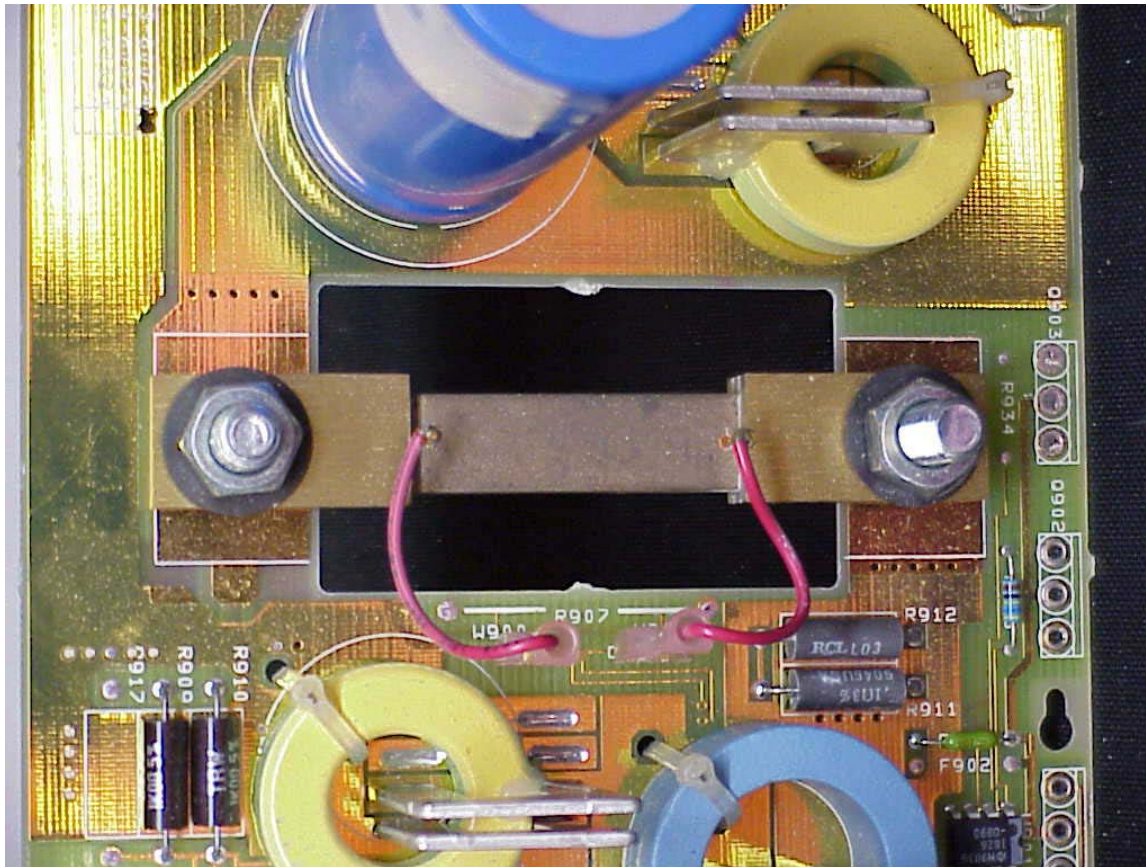
The Current Shunt (Circuit Reference “R907”) may have intermittent sense wires, which may cause Instability of Current regulation, Current read back and current programming.

When the push-on connectors become intermittent the output current will become unstable. Loose push-on connectors can cause the output current to change dramatically. The current can change from any set current, and may go to the maximum rated output current of the instrument.

This picture shows how the Shunt R907 is connected using the term-crimp connectors. The Shunt R907 is connected to "W900" & "W901"
