6691A-02

S E R V I C E N O T E

6691A DC POWER SUPPLY

Serial Numbers: US0000000/US41280107 & MY41000101/MY41000179

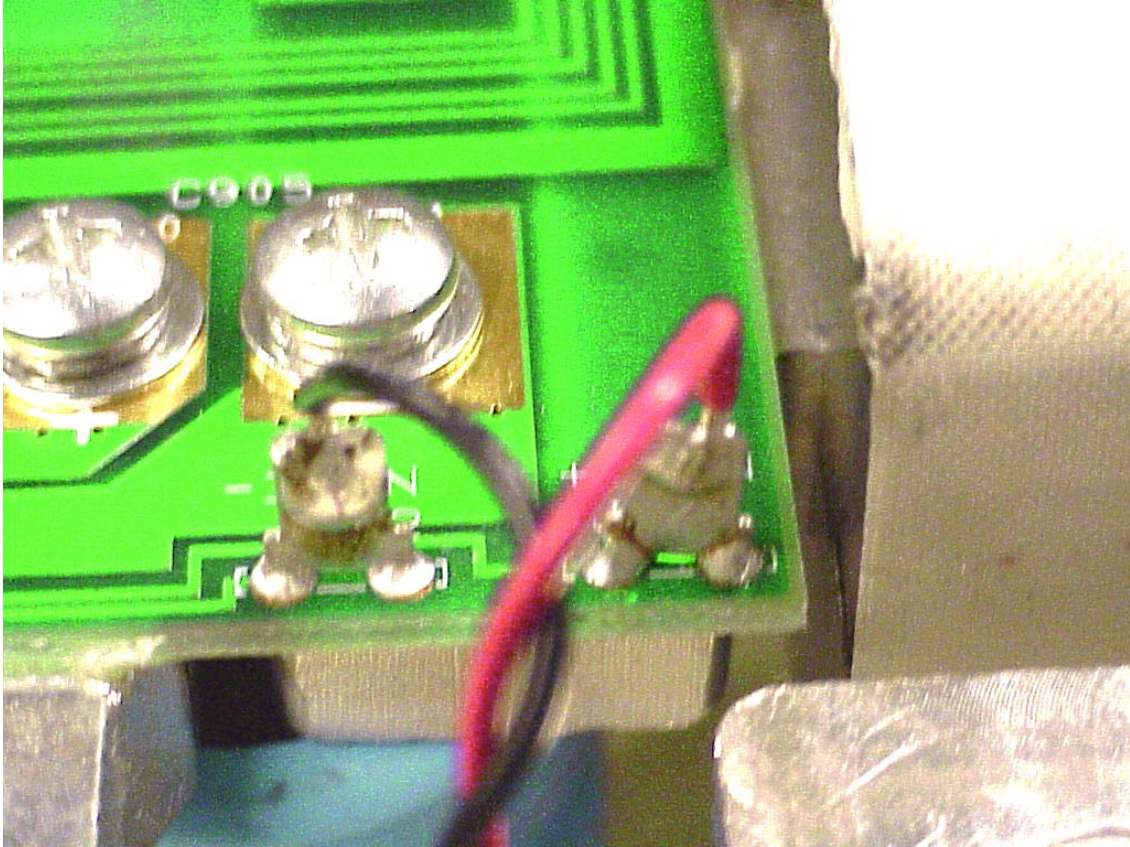
The second and the third pictures show how the Shunt “R900” is connected when soldered.

This strip length will be used to solder to the connectors to (-ISEN J912 Black wire) & (+ISEN J911 Red wire). The length of these wires is critical. If the strip length of the wires is too long, the wires may cause a short to adjacent components. If the length of the wires is too short the solder connections may be poor. If replacement of the Red or the Black wire is required the same type and color wire should be used (22 AWG. 300V 105C).

The wires should be connected as shown below. The holes in the male connectors should be used to solder the Red and Black wires to the printed circuit assembly marked (-ISEN J912) & (+ISEN J911). Do not mix the Red & Black wires when making this modification. See picture below for details. The pictures shown below show the required modification.

1. Inspect the solder connections to determine the solder joints are acceptable.
2. Inspect the printed circuit board to insure the solder joints are acceptable around (-ISEN J912) & (+ISEN J911) connectors.
3. The wires that are now soldered to (-ISEN J912 Black wire) & (+ISEN J911 Red wire) MUST be twisted.
