**5517D-05B**

**S E R V I C E N O T E**

5517D, 5517D-C19, 5517DN06, N07 and N13 Laser Heads

**Controller Board A3F1 Nuisance blows**

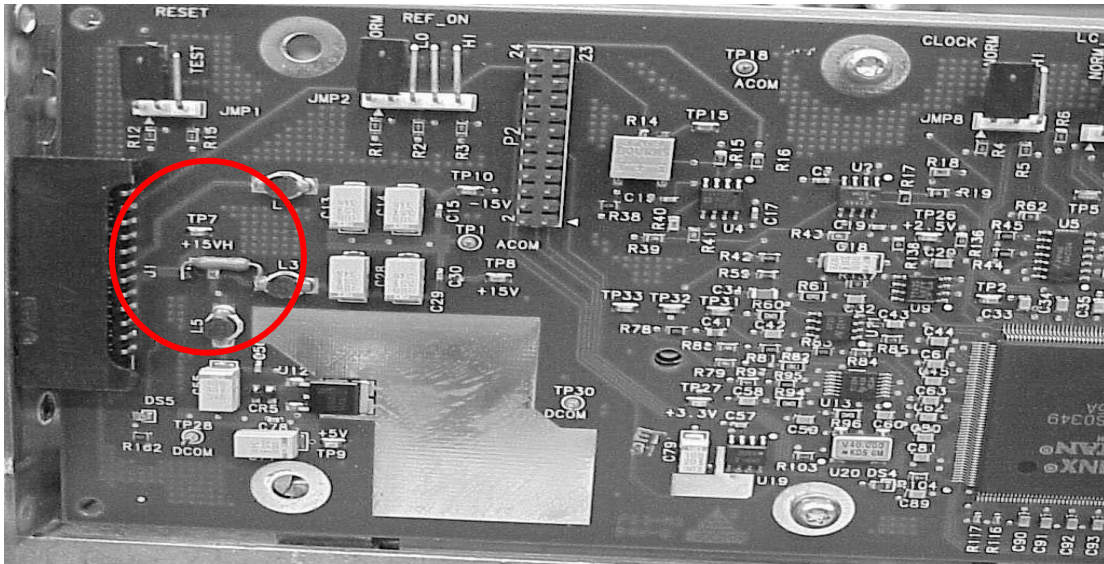
Agilent has identified some applications in which there is nuisance blows of the fuse (A3F1) on the laser controller board (05517-60031). This is a secondary fuse; the main fuses are not affected.

Nuisance fuse blowing is sometimes seen when the laser head is operated in a high temperature environment with limited to no air circulation around the unit. This condition causes very high temperatures inside the laser, greatly reducing the operating margin for the fuse.

Picture shows the 0.63A TH fuse installed.

We recommend that you remove the 0.5A surface mount fuse and replace it with a 0.63A through hole fuse (see picture below). In order to do this, bend the leads on the fuse to be able to attach the through hole fuse from the left fuse pad to L3. Then solder the fuse in place. After replacing the fuse the laser head needs to be powered up to ensure the unit is working. Additional test are optical power and split frequency tests. No adjustments are needed. Also, to identify laser heads that have had the fuse replaced, we recommend a label be placed on the rear panel (see picture below).

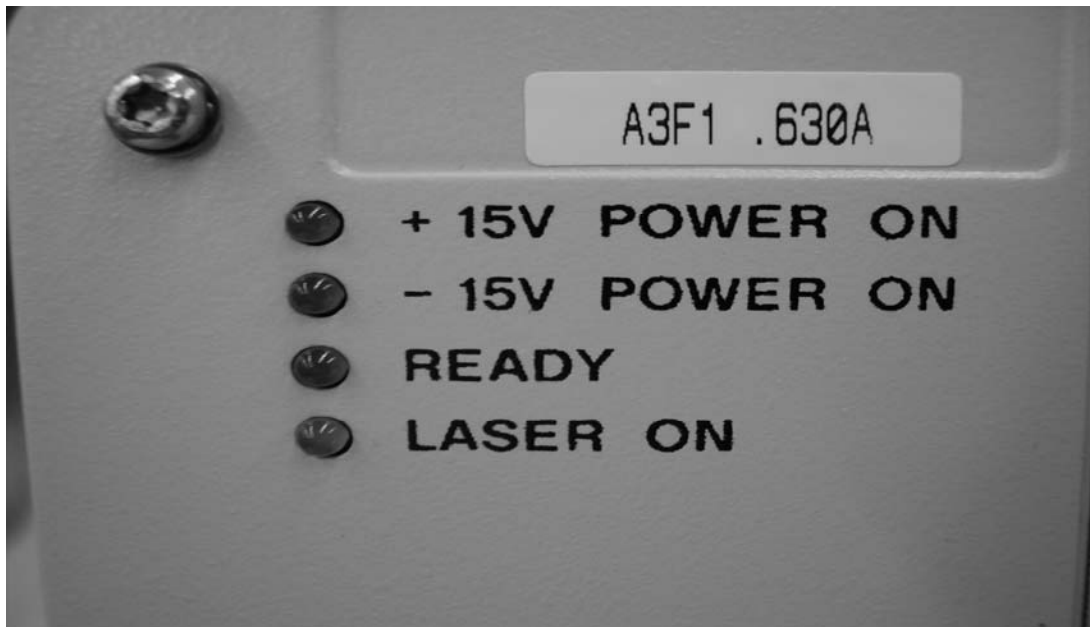
Picture shows placement of label.
