8156A-02

S E R V I C E N O T E

8156A Optical Attenuator

8156A Firmware Update to fix optical output power overshoot when switching from Enable to Disable

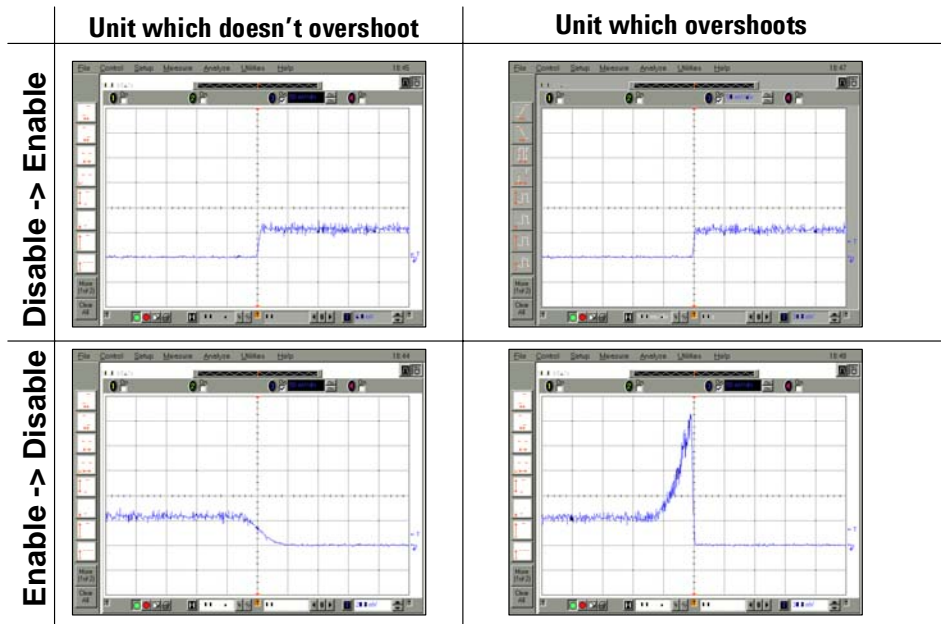
There is a potential risk of increased light power passing the optical attenuator’s output for a few milliseconds when switching from the Enable to the Disable mode. In the worst case, 100% of the incoming light will be emitted. The inconsistency is present in roughly 50% of the 8156A optical attenuators. Whether a particular unit is affected cannot be identified externally.

When 8156A gets Disabled from the Enable state, light might overshoot and the 8156A might output higher optical power level than given by the set attenuation value. (See the Figure below)

Solution is provided by firmware update which fixes the inconsistency.
