81142A-01-S

S E R V I C E N O T E

Product Number: 81142A High Speed Pulse Generator

POSSIBLE FIRE HAZARD

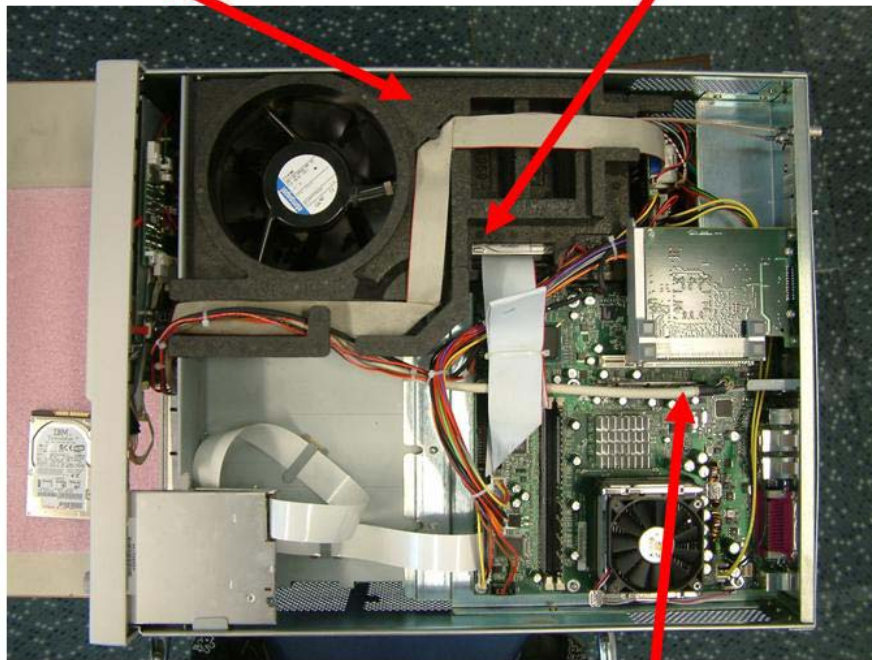
A surface-mount ceramic capacitor suffered physical stress during the manufacturing process, leading the capacitor to crack. During operation this crack placed stress on the internal structure of the capacitor, and caused the plates to short together. (The plates are separated by very little space, made up of very thin insulators.) This caused the capacitor to have very low residual impedance, resulting in a very high current conducted through the capacitor and the 12V path on the motherboard for some period of time. The low impedance didn't lead to a current high enough for blowing the fuse. Therefore the higher current was available long enough to create a very high temperature ($T > 300^{\circ}\text{C}$). The high temperature ignited the polyurethane molding used to conduct the airflow for cooling through the instrument.

The following photo illustrates the layout of the instrument. It shows the polypropylene molding, the graphics card and the starting point of the fire.

Polypropylene Molding

Start of Fire

Graphics Card

The countermeasure for this issue is to exchange the graphics cards. The new graphics cards are produced with an improved manufacturing process eliminating the risk of micro cracks and have additional fusing to protect the 12V path. The graphics card can be exchanged by Agilent authorized personnel only.

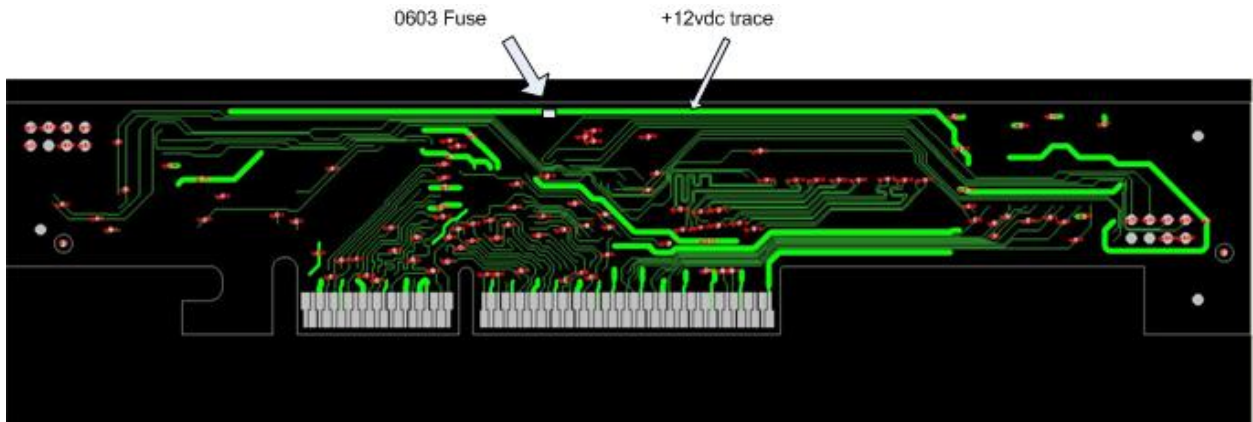
The following picture shows the graphics card with the added fuse:
