S E R V I C E N O T E

8116A Pulse/Function Generator 50 MHz

Serial Numbers: 3134G11521 / 3134G12895

New Firmware Avoids EOI Problems**To Be Performed By:** Agilent-Qualified Personnel**Parts Required:**

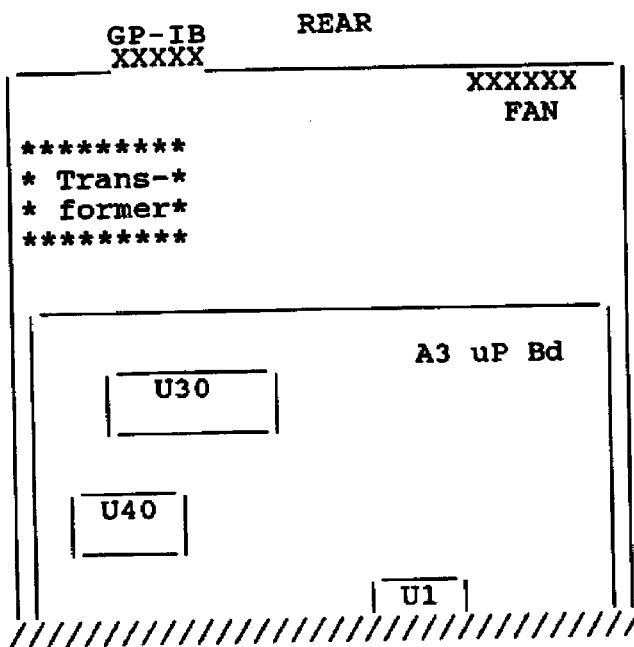
Topview:

Some customers have indicated that the GPIB hangs up/front panel locks up when the 8116A is under GPIB control and the used terminators are 'CRLF' and 'EOI'. The instrument is designed to operate with messages terminated by 'CRLF' or 'END'!

Order the new firmware 08116-10027 and replace A3 U40: Remove the bezel rear and the cover. The A3 microprocessor board is the top board. U40 is mounted in a socket.
