S E R V I C E N O T E

**E2225A/E8600A Calibration System Modules
E9119A Calibration System CON2 Module**

CON2 SRAM Data Loss modification.

DATE: January 1999

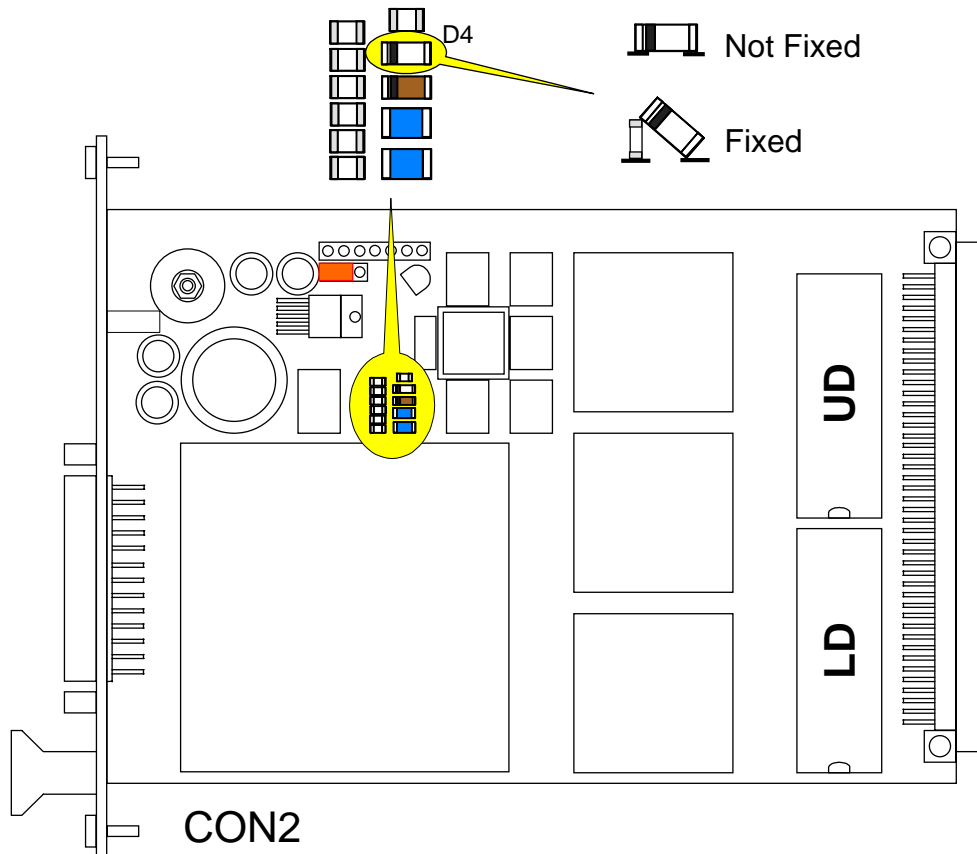
The CON2 module can experience data loss under extreme environmental conditions causing the power supply voltage rise time to be unusually long. Such conditions do occur however, during routine (and specified) use of the CAS.

The problem occurs because of a design error made by our supplier. The supplier has agreed to fix faulty modules free of charge. Because of the nature of the HW-modification required to fix the problem the repair cannot be done in the field. Therefore the recommended repair strategy is PCA-exchange.

The fix can be recognized by looking at the SMT diode marked D4 in figure 1. If the diode is replaced by a combination of an SMT resistor and a diode, the board has been fixed.

Figure 1. CON2 SVRAM Data Loss Modification
