**4395A-16**

# S E R V I C E N O T E

## Agilent 4395A Network/Spectrum/Impedance Analyzer

**Firmware upgrade to fix occasional rise in noise floor and the shift of measurement signal in frequency with SA mode.**

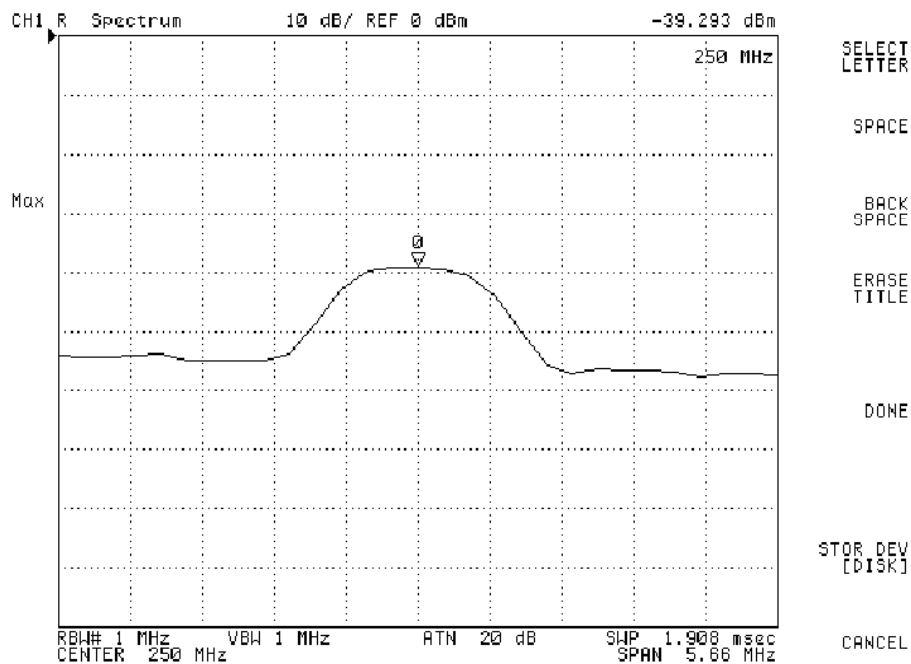
- 1) Press [Preset]
- 2) Press [Meas] and set analyzer type to spectrum analyzer.
- 3) Set frequency to Center: 250 MHz, Span: 5.66MHz.
- 4) Press [Bw/Avg] and set RES BW to 1MHz.
- 5) Press [Display] and set DATA HOLD to MAX
- 6) Leave the unit running for an hour and confirm if a peak can be observed. See Fig.1 for the type of peak that can possibly be observed. Typically the peak is around  $-40\text{dBm}$ .  
If a peak is observed, upgrade the firmware to revision 1.10 or above.

Fig.1 Peak observed with the indicated procedure.

To install the latest firmware, click “Software & Firmware Downloads” at below URL. Then click the heading in the column of Firmware Update and follow the firmware installation procedure to install the latest firmware.

Order firmware revision label 1.10. Detach the old firmware label on the rear panel of 4395A and attach revision label 1.10.
