S E R V I C E N O T E

4396A Network Spectrum Analyzer

A2 Shutdown Circuit Malfunction

DATE: 10 June 1993

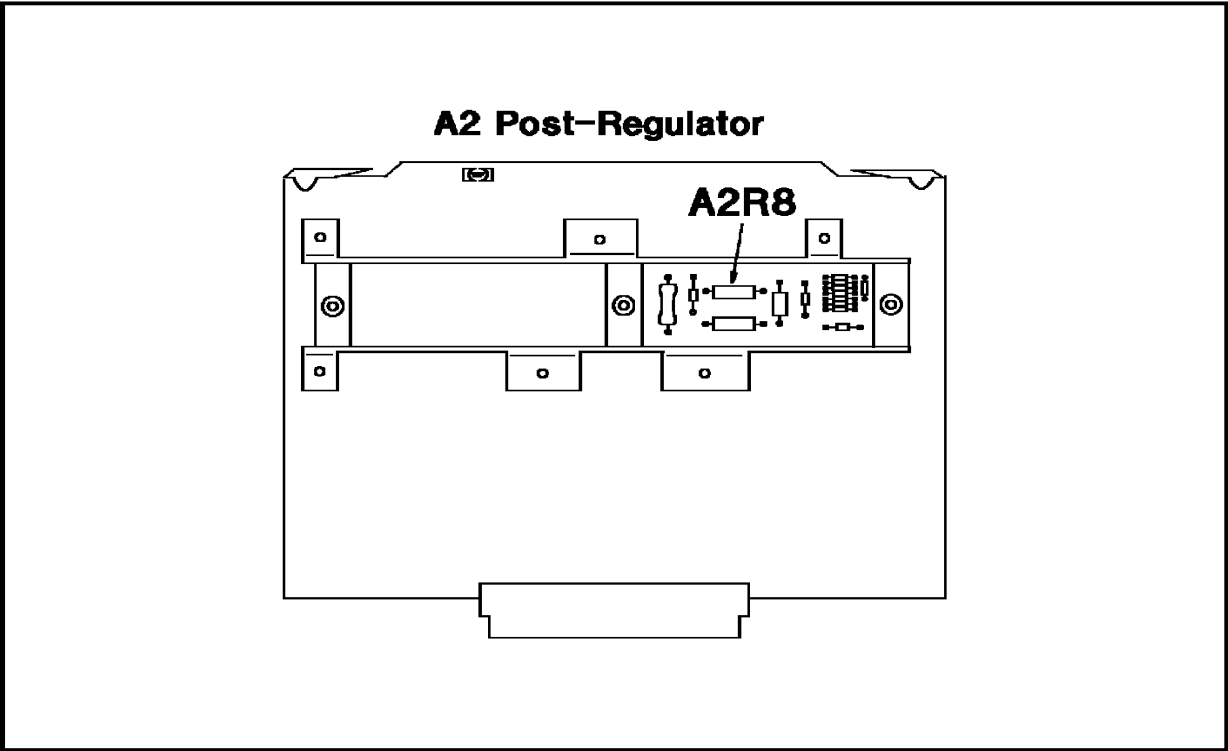
Figure 1. A2R8 Location

The A2 shutdown circuit in the 4396A with one of serial numbers listed above may not work properly. When one or more circuit board power traces of -15 V, -5 V, +5 V, +5.3 V, + 8.5 V, and +15 V is shorted to the ground, the A2R8 resistor fails or is damaged by overheating before the shutdown circuit is activated.

- 1. Remove six screws on the shield plate of the A2 post-regulator. Then remove the shield plate.
- 2. Inspect the A2R8 resistor for any damage due to over heat or check if its resistance is approximately 1 ohm using a Multimeter. See Figure 1 for the A2R8 location.

When the A2 assembly is defective, replace it with a new one. Before throwing the old A2 away, inspect the A2R8 resistor according to the following procedure.

If A2R8 is damaged due to over heat, the A2 replacement is covered by this service note, but other assembly replacements are not applicable.
